Historic Building Condition  
Assessment Report and Preservation Plan for the

# Victory Hotel

Located at 307 S. Main Street, Las Vegas, Clark County, Nevada

September 2013

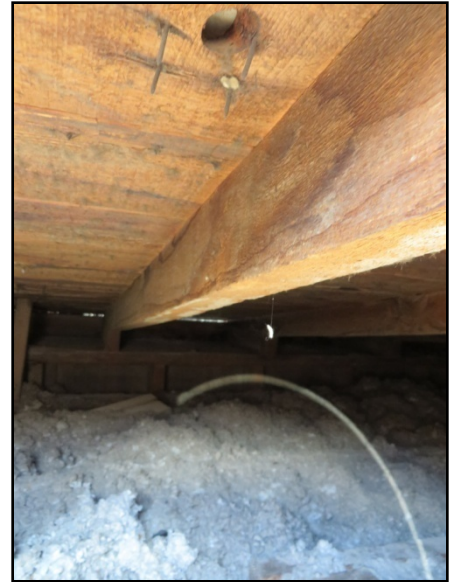
**Upper Main Roof:** Roof framing forming a shallow-pitched (1:12 slope), hipped roof configuration is intact and in good condition. The majority of the wood framing is 2 X 4 roof and ceiling joists at 24 inches on center. There are two built-up wood “trusses” consisting of 1 X 4 boards with x-bracing between vertical supports spanning at approximately one-third intervals longitudinally (east/west parallel with the ridge) which appear to stabilize the perpendicular roof joist framing at approximately mid-span from the eaves to the ridge. There appear to be a series of 1 X 4 supports at roughly 4 feet intervals running along the central longitudinal ridge line. The ridge board appears to be a 1 X 4 that has no carrying capacity, but instead functions as the intersection line for the roof joists. Roof sheathing consists of wood planks (approximately 1 X 8) spanning perpendicular to the roof joists.

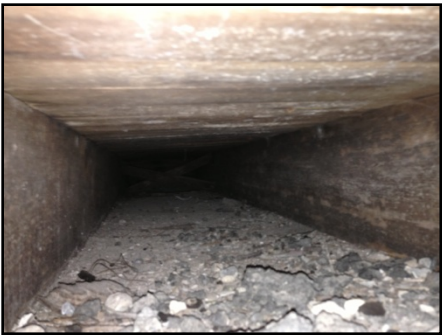
**Ground Floor Framing:** This floor is framed with full dimension 2 X 6 lumber at 16 inches on center. It frames to a double 2 X 6 rim joist under the perimeter exterior walls and likely the same condition at intermediate bearing walls. The joists span a maximum of 12 feet and are covered with diagonally placed wood subfloor planks and 3½-inch-wide hardwood tongue and groove boards which appear to be in good condition except where newer waste plumbing was added.

**Ground Floor Framing:** The entire perimeter should be excavated to reveal the extent of damage to the double rim joists and to confirm whether any unexpected or unobserved pier foundations may exist. If none exist, the entire perimeter and key locations on the interior at intermediate bearing walls, such as the posts supporting the stair opening and adjacent to wall offsets in the hallway, should be excavated deep enough to jack up the vertical wall framing while the rotted rim joists are removed and the lower wall studs inspected. The new double 2 X 4 rim joists or 4 X 6 floor beams should be pre-treated termite resistant lumber.

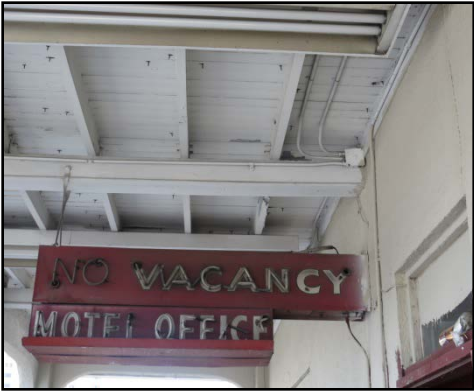
**Balcony Floor Framing:** This 2 X 6 wood framing at 16 inches on center runs lengthwise over 4 x 6 beams at roughly 9 feet 3 inches on center spanning 10 feet from the front wall to the original outer balcony columns. All floor framing is exposed to view from underneath (no ceiling) and appears to be in good condition. However, the balcony floor was enclosed by low infill framing between the ca. 1920s stucco arches which likely traps rainwater, and causes water damage to the top side of wood plank sheathing.

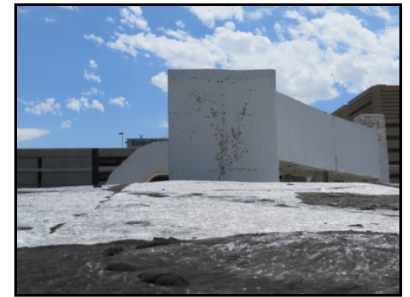
The roofing appears to be up to six layers of built up and hot mopped roofing, much of it a series of patches. The multiple layers add considerable weight to the roof, and likely conceal water damaged wood plank sheathing and various sources of leaks. Some of the roof layers, especially the original cap sheet, are likely asbestos laden. See the Asbestos survey report in the Appendix C.

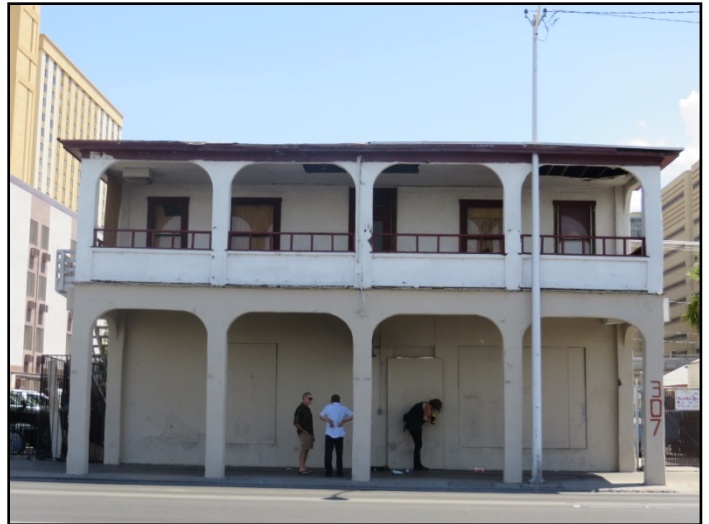
The existing stucco on chicken wire finish is suspected to have been added ca. the early 1920s over the original wood clapboard siding. The stucco finish was very likely part of a re-imaging effort to change the character of the building from the Vernacular architectural style to the *en vogue* Mission Revival Style. Adding stucco over wood siding would reduce maintenance and upkeep to wood as well. This effort likely included furring out the original front balcony columns to add “mass” and applying false shallow arches in between. The resultant narrow column massing and slim proportions of arches appear visually awkward and false.

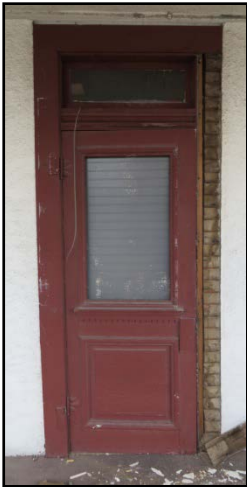
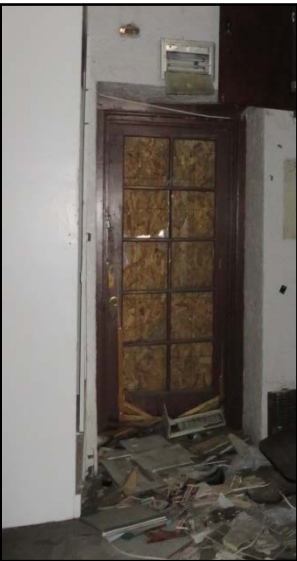
Judging from the oddly angled and recessed configuration, the resultant narrow sidelight and the location of the original transom, the main front door (00) appears to have been relocated ca. 1959 and replaced by a single lite door. None of the hardware appears original except perhaps the door closer at the top.

The front door (00) should be moved back to its original location with the new door matching the original balcony door above.

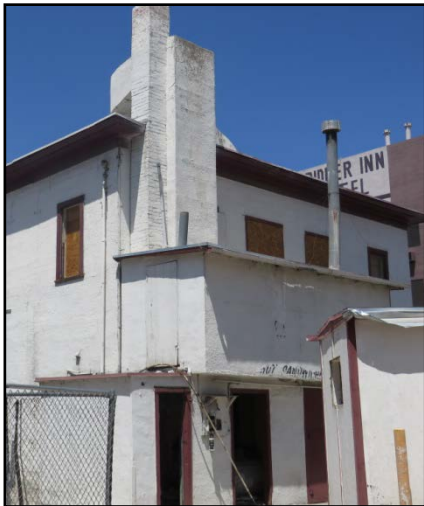
The rear door (00D) is a ca. 1970's 10-lite French door meeting ADA accessibility door width criteria. The door frame appears to be original, but there is no original hardware remaining. A suspected original operable transom window above this door has been enveloped a by ductwork soffit.

The rear shed doors (00E & 00F) vary and are non-original. Two shed doors providing access to the laundry/electrical/furnace room are missing.

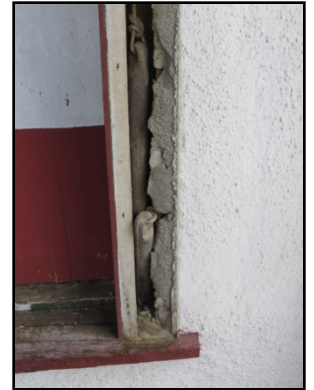
All windows are in various states of repair and disrepair, some vandalized, others having harsh sun exposures and multiple layers of paint.

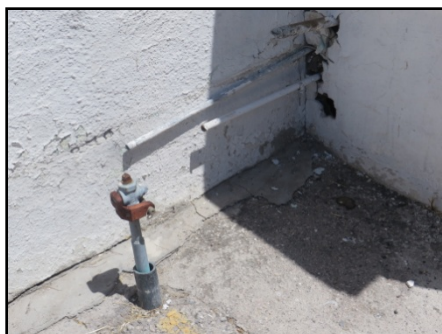
The ground floor is virtually flush with its surroundings, now almost entirely asphalt paving with coved cement patching at the base of stucco clad walls. Roof drainage pours directly off all four side of the building along the projecting eaves. There are no gutters or roof drain leaders on the roof to direct drainage away from the building causing water damage to the perimeter wood rim joists causing them to decay.

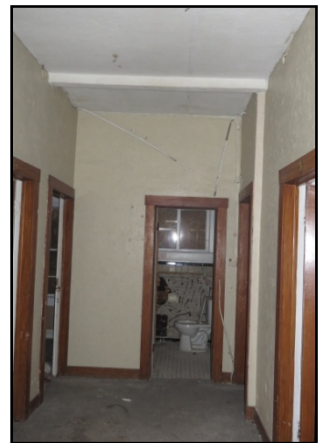
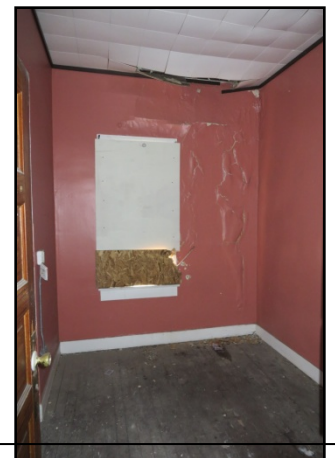
**Other:** Obviously newer non-full height walls were added in Guest Rooms 04 and 05. Early 1920s mud-set ceramic tiles form a wainscot in Bathroom 16. Un enclosed and unfinished remodeled walls were found in Bathroom 06.

Remove newer non-full height walls added in Guest Rooms 04 and 05.

Finish recently remodeled walls in Bathroom 06.

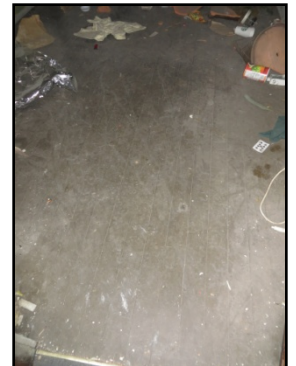
Non-original, non-full height walls in Guest Room 04 & 05 are attached to hardwood flooring. The c. 1970's corner bathroom in Guest Room 04, where toilet and sink waste plumbing were

added below the floor, has been compromised and severely termite damaged due to an abundance of leaking water.

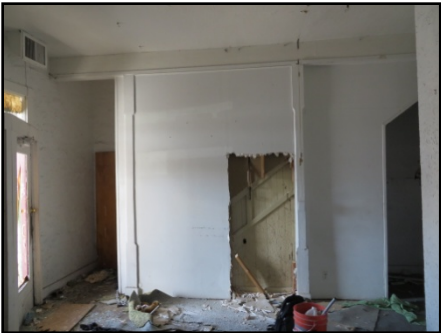
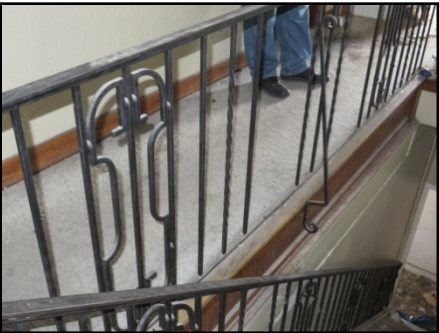
Interior stairs are intact and unaltered with the exception of the circa 1975 stairway enclosure. The original wrought iron balcony and stair railings are generally intact, missing only a few segments of wrought iron balustrades with decorative filigree. Carpet added to stair treads does not allow visual condition assessment, but the treads all felt firm and quite sturdy. The view of originally open stairway and a degree of openness from the Lobby has been lost due to its enclosure.

Stair enclosure is non-original and does not meet Code with door located at the bottom of the stairs disallowing proper access to the floor/landing.

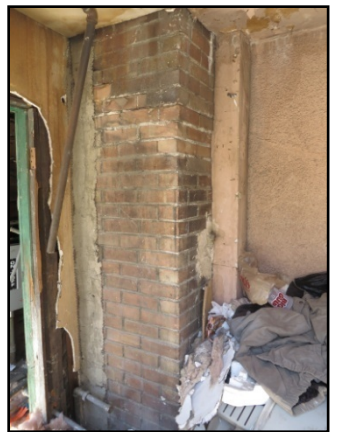
The original building had no mechanical HVAC systems. Heating most recently was likely from a gas furnace and ducted. There is written evidence of individual gas heaters in each room once causing a fire, but none were found. There is an abandoned use brick chimney near the center of the building likely used for a wood cooking stove for the kitchen.

The latest existing mechanical system could not be accessed or tested. The present system appear awkwardly integrated into the building with exposed ductwork spanning above on the roof into the attic there are exposed vertical ducts found and in the upper Hall 15 penetrating into soffits for distribution above closets and the Lobby ceiling.

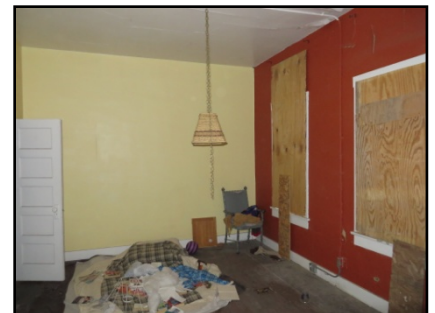
The majority of electrical systems and copper wiring were missing, likely stolen for salvage value. The outdated electrical distribution boxes were still in place in the Electrical shed located below the overhead electrical service. Evidence of later exposed conduit on the interior indicated an upgrade to the original fabric wrapped wiring with ceramic insulators found in the attic attached to ceiling joists.
