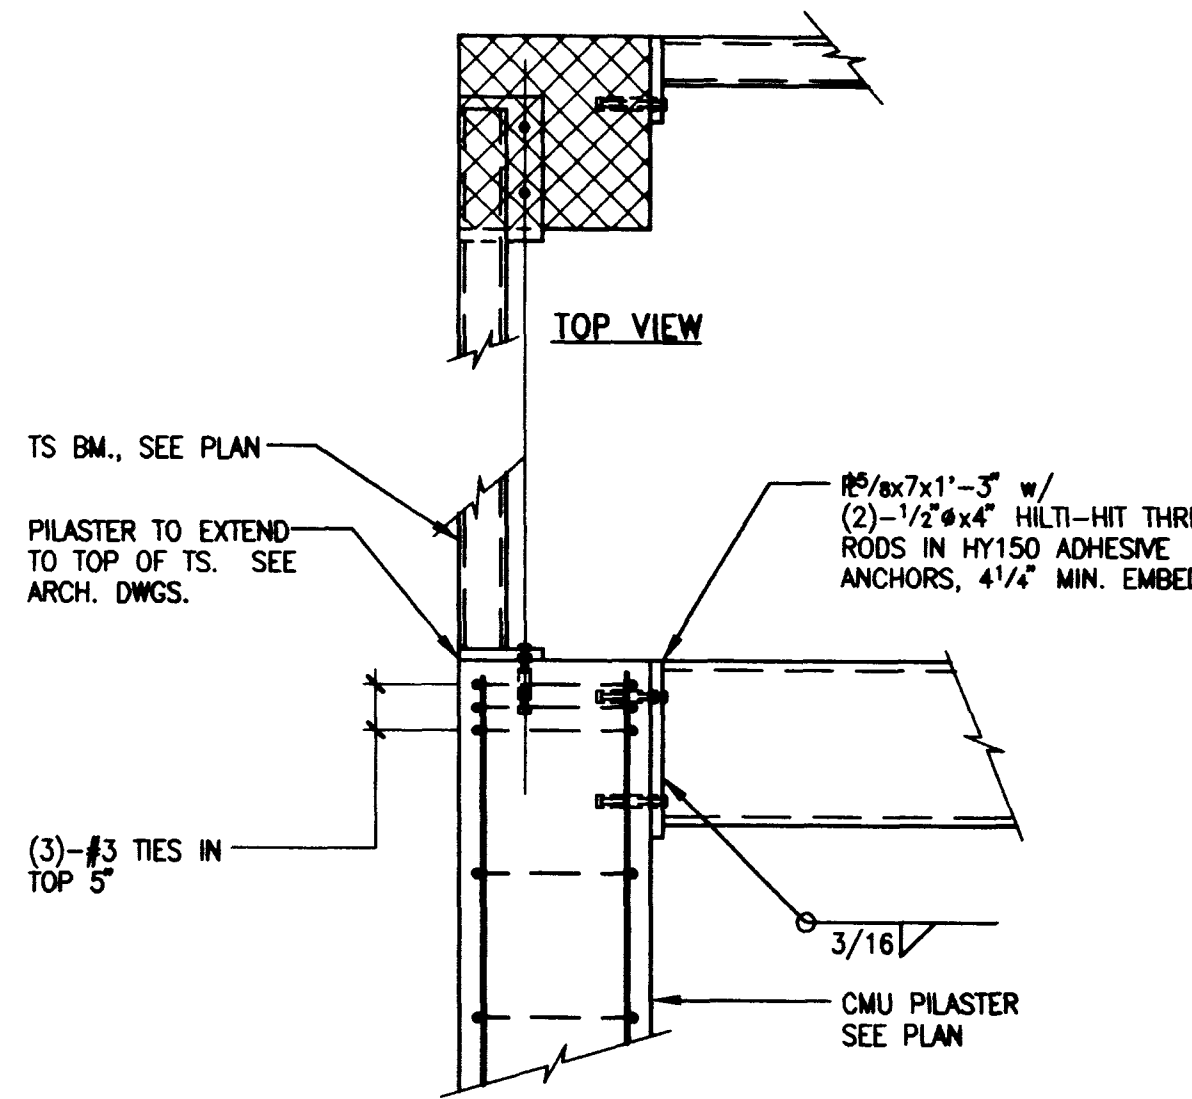
**DETAIL 12**  
BEAM BEARING PLATE AT PILASTER

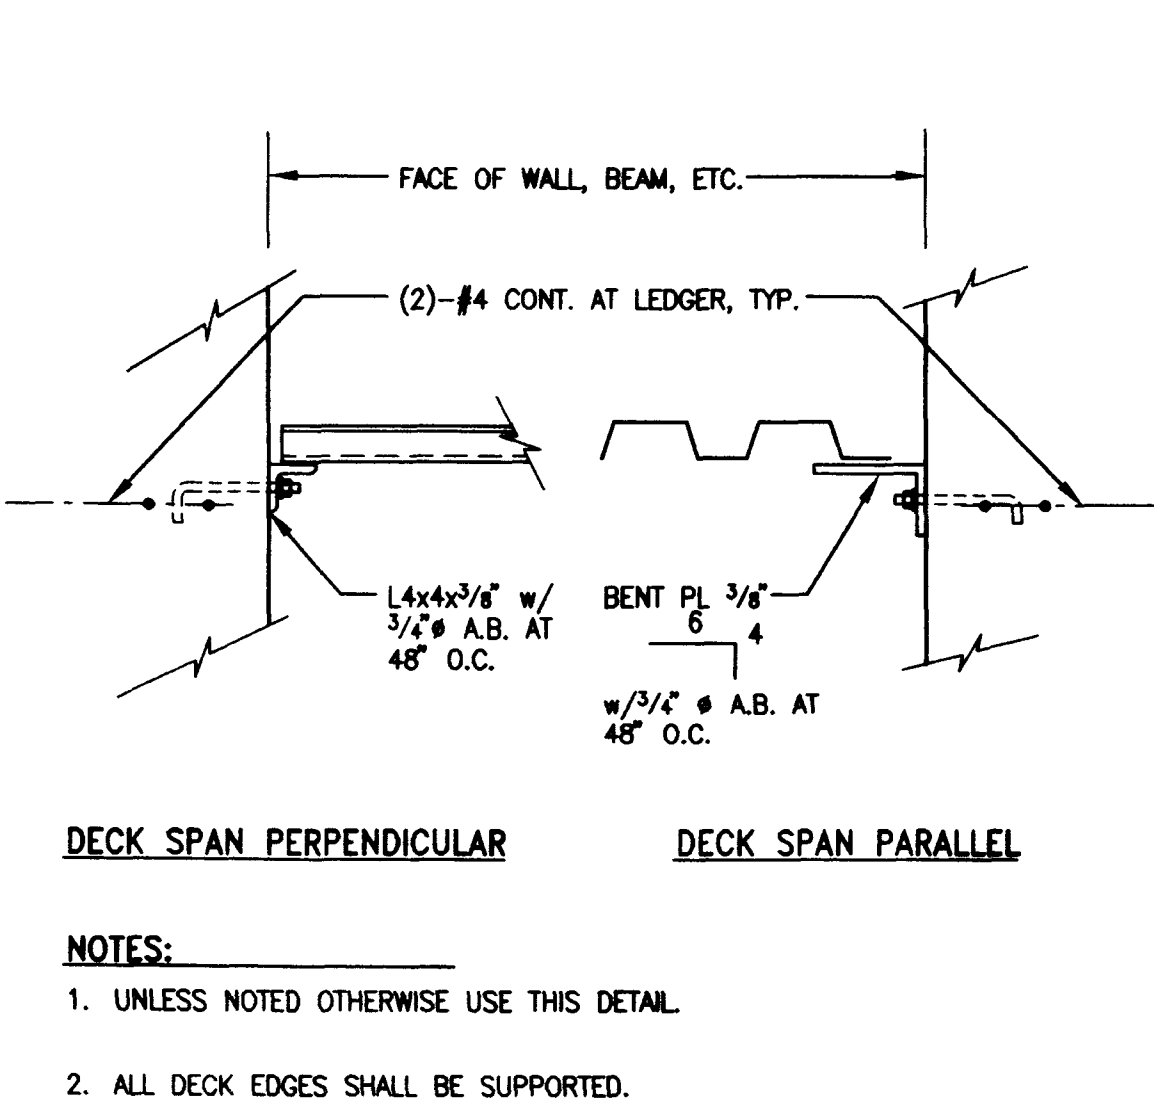
**DETAIL 9**  
LEDGER ANGLES

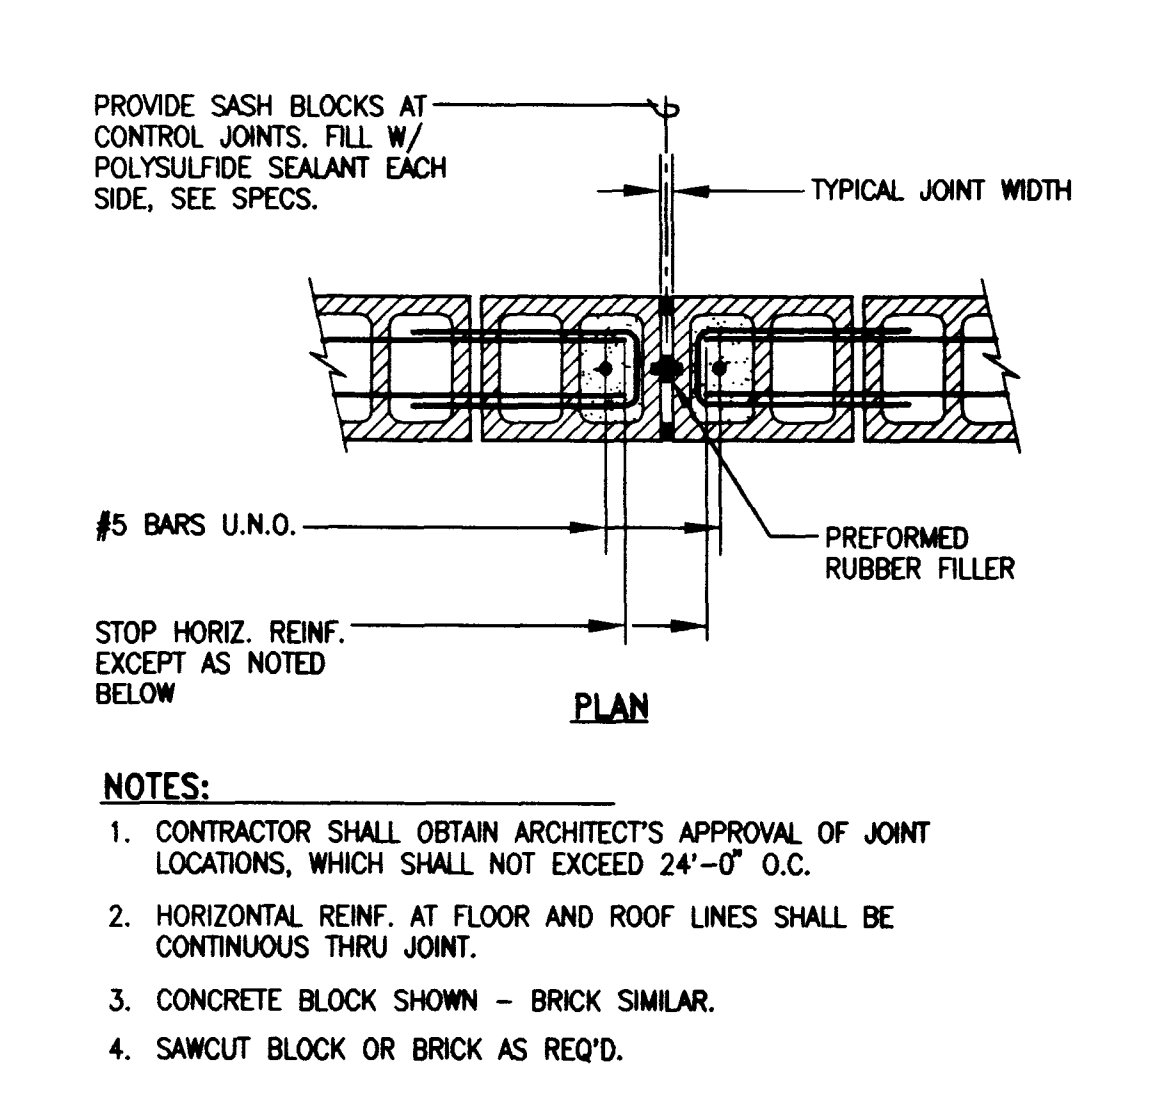
**DETAIL 6**  
CMU WALL CONTROL JOINT

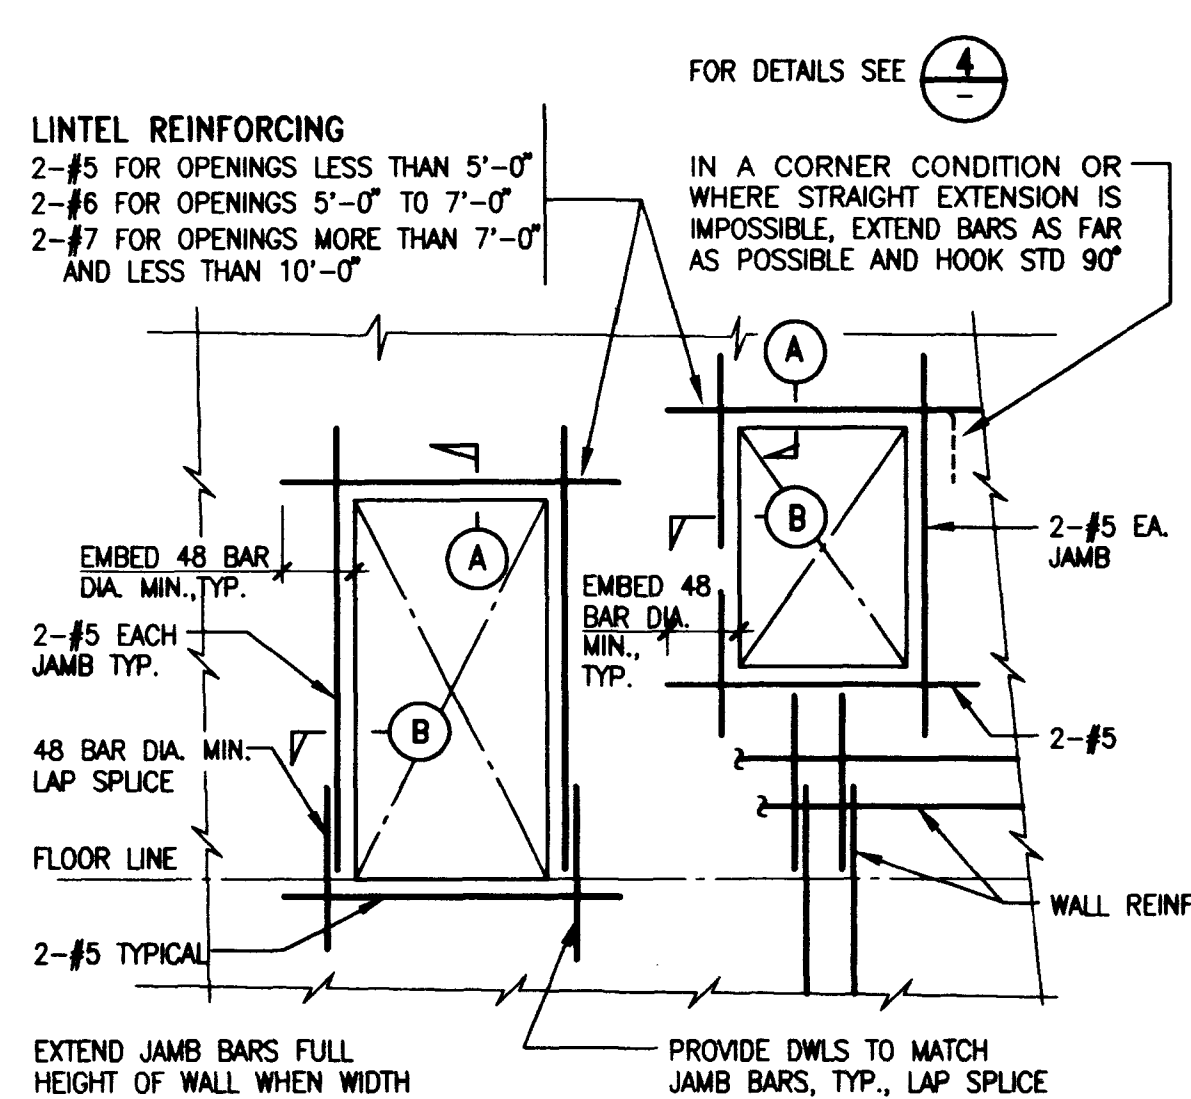
**DETAIL 3**  
MASONRY WALL OPENINGS

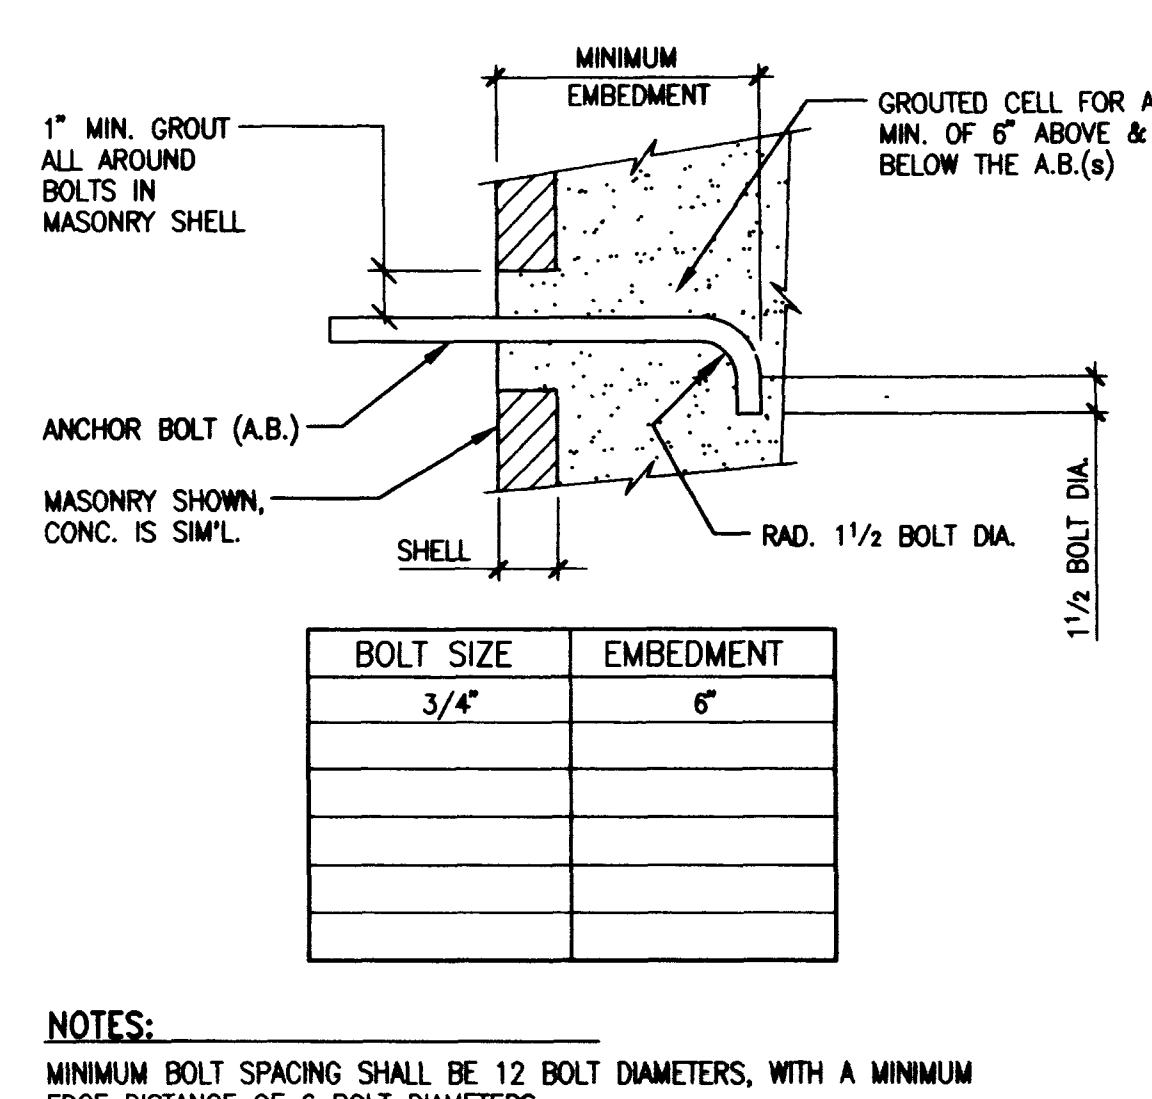
**DETAIL 1**  
ANCHOR BOLT EMBEDMENT

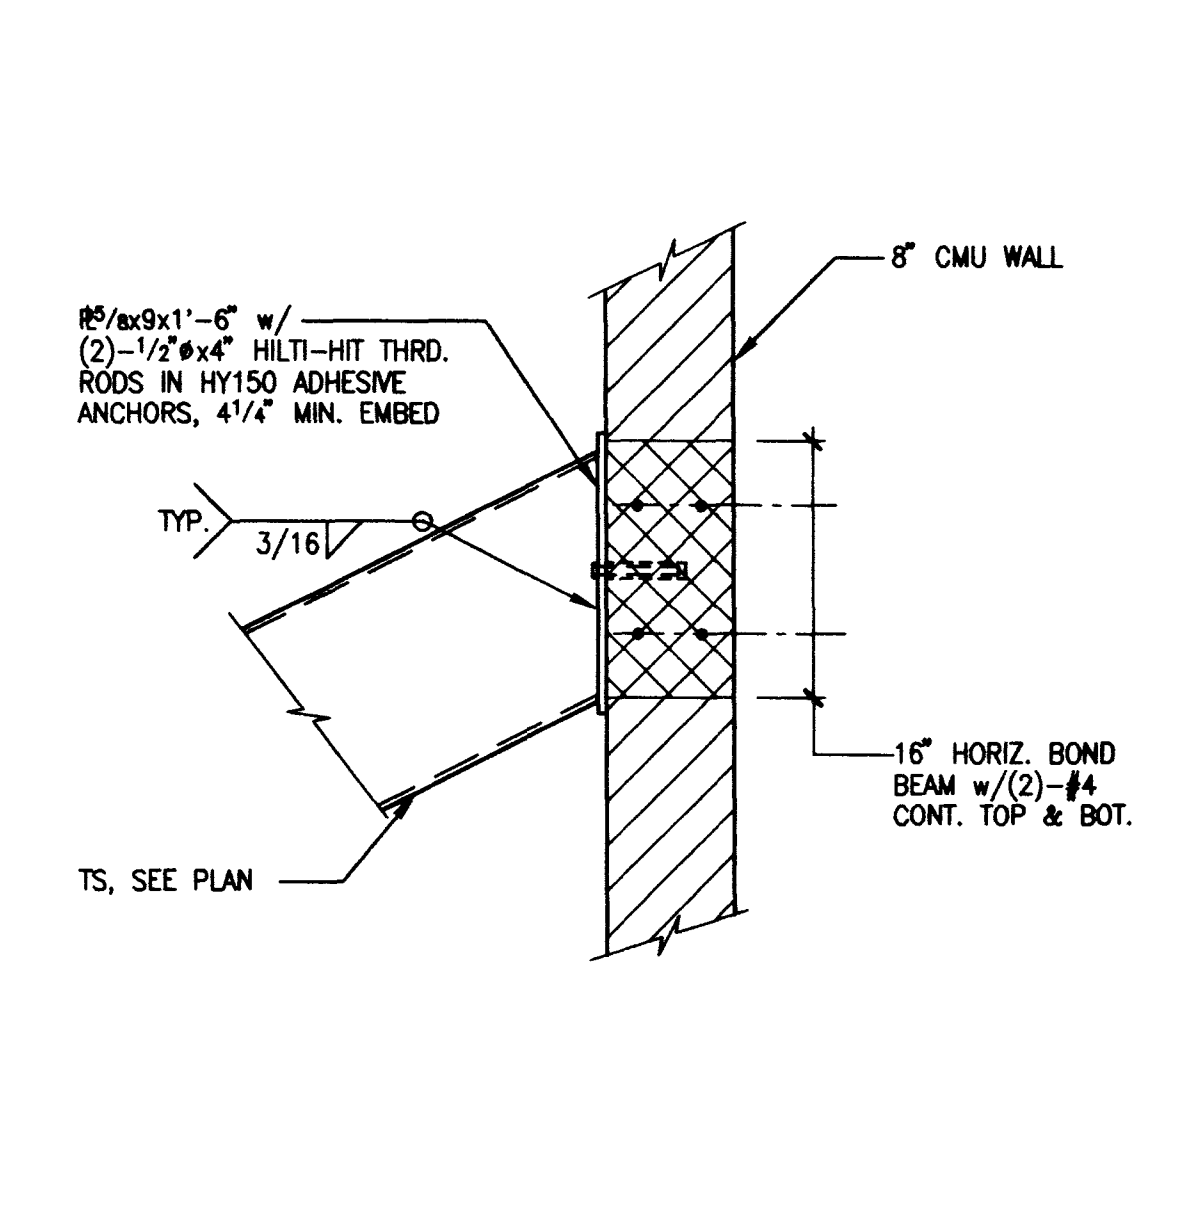
**DETAIL 13**  
SLOPED BRG. PLATE AT TOP OF MASONRY WALL

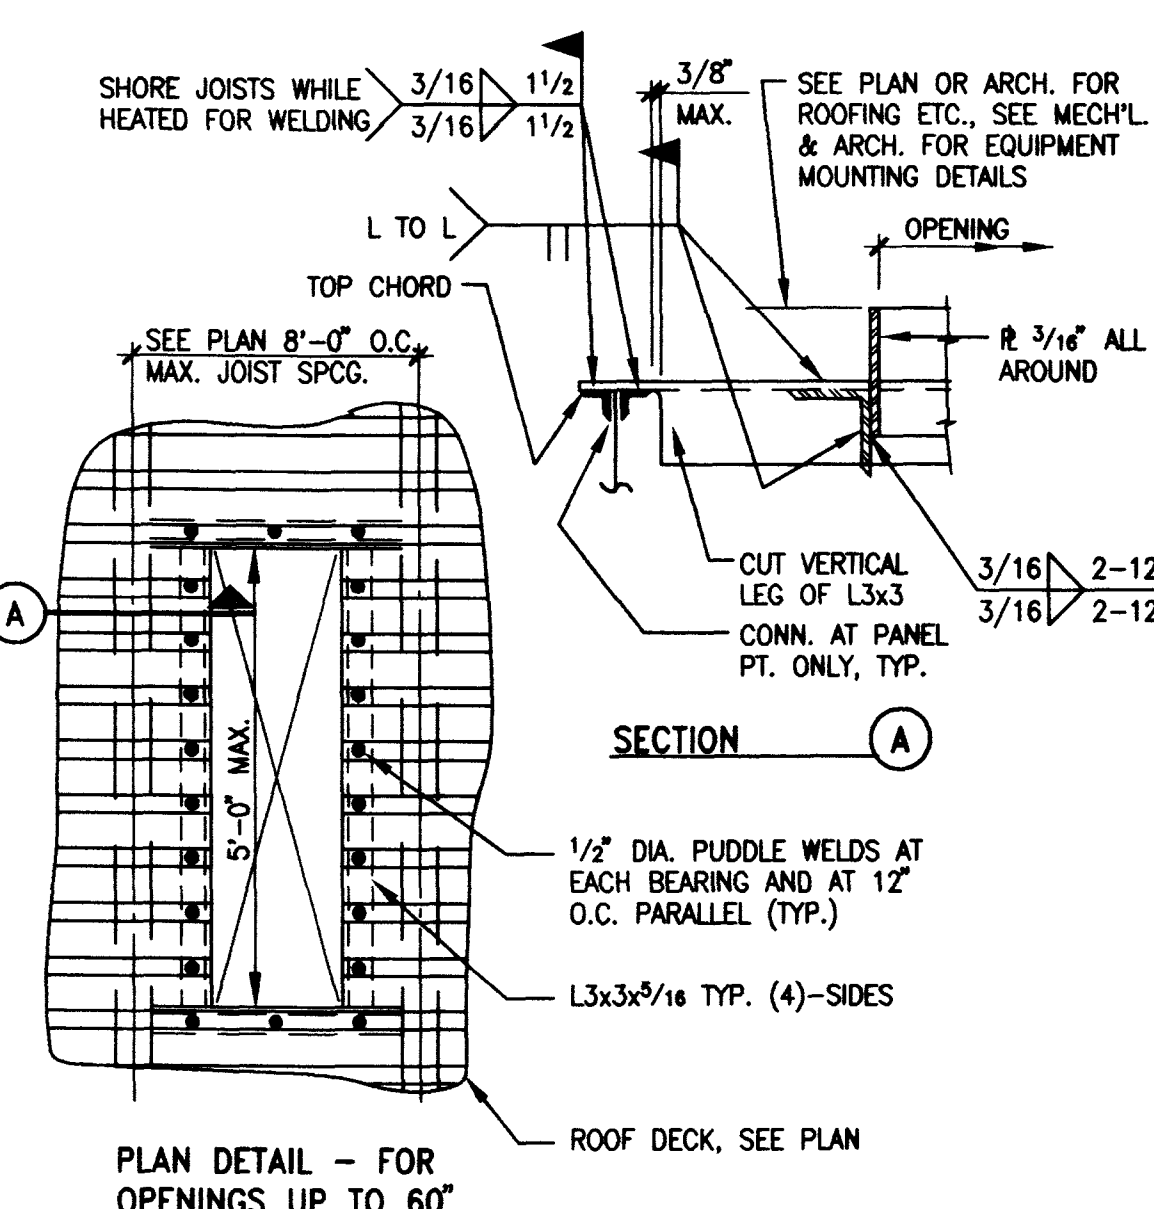
**DETAIL 10**  
OPENINGS IN ROOF DECK

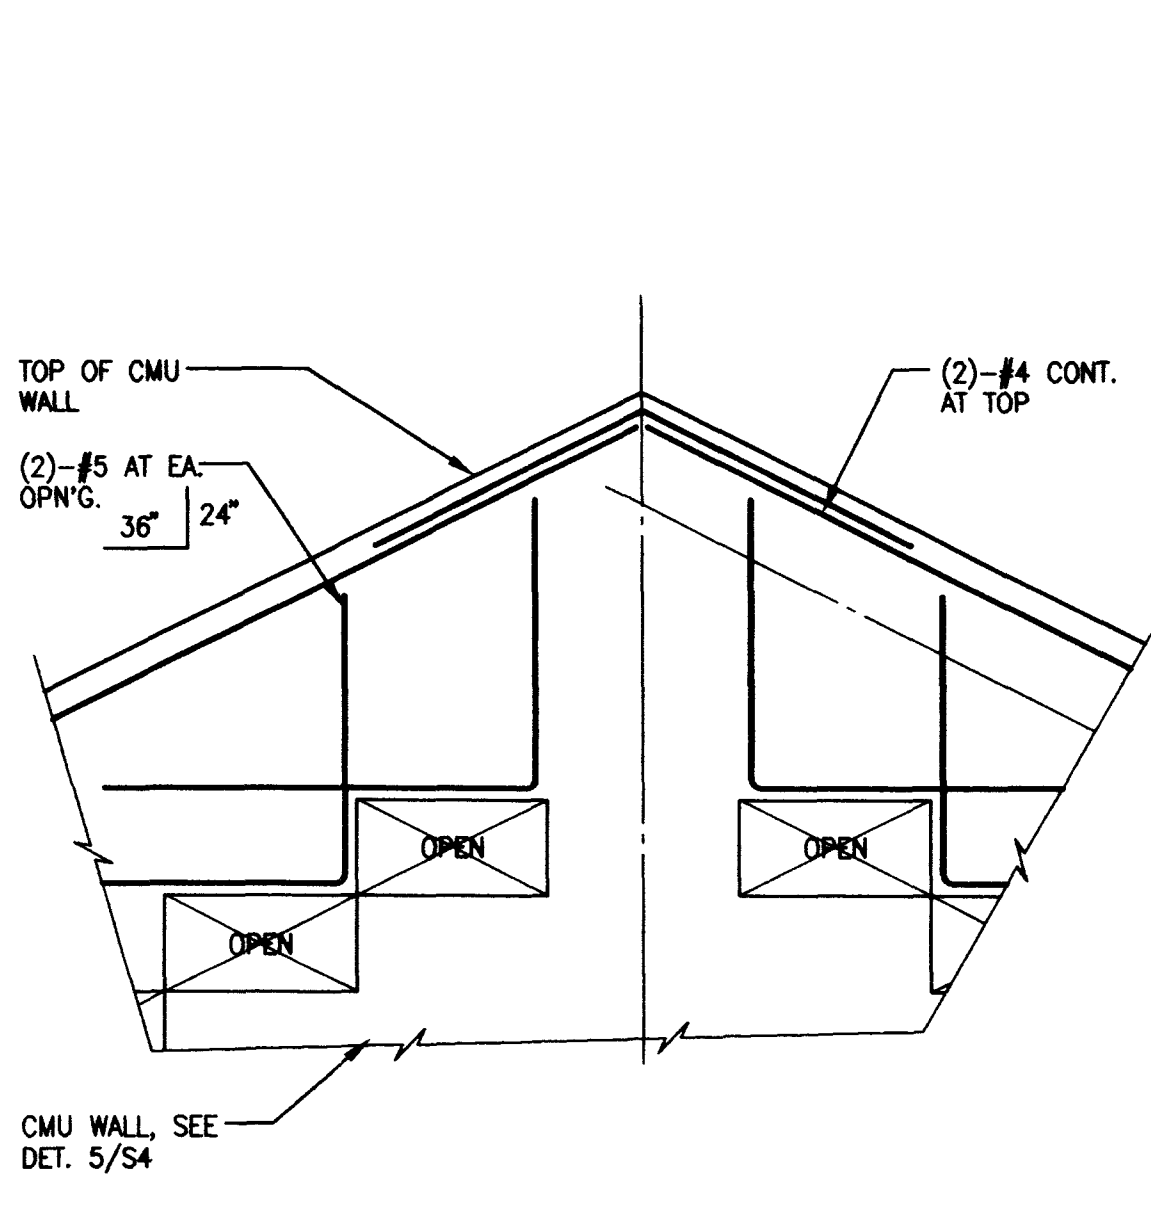
**DETAIL 7**  
TOP OF WALL

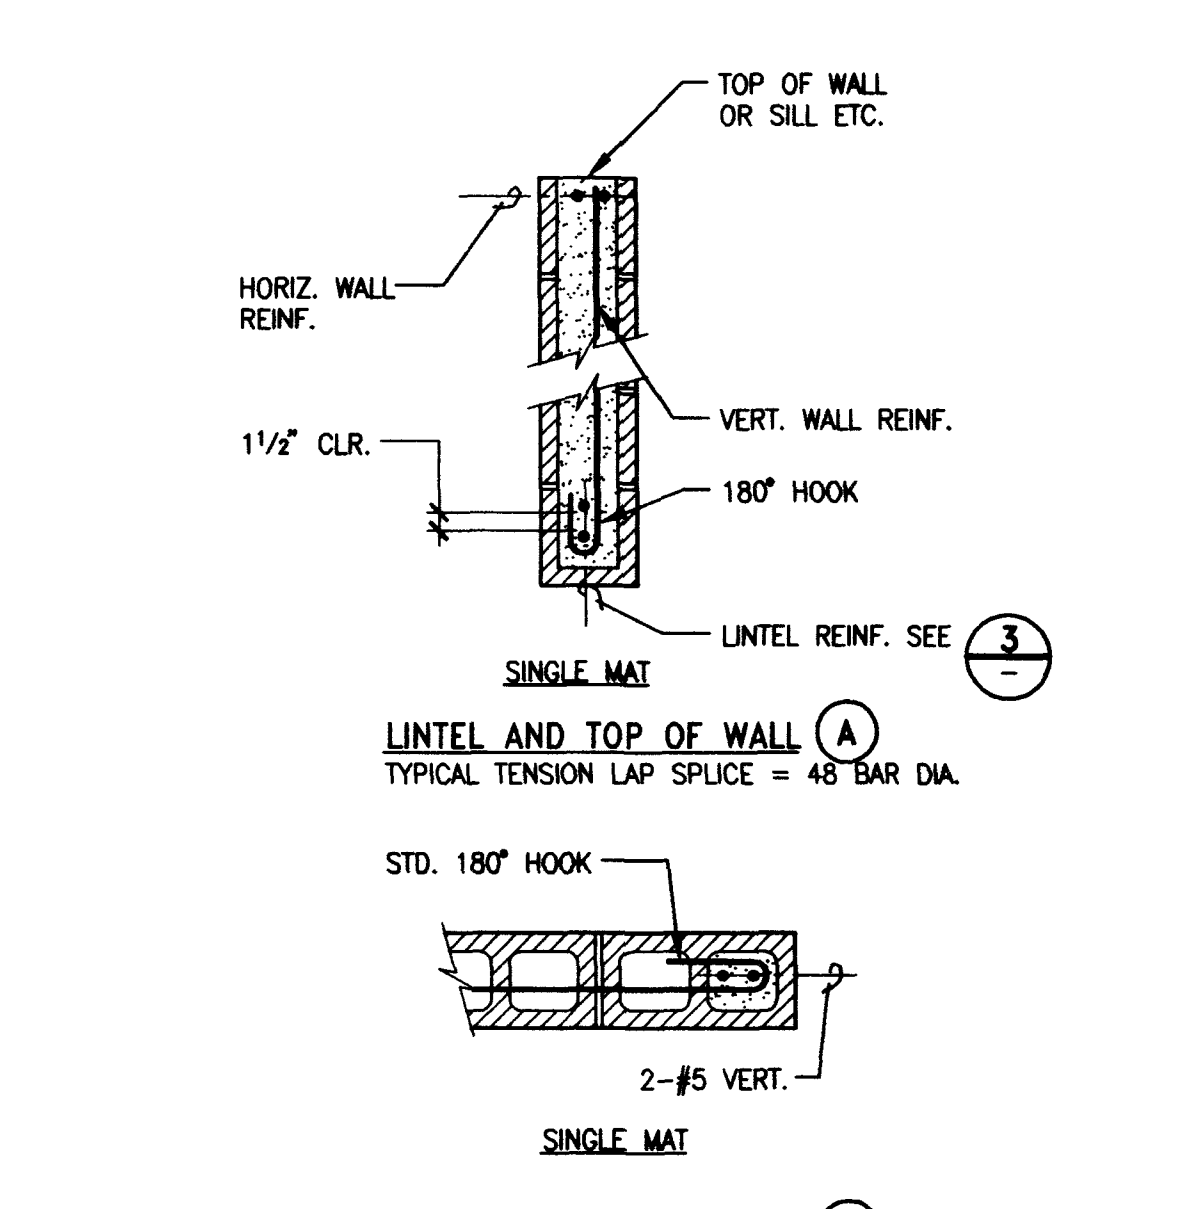
**DETAIL 4**  
WALL OPENINGS DETAILS

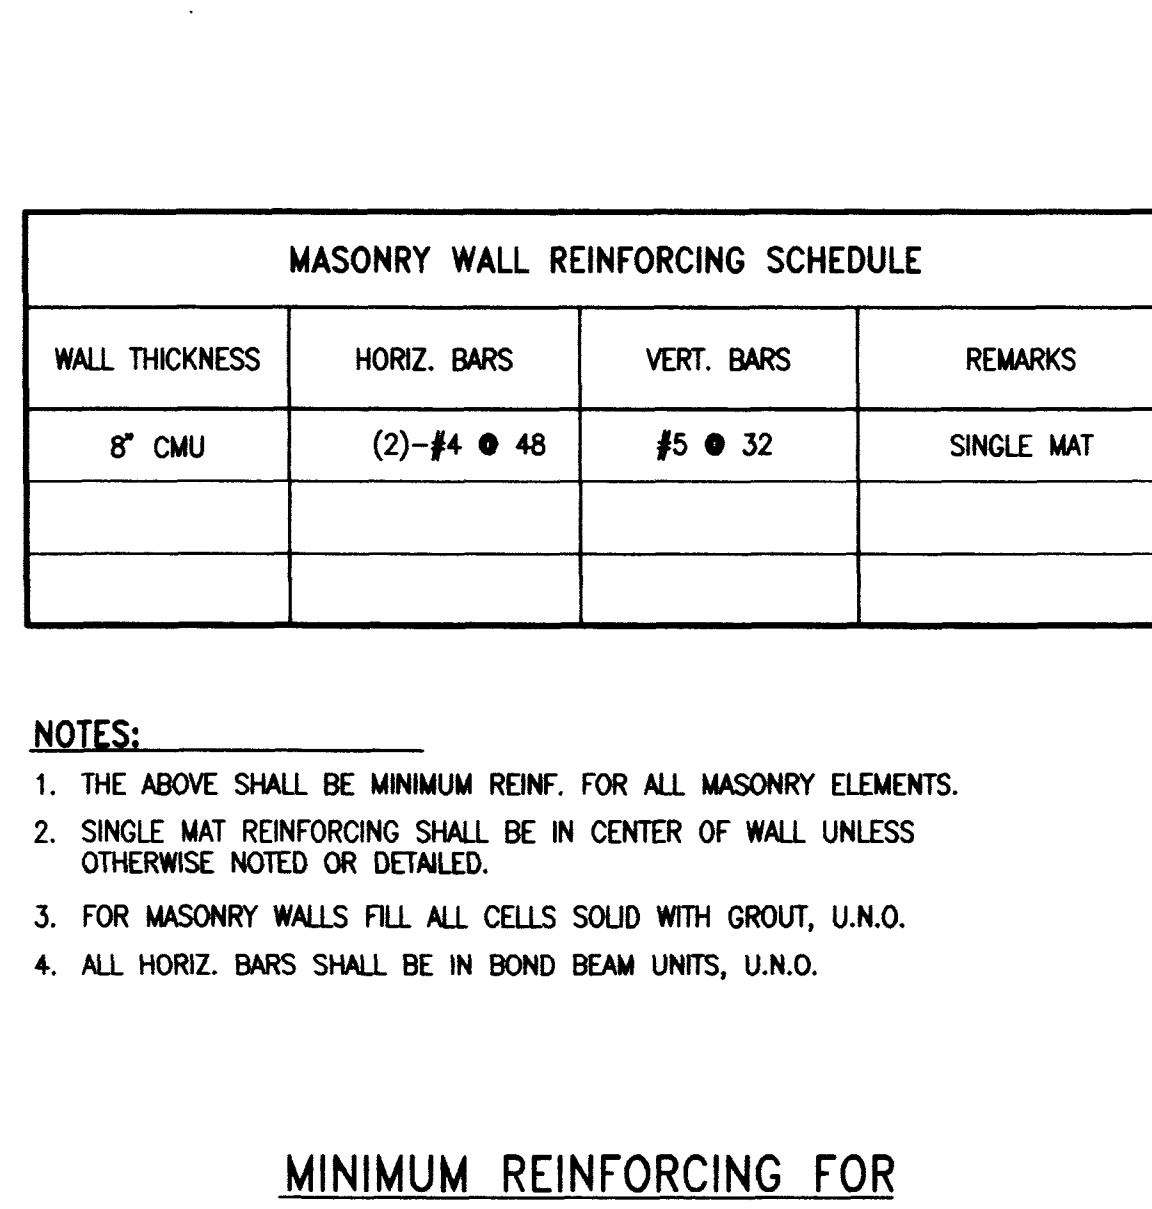
**DETAIL 2**  
MINIMUM REINFORCING FOR MASONRY WALLS

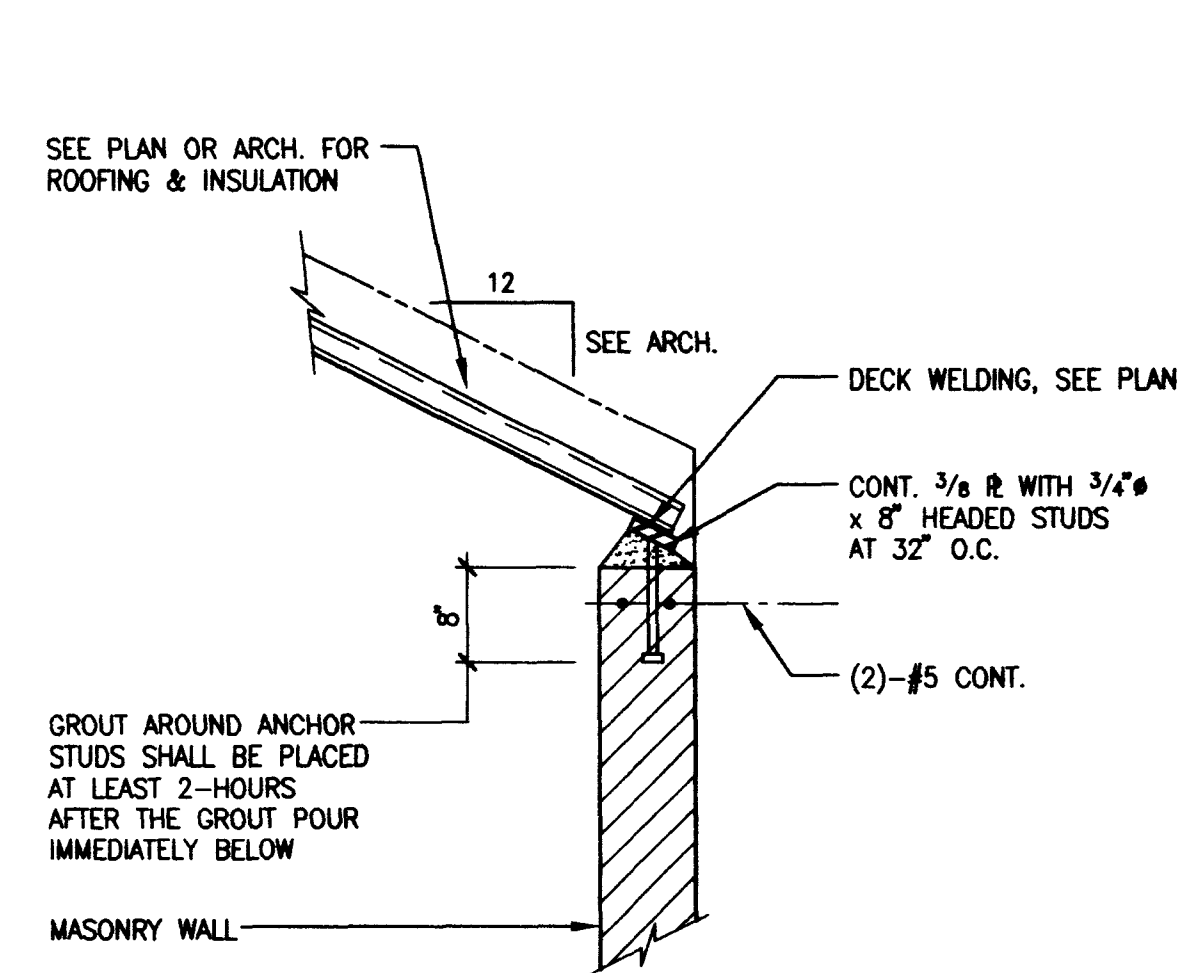
**DETAIL 14**  
SLOPED BRG. PLATE AT TOP OF MASONRY WALL

**DETAIL 14**  
SLOPED BRG. PLATE AT TOP OF MASONRY WALL

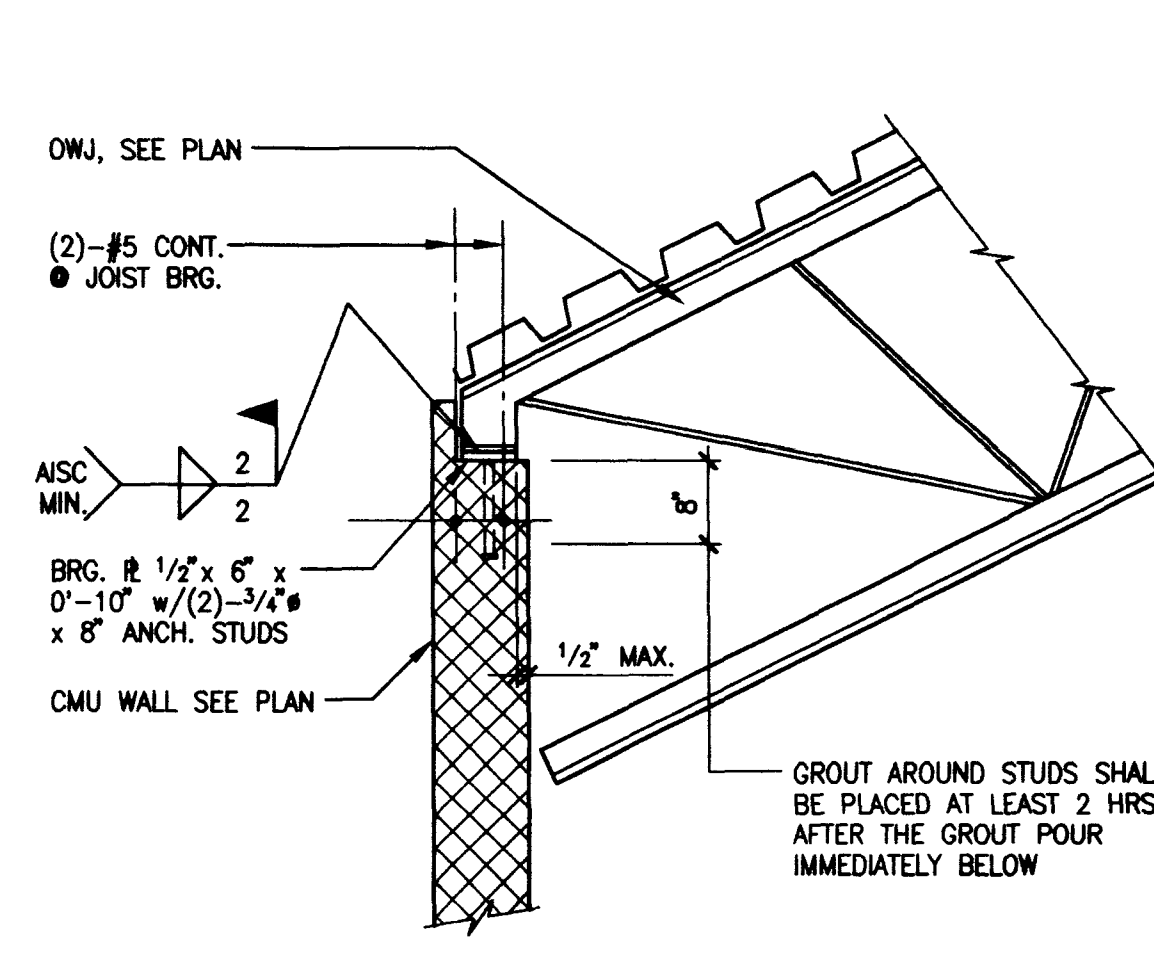
**DETAIL 11**  
JOIST BEARING PERPENDICULAR TO WALL

**DETAIL 11**  
JOIST BEARING PERPENDICULAR TO WALL

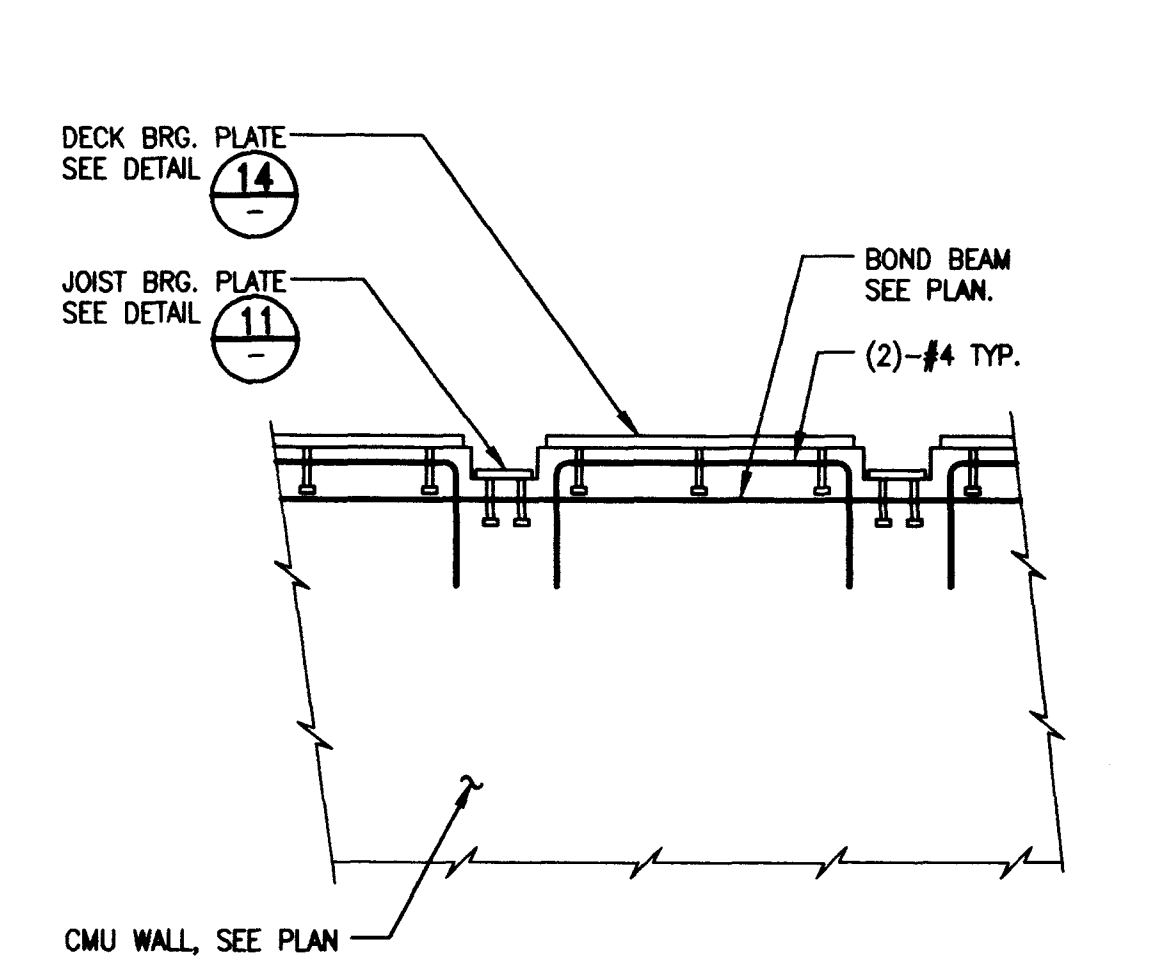
**DETAIL 8**  
TOP OF WALL

**DETAIL 8**  
TOP OF WALL

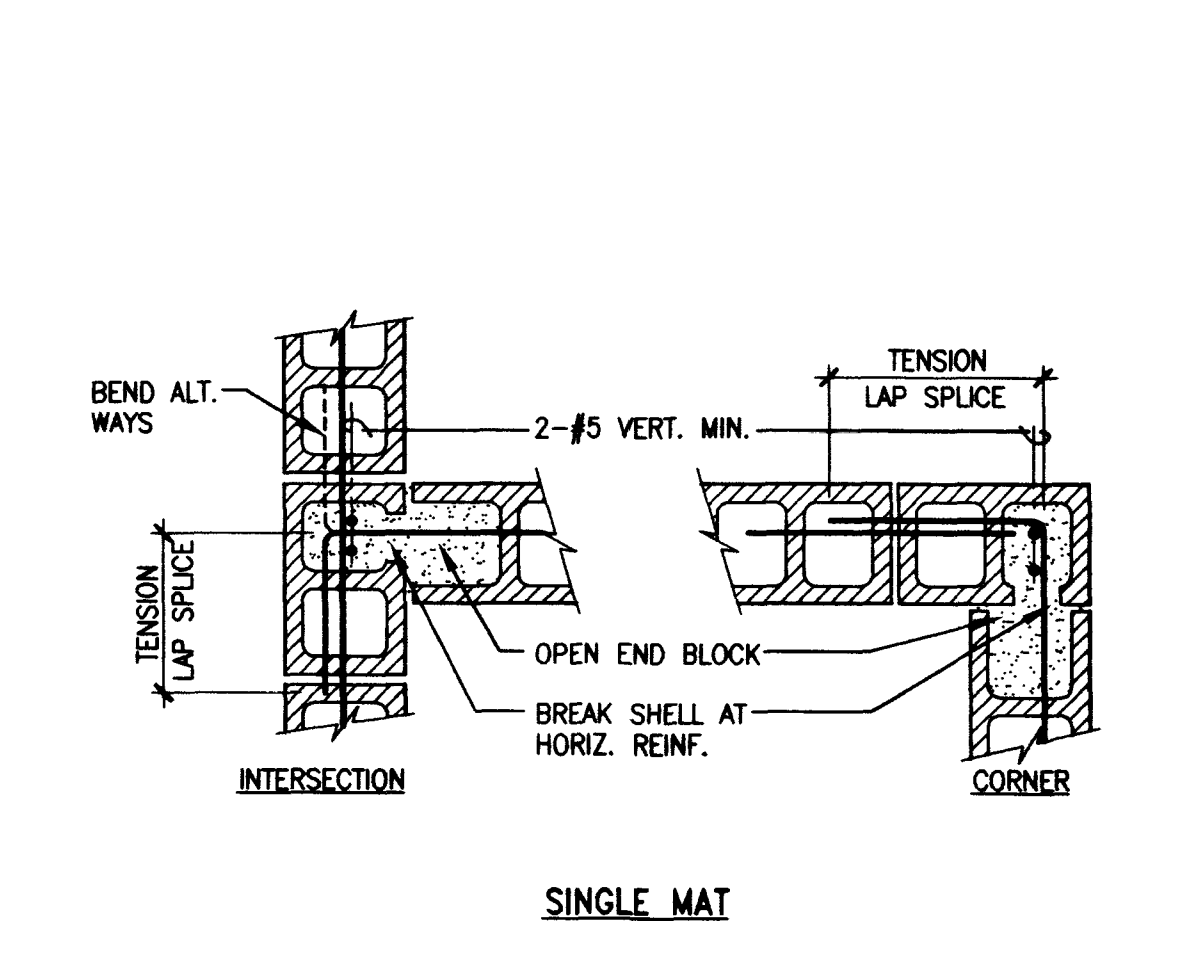
**DETAIL 5**  
CMU WALL INTERSECTIONS

**DETAIL 5**  
CMU WALL INTERSECTIONS
