# Moccasin Diversion

Technical Support Data Notebook  
Levee ID #800, Clark County, Nevada

Levee Data and Documentation for the  
National Flood Insurance Program

June 2010

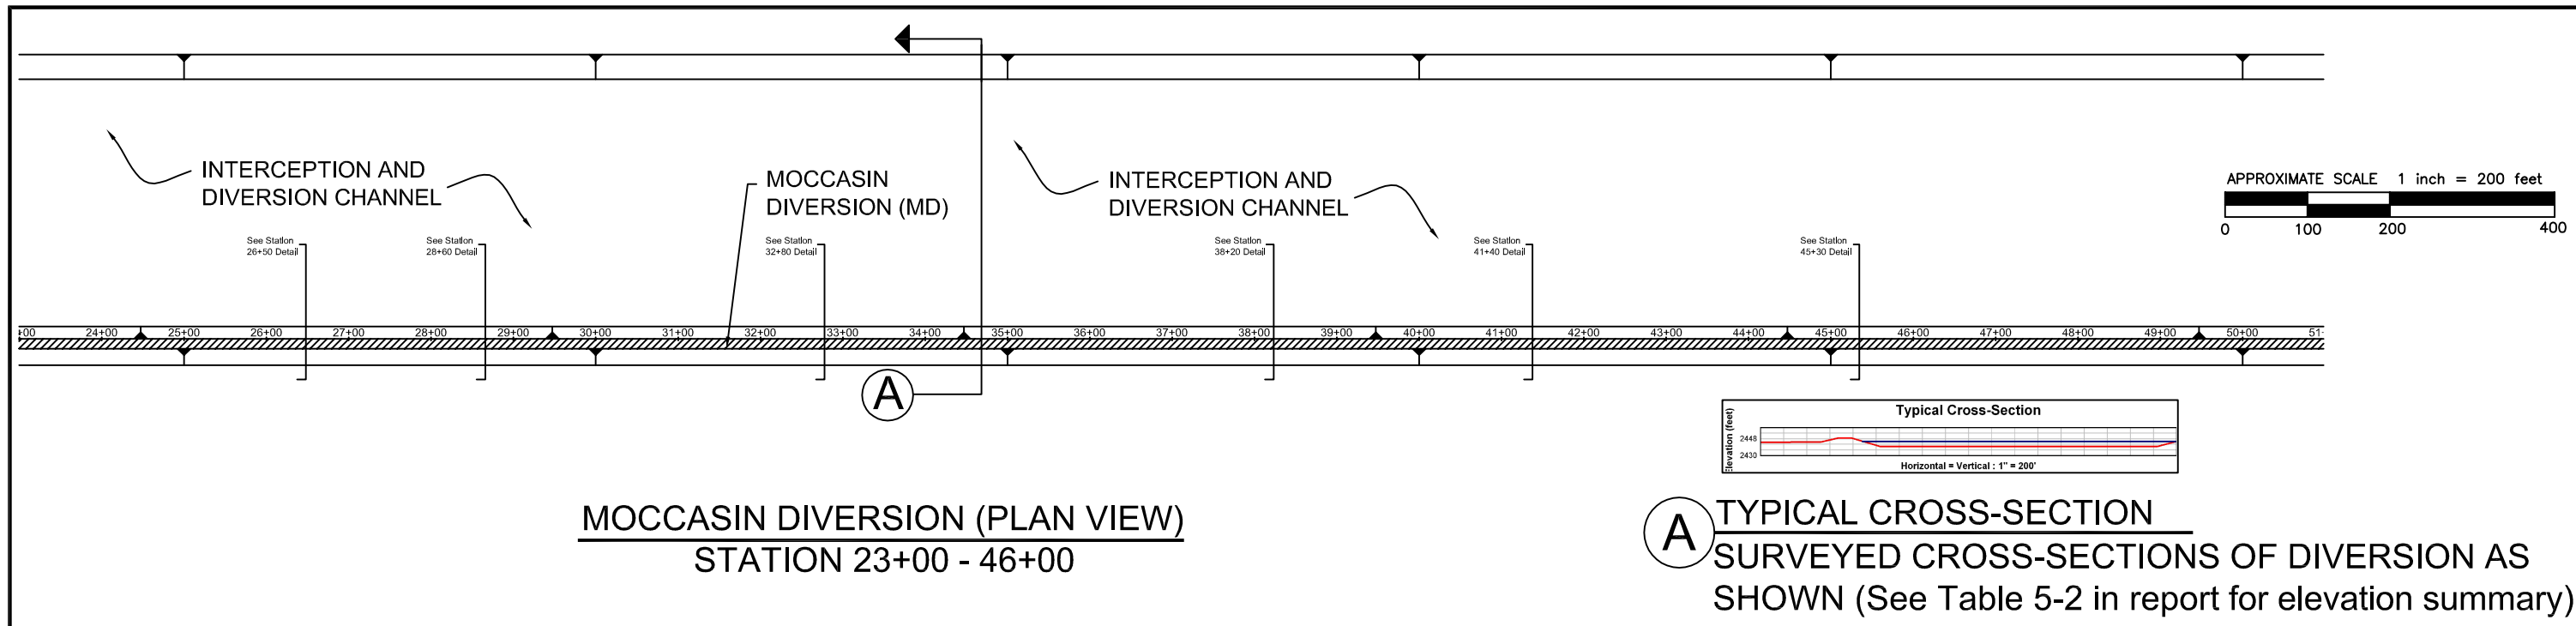
**MOCCASIN DIVERSION (PLAN VIEW)**  
STATION 23+00 - 46+00

**A TYPICAL CROSS-SECTION**  
SURVEYED CROSS-SECTIONS OF DIVERSION AS SHOWN (See Table 5-2 in report for elevation summary)

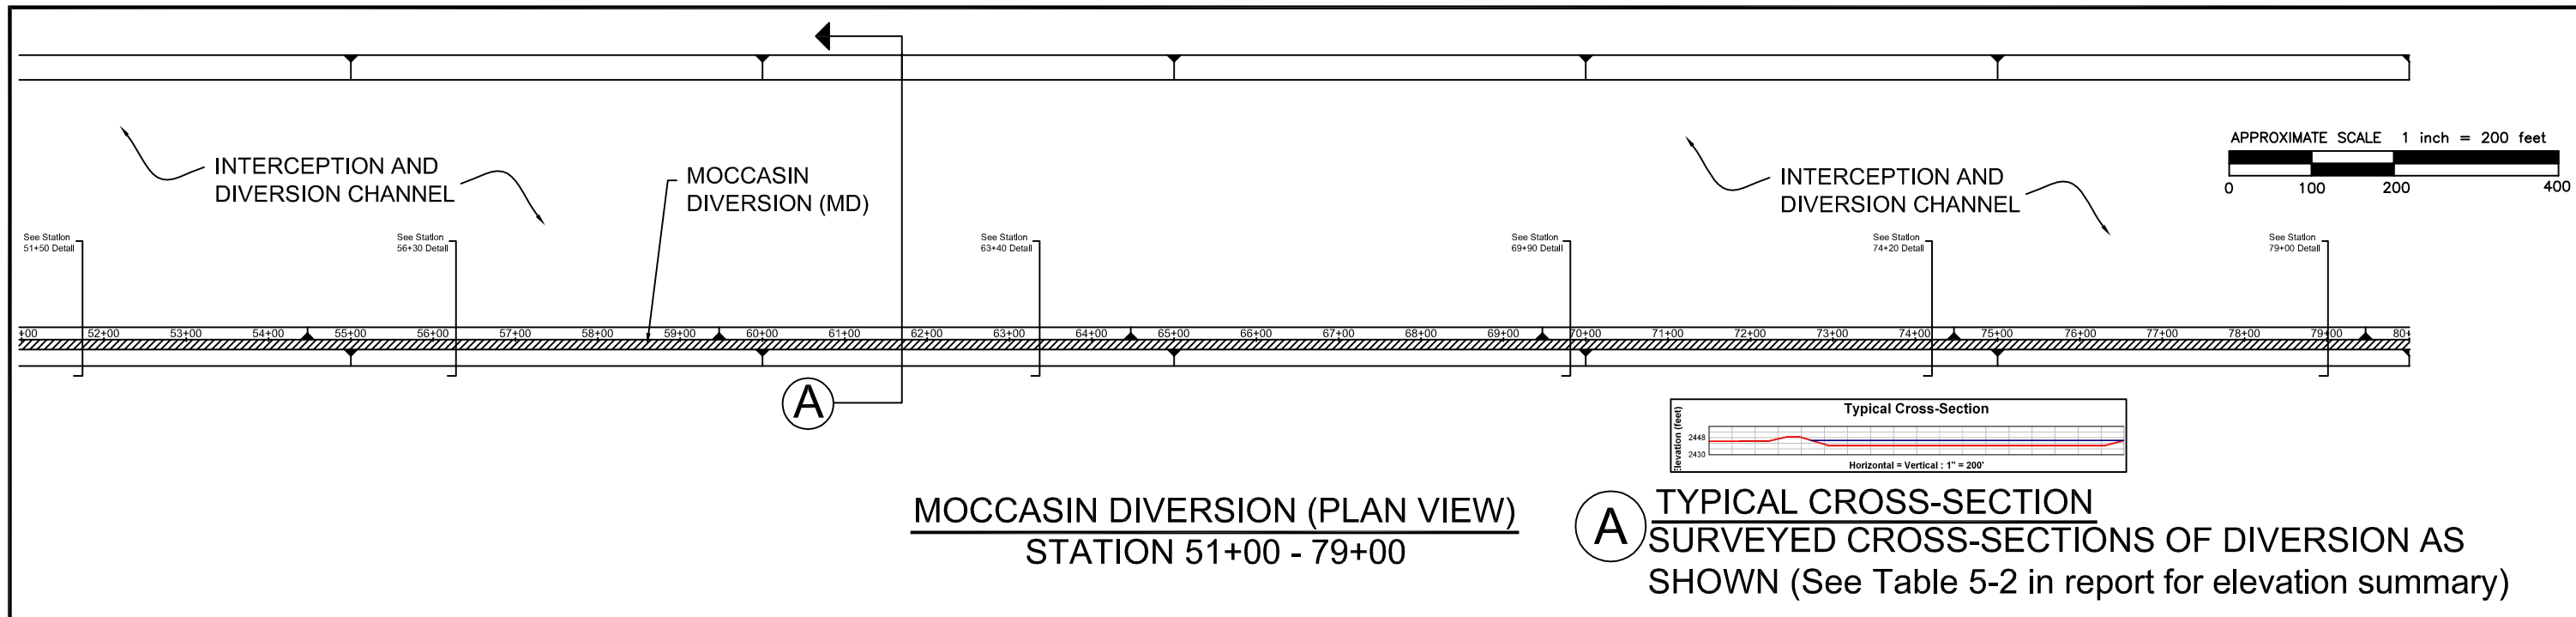
MOCCASIN DIVERSION (PLAN VIEW)  
STATION 51+00 - 79+00

A TYPICAL CROSS-SECTION  
SURVEYED CROSS-SECTIONS OF DIVERSION AS  
SHOWN (See Table 5-2 in report for elevation summary)

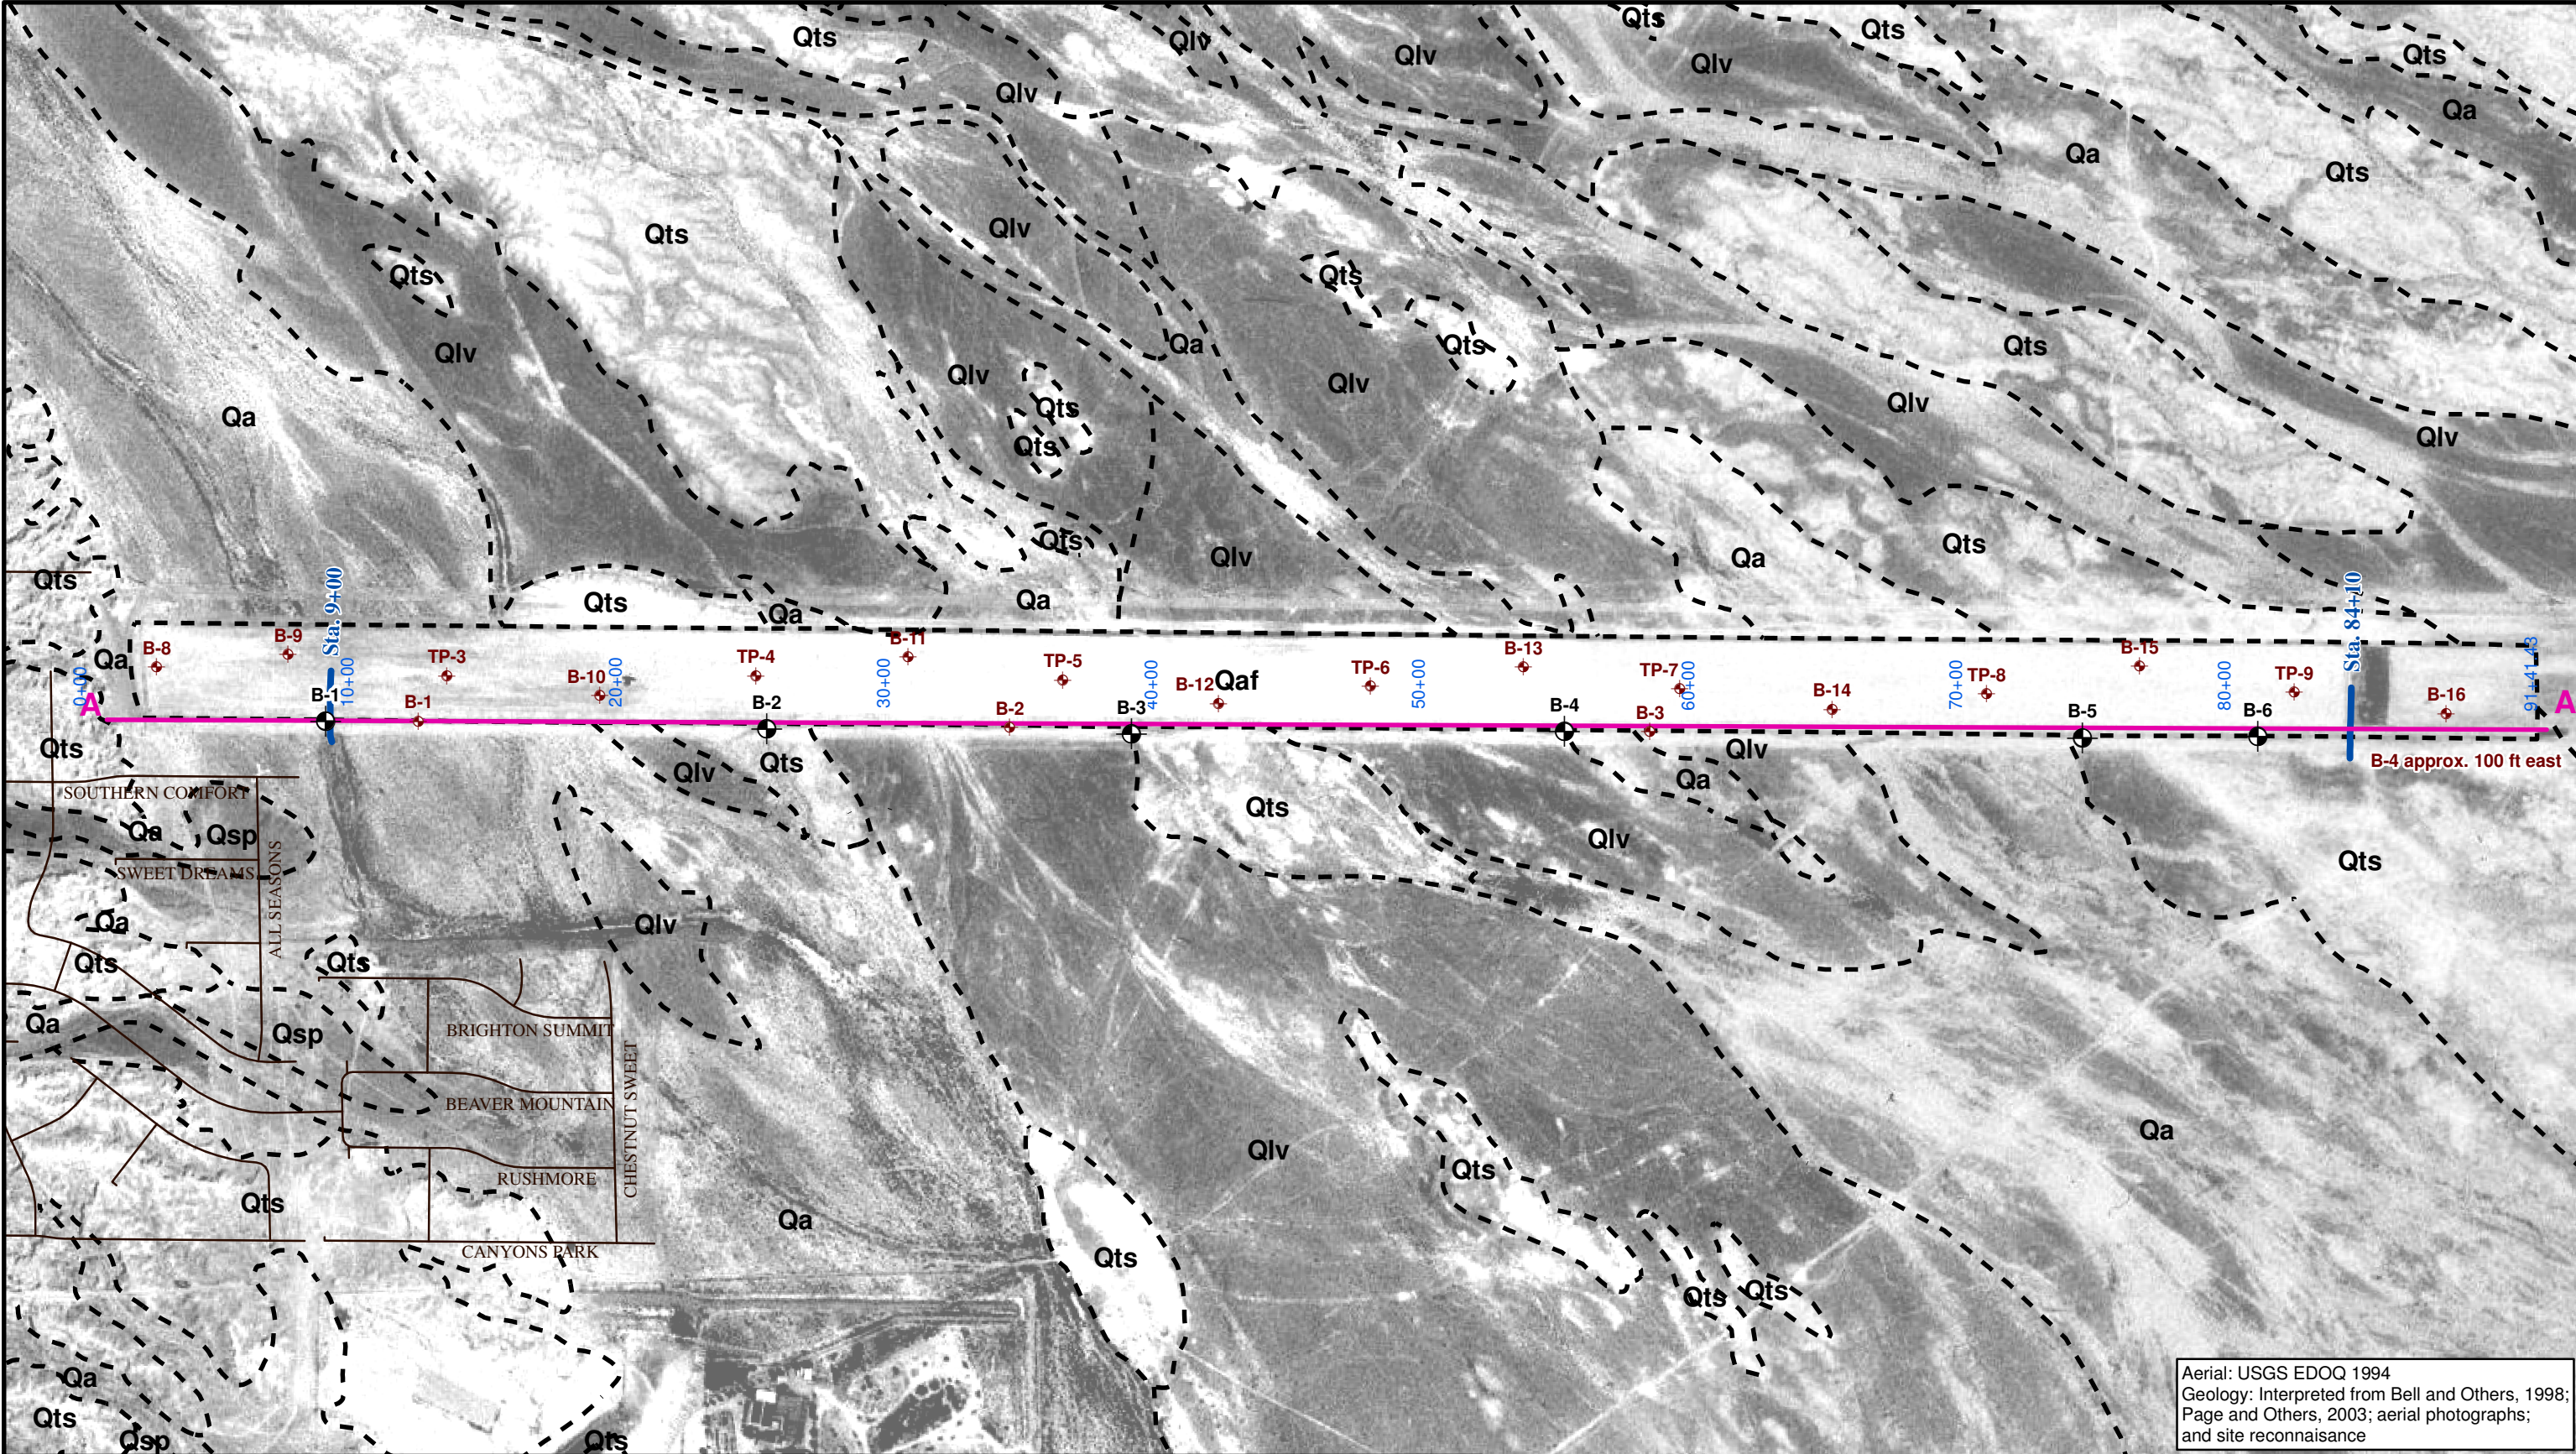
Aerial: USGS EDOQ 1994  
Geology: Interpreted from Bell and Others, 1998;  
Page and Others, 2003; aerial photographs;  
and site reconnaissance

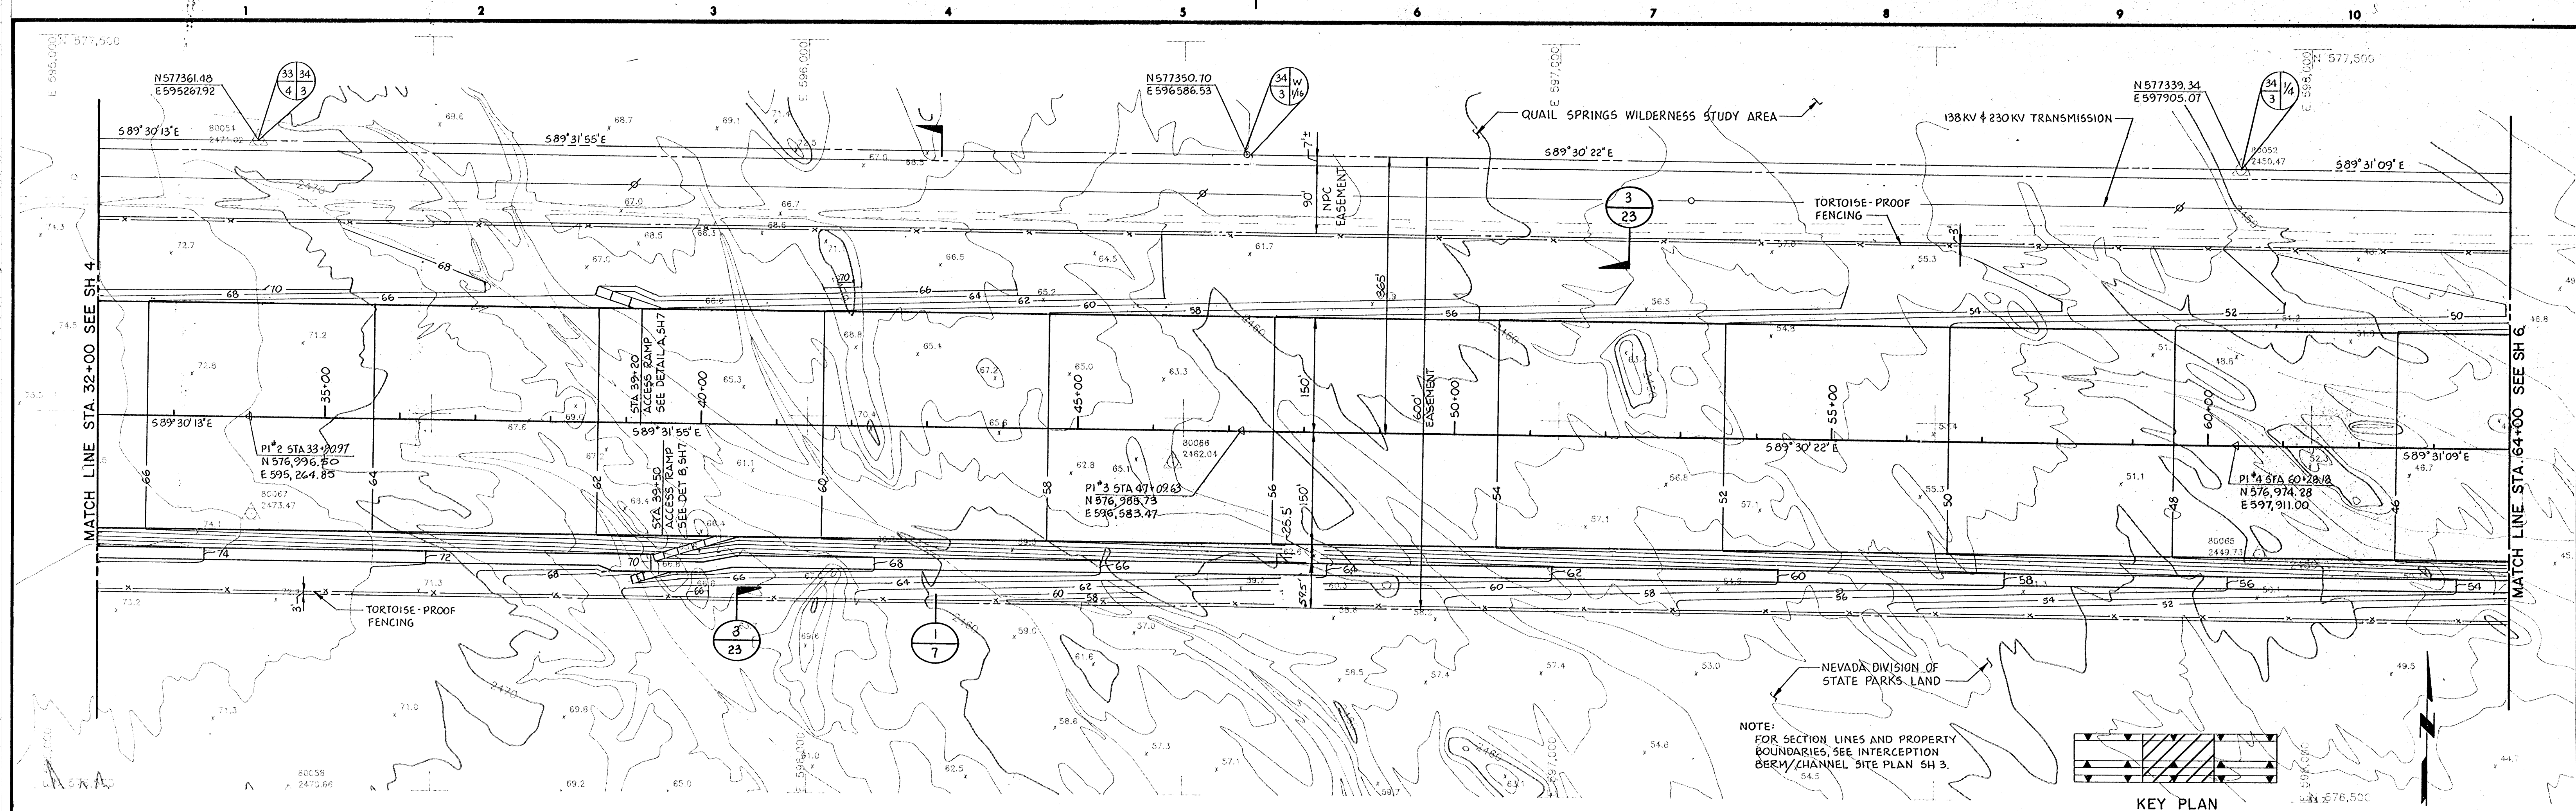
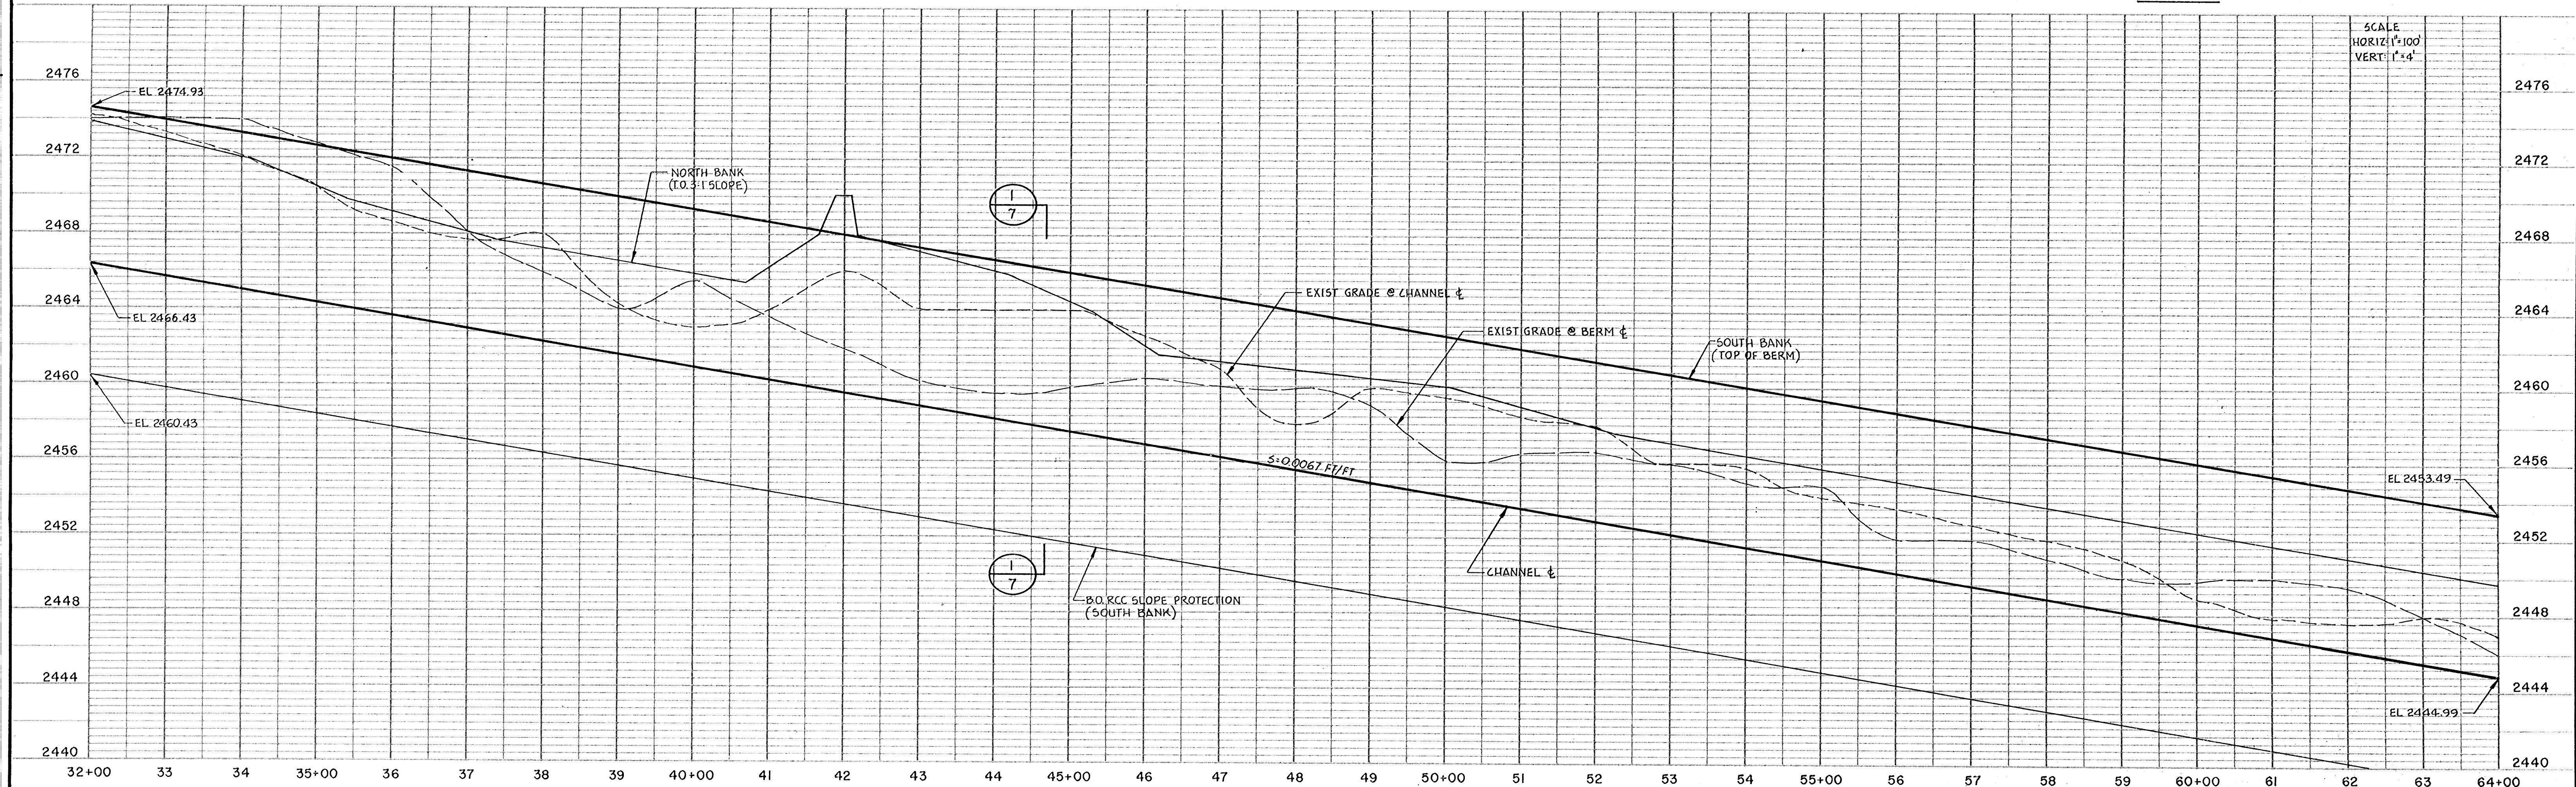
| DESIGNED: ALK, JWS<br>CHECKED: HLR<br>APPROVED: <i>[Signature]</i><br>DATE: 5-22-01 | | PROJECT NO.: 17149 | | CITY OF NORTH LAS VEGAS<br>UPPER LAS VEGAS WASH<br>DETENTION BASIN<br>INTERCEPTION BERM/CHANNEL<br>PLAN & PROFILE STA. 32+00 TO 64+00 | | SHEET<br>5 OF 25 | |

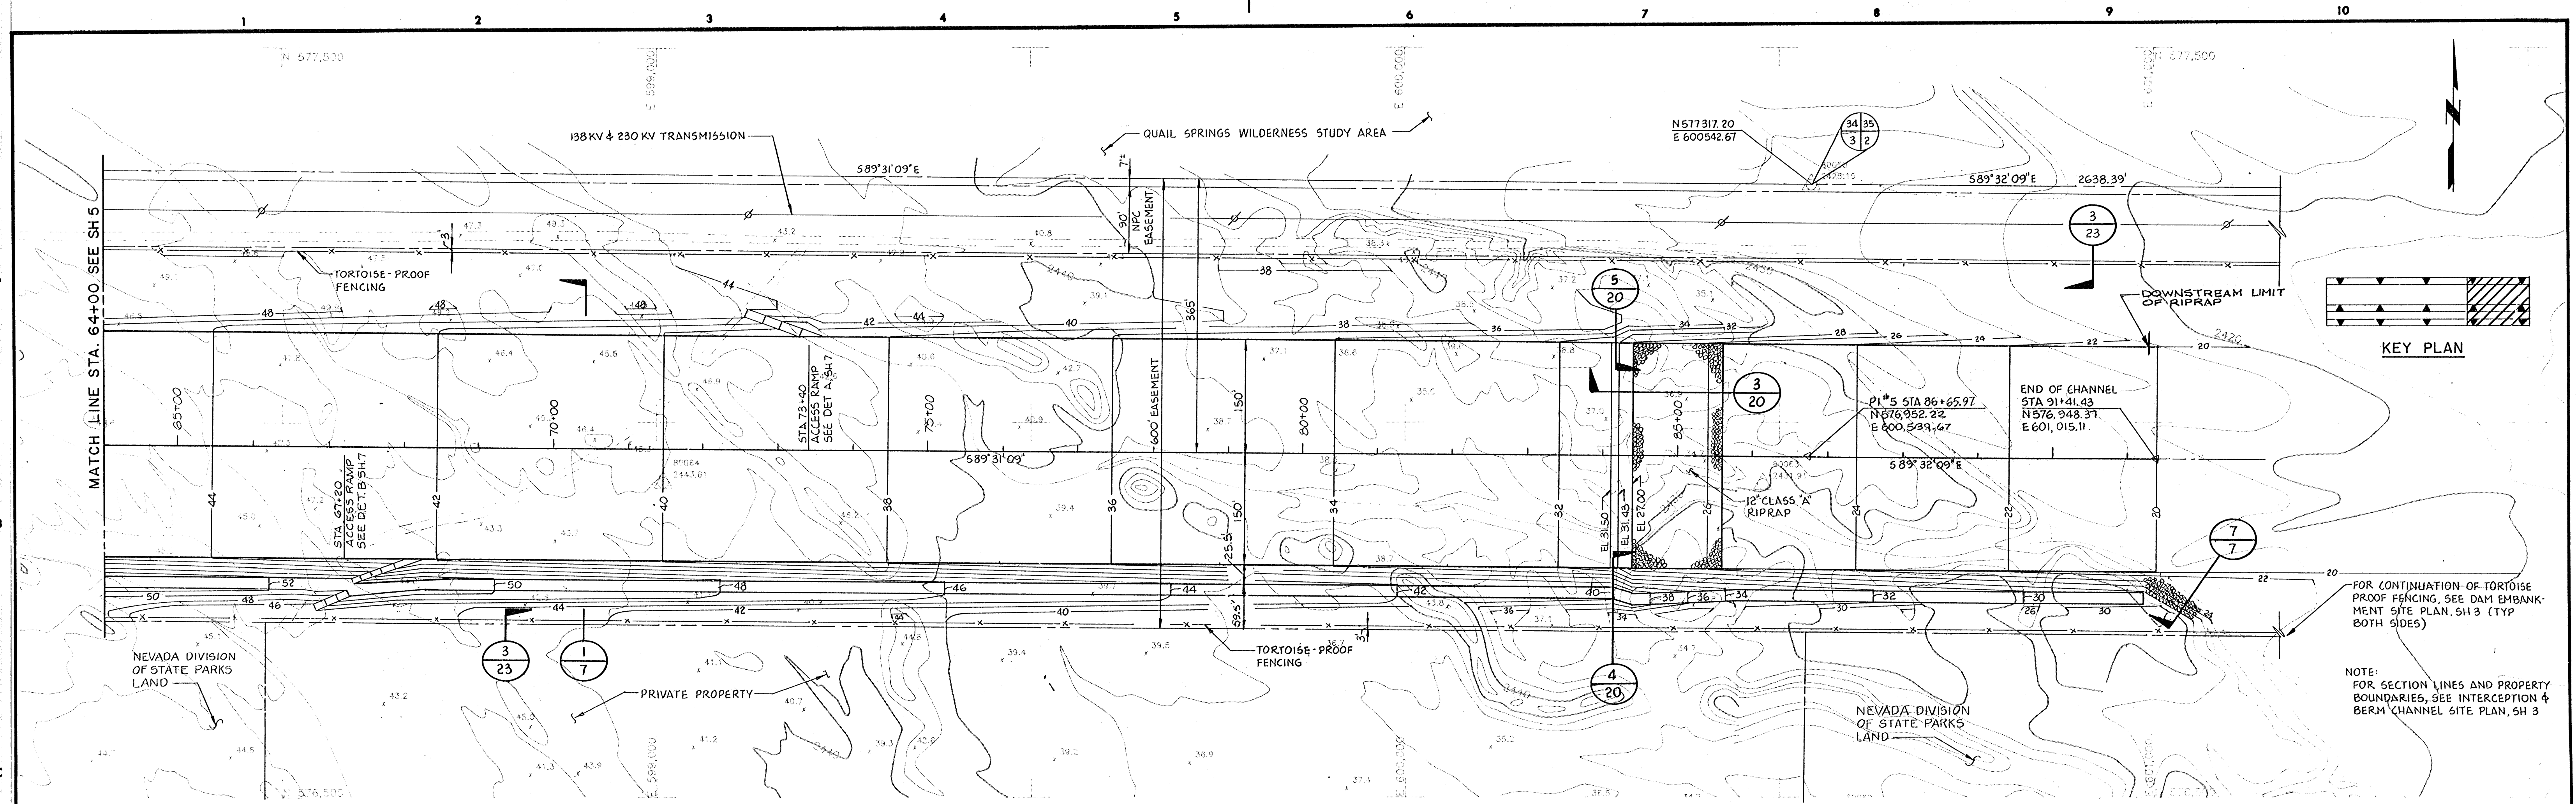
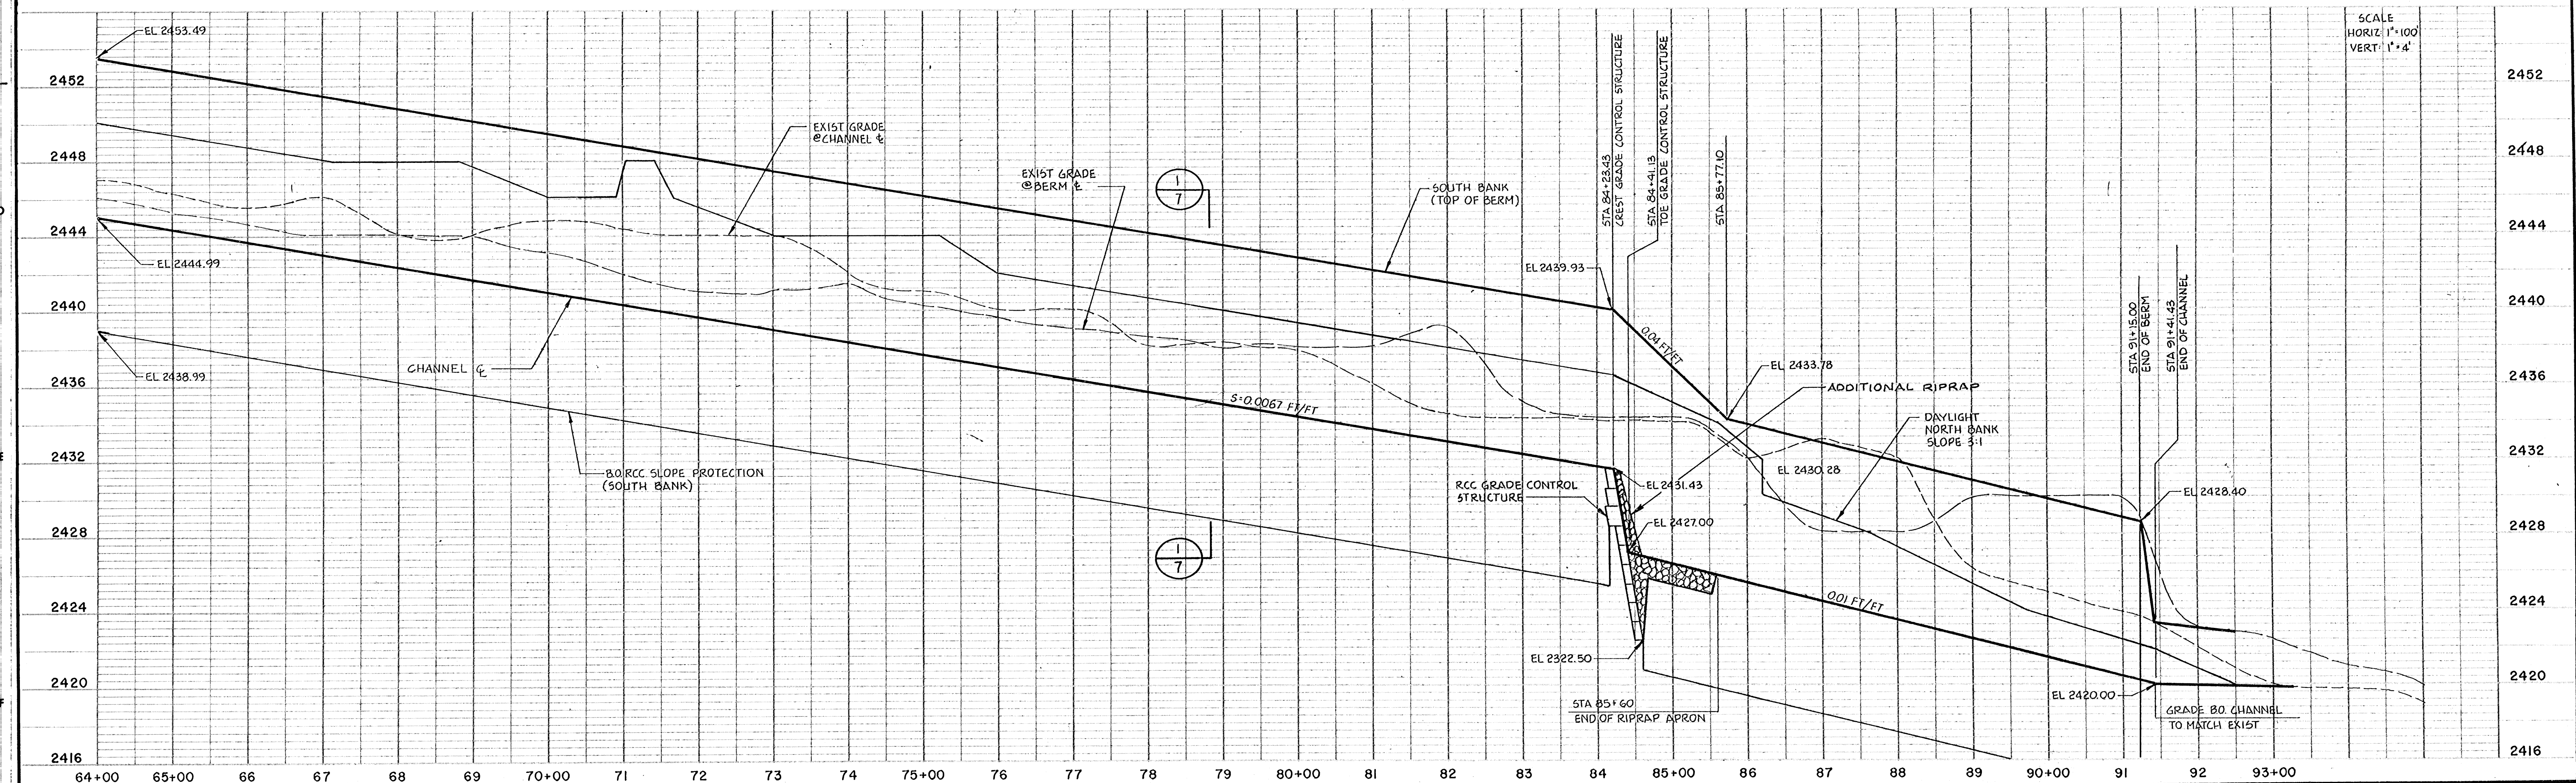
| DESIGNED <u>ALK, JWS, SDC</u><br>CHECKED <u>DH</u><br>APPROVED <u>AL Roberts</u><br>DATE <u>5-28-91</u> | | <b>Black &amp; Veatch</b><br>Engineers - Architects<br>Las Vegas, Nevada | PROJECT NO.<br>17149 | <b>CITY OF NORTH LAS VEGAS</b><br>UPPER LAS VEGAS WASH<br>DETENTION BASIN<br>INTERCEPTION BERM/CHANNEL<br>PLAN & PROFILE STA. 64+00 TO 93+00 | | SHEET<br>6 OF 25 |

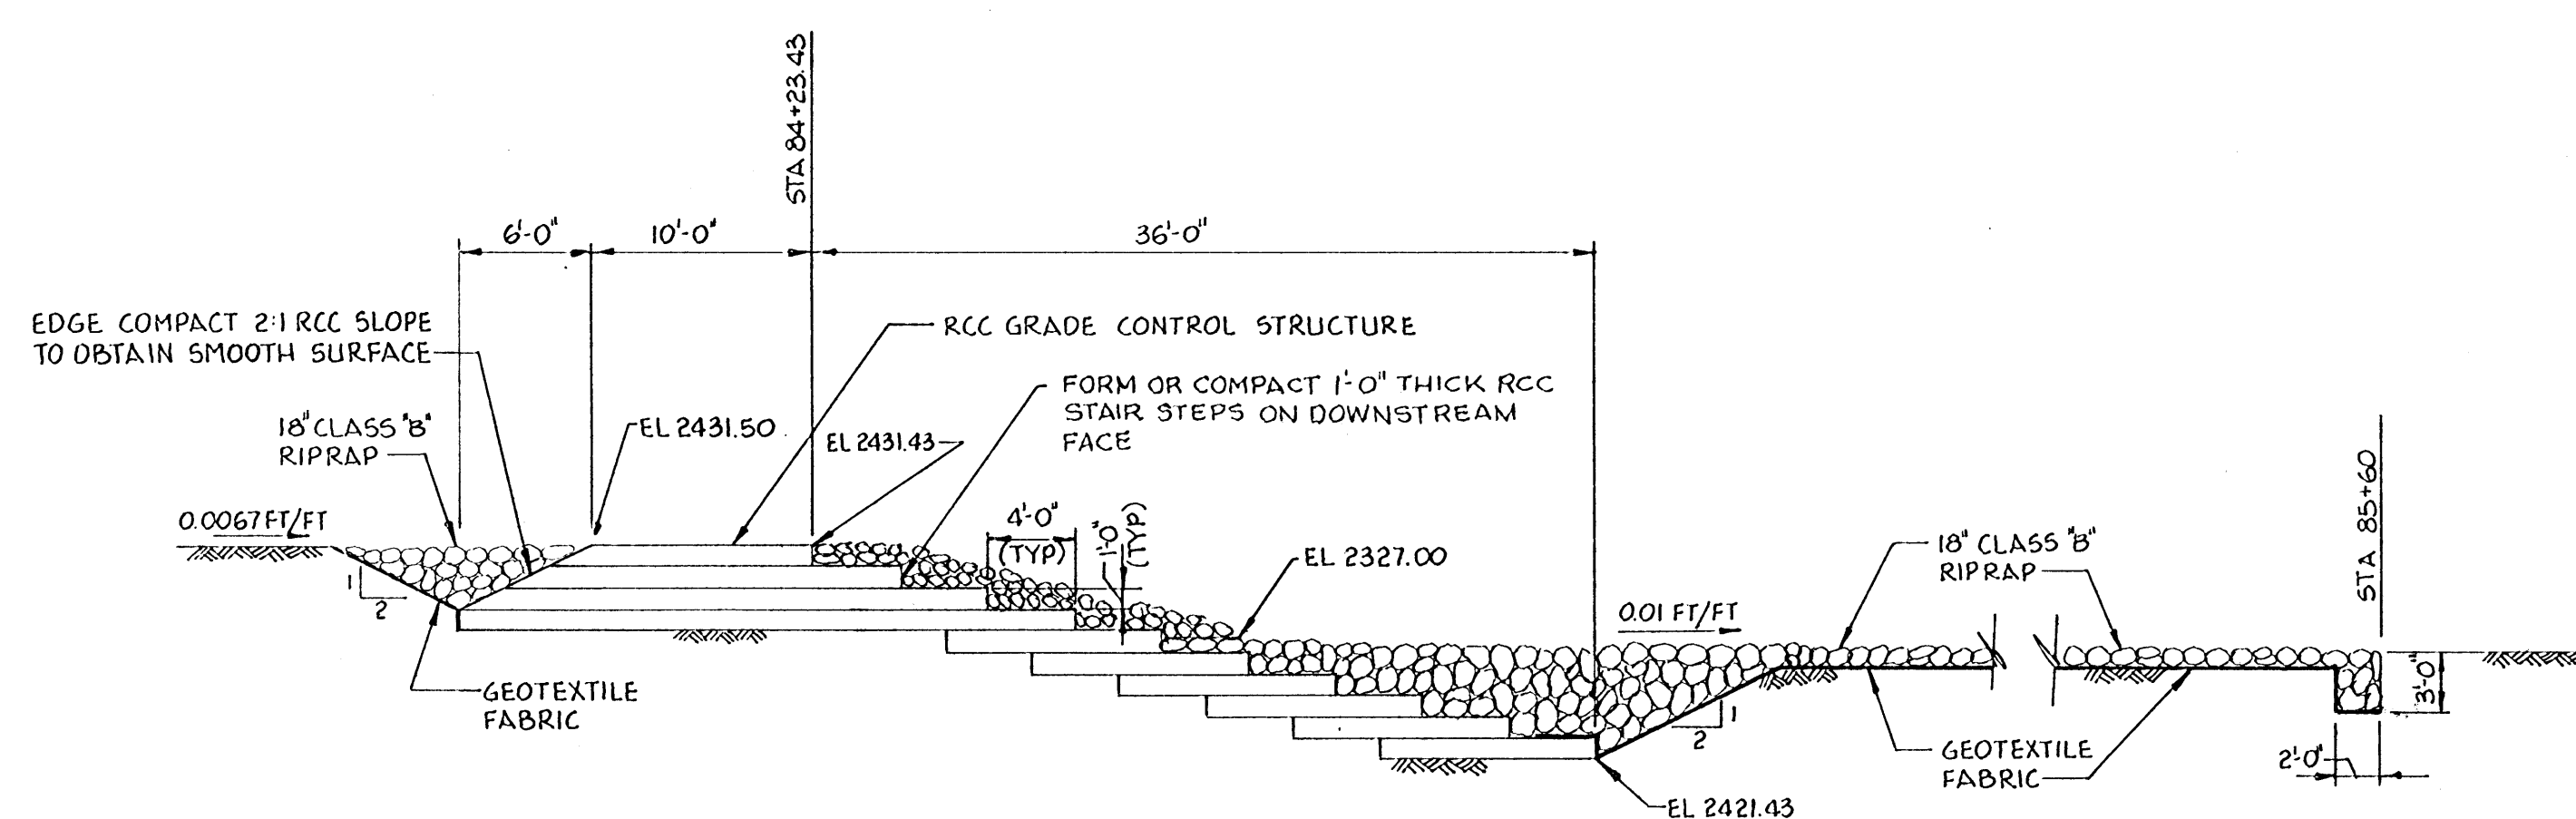
SECTION 3  
6

NOTE:  
GRADE CONTROL STRUCTURE SHALL SERVE  
AS RCC TEST SECTION AS REFERENCED IN  
THE SPECIFICATION.

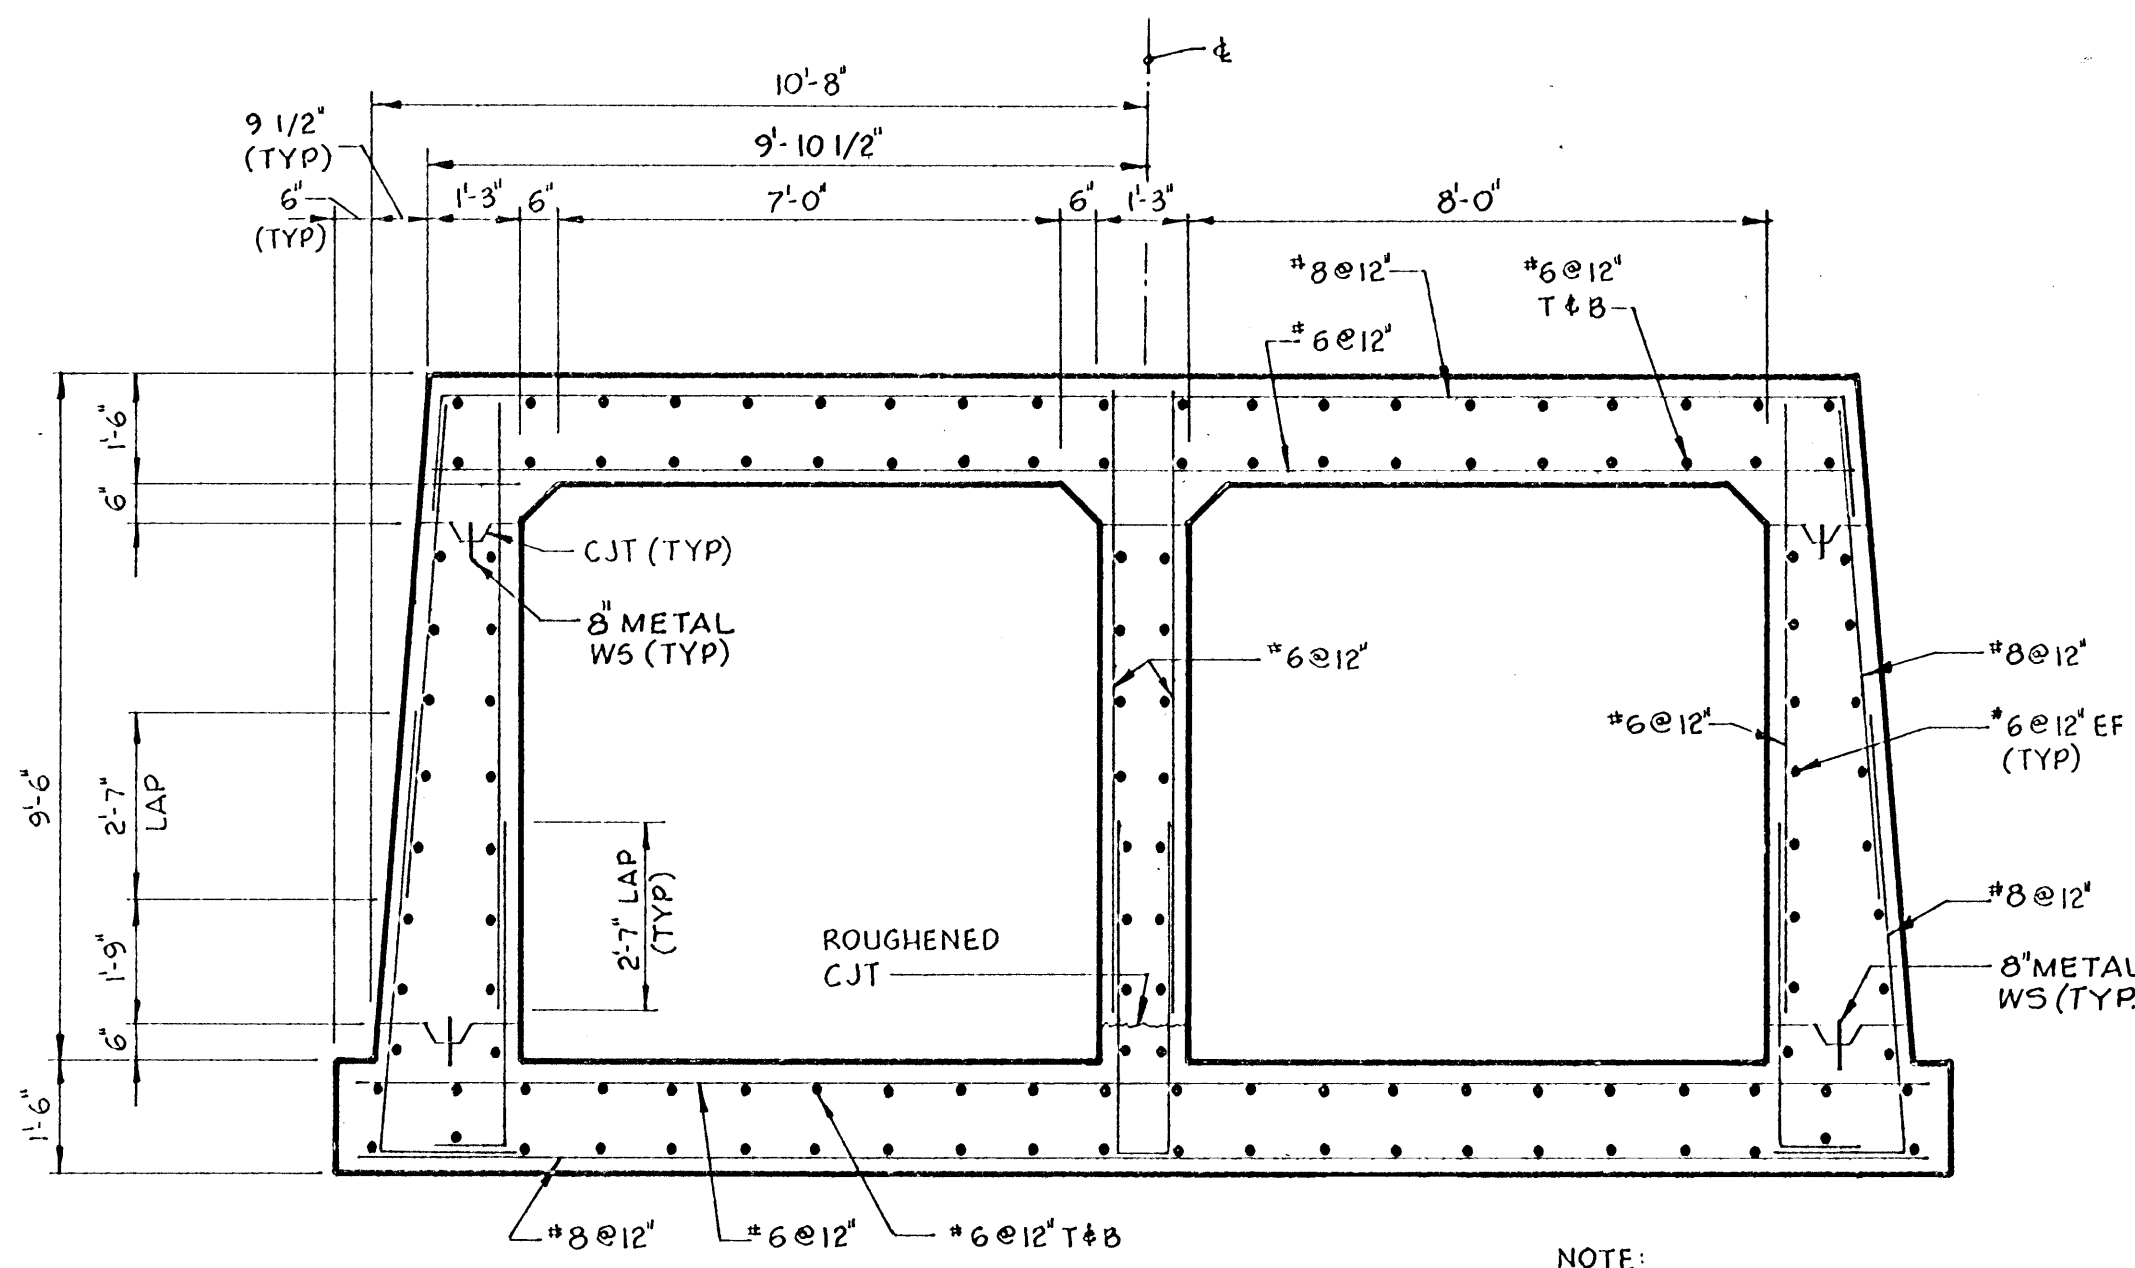
SECTION 2  
3/8'-1'-0'

NOTE: BACKFILL OF BOX CULVERT SHALL NOT BEGIN UNTIL THE ROOF SLAB IS IN PLACE AND HAS ACHIEVED 75% OF DESIGN STRENGTH
