# Moccasin Diversion

Technical Support Data Notebook  
Levee ID #800, Clark County, Nevada

Levee Data and Documentation for the  
National Flood Insurance Program

June 2010

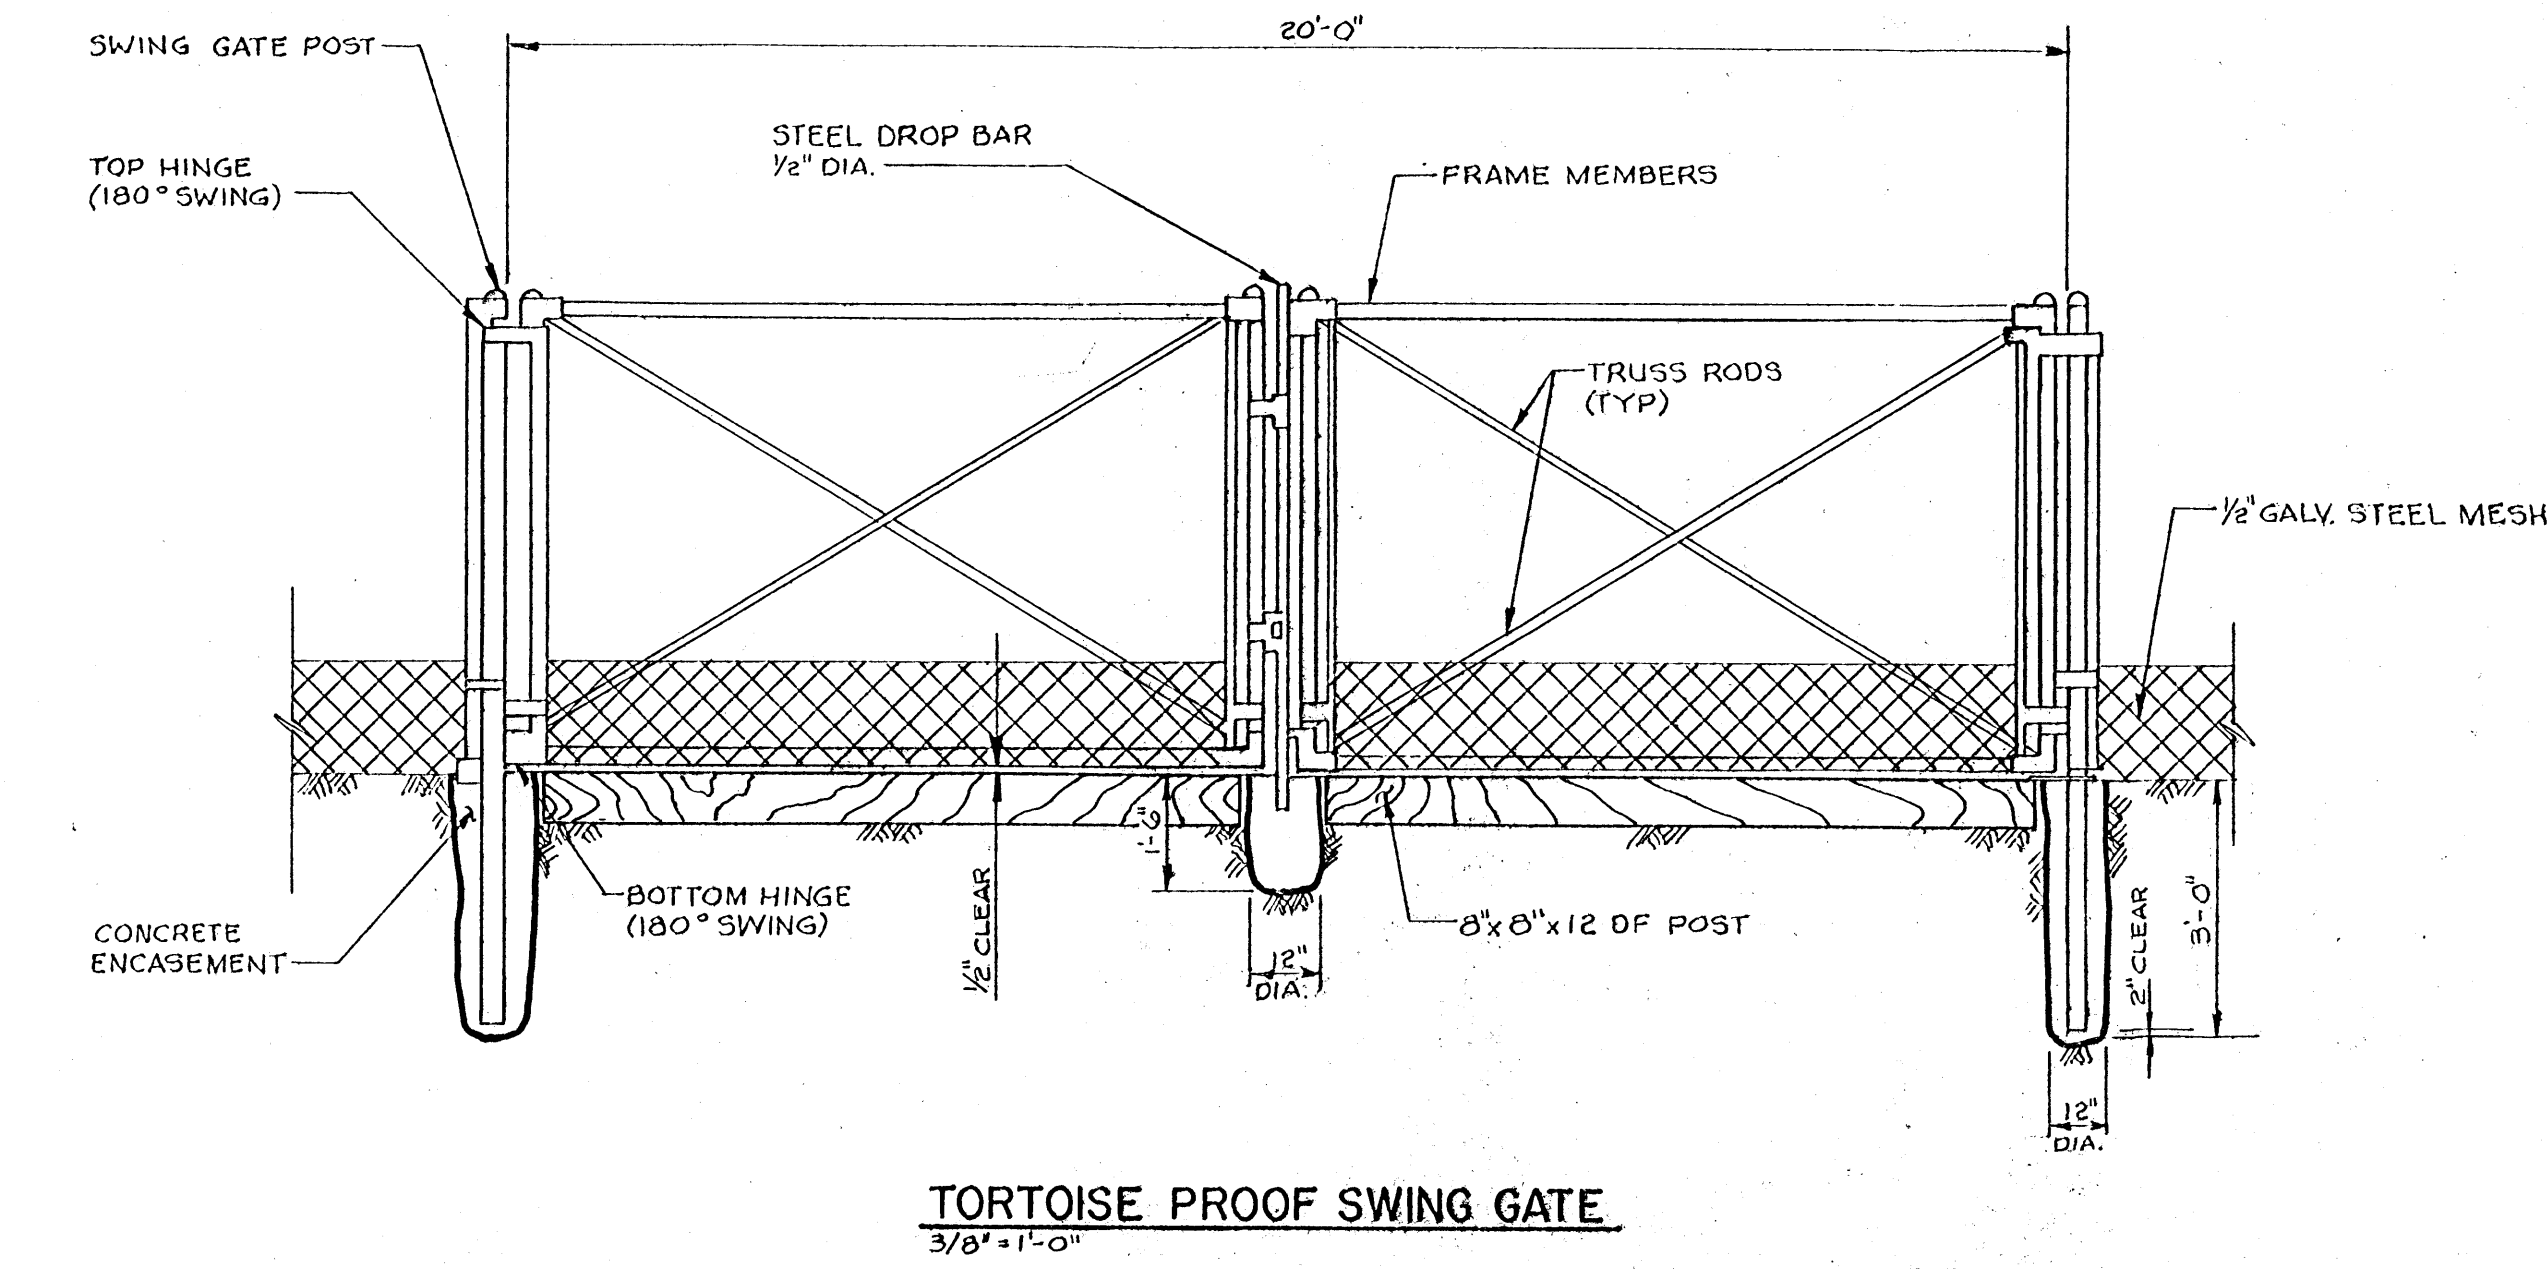
TORTOISE PROOF SWING GATE  
3/8" x 1'-0"

NOTES:  
 1. BOTTOM HINGE SUPPORT RING SHOP WELDED. TOP HINGE SUPPORT RING SHALL BE FIELD WELDED FOLLOWING GATE INSTALLATION.  
 2. SHOP APPLIED: 2 COATS RUST INHIBITIVE PRIMER: TNEPEC "77 CHEM-PRIME" OR ACCEPTABLE EQUAL. AFTER FIELD CONST, APPLY 2 COATS OF WHITE SEMI-GLOSS ALKYD ENAMEL: TNEPEC "SERIES 23 ENDURATONE" OR ACCEPTABLE EQUAL.
