AS BUILT

333 RANCHO
LAS VEGAS
NEL POWERS
INVESTMENT BUILDER
NEVADA

PROJECT NUMBER
79-24
DATE
5-1-80

SHEET
G54-2
OF 13

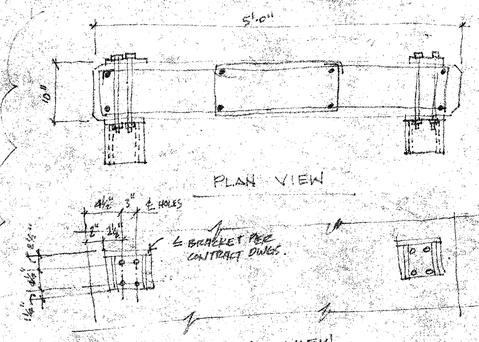
SECTION

REMEDIAL ACTION REQ'D FOR MISSING 12x12 PL'S @ 4TH WALL COLUMN NORTH OF GRID "C", TOP FLOOR.

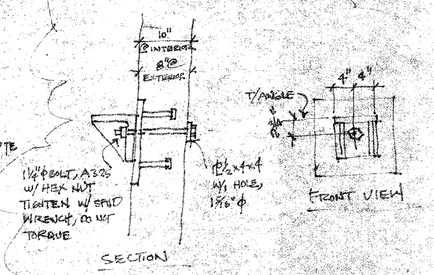
REMEDIAL REPAIRS DUE TO DEFECTIVE PL'S

NOTE: WHERE CAST-IN PL'S ARE FOUND TO BE DEFECTIVE BY ULTRASONIC TESTING THE ABOVE DETAIL SHALL APPLY. DRILL HOLES FOR BOLTS 1⅛" OVERSIZE, MAX., BOLTS SHALL BE 1'-4" LG @ 10" PANEL, 11" @ 8" PANEL.
