Historic Building Condition  
Assessment Report and Preservation Plan for the

# Victory Hotel

Located at 307 S. Main Street, Las Vegas, Clark County, Nevada

September 2013

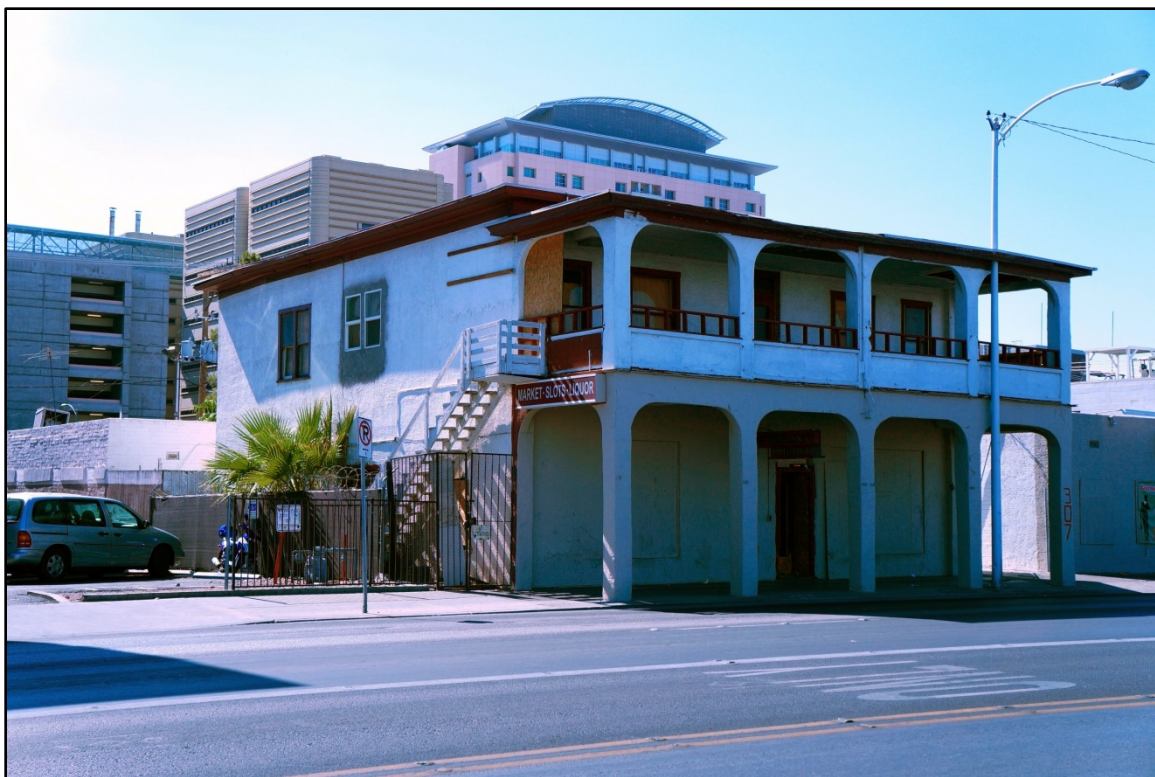
Photograph 1. Main (western) and northern facades of the Victory Hotel building, facing east.

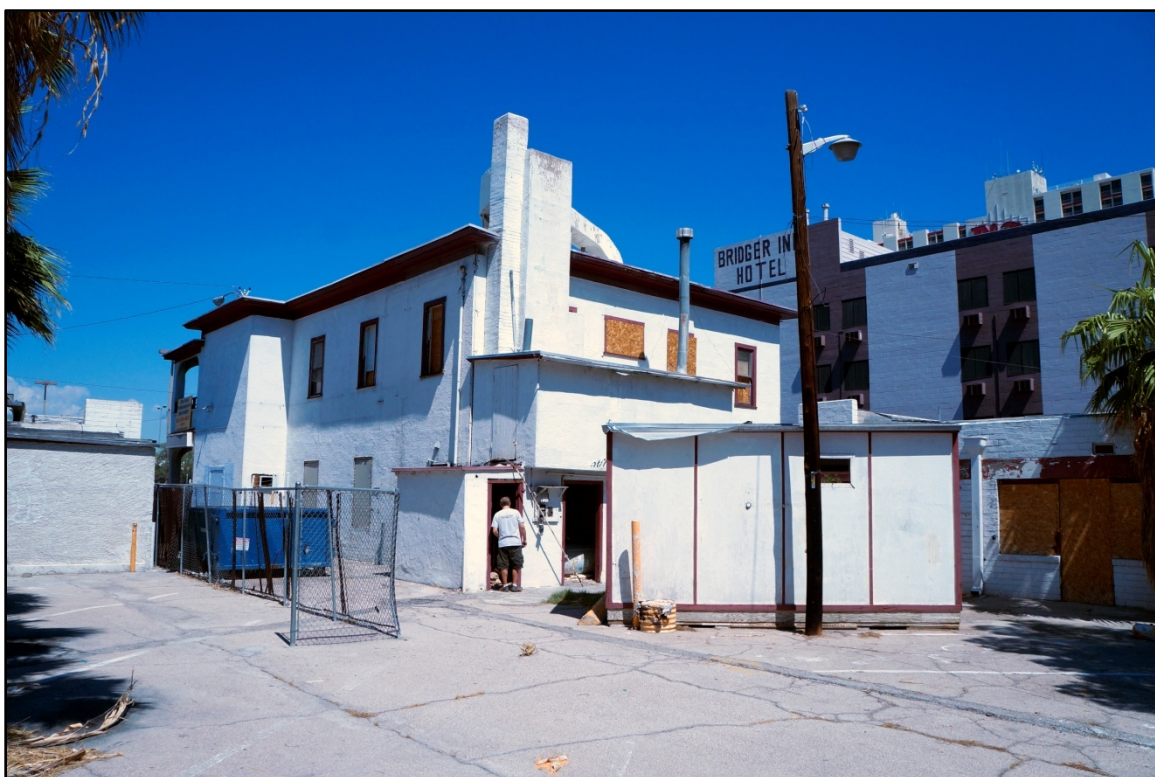
Photograph 2. Rear (eastern) and southern facades of the Victory Hotel building, facing northwest.

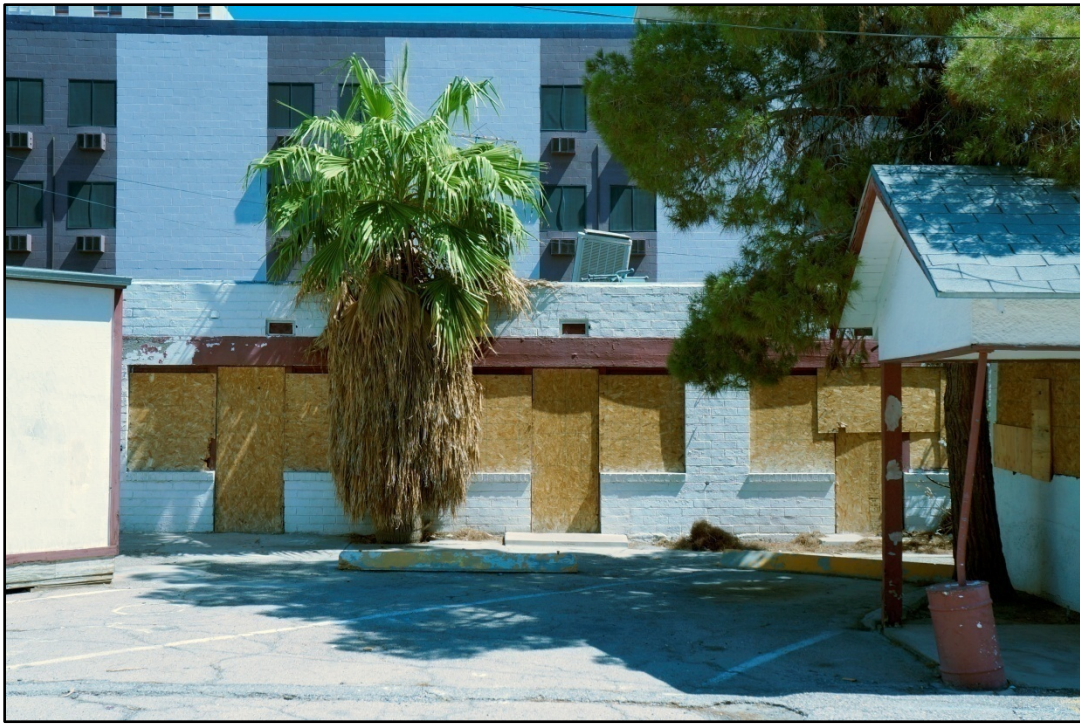
Photograph 3. Main (southern) façade of Building No. 2, facing north. The small porch on the main (western) elevation of Building No. 3 is visible at right.

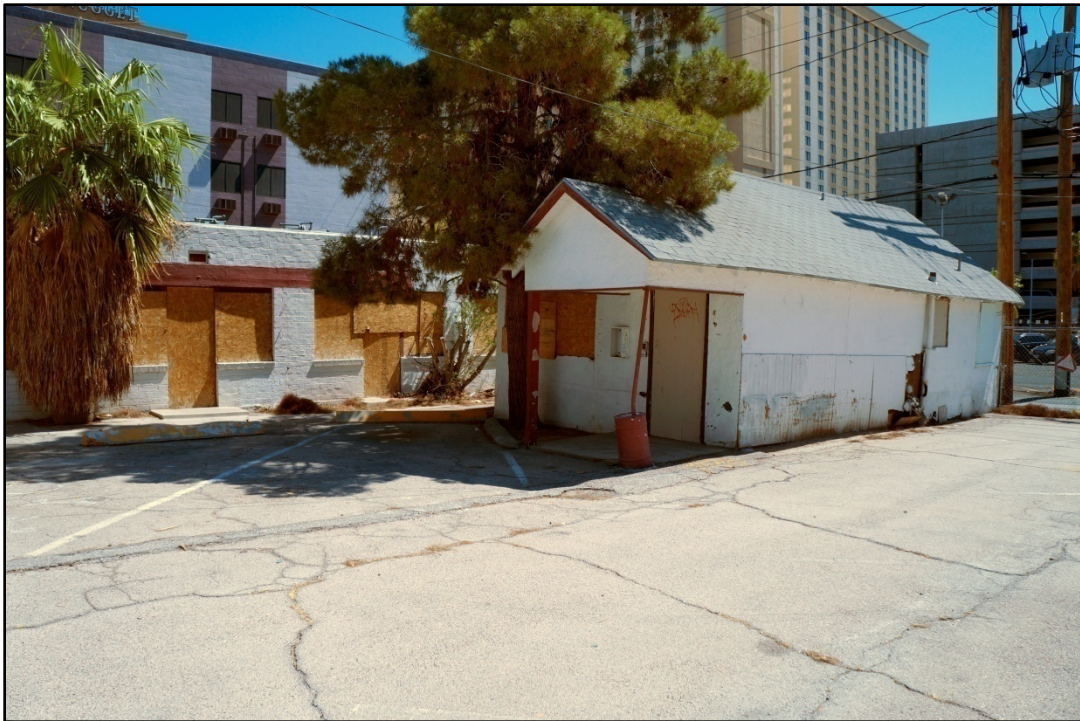
Photograph 4. Photograph showing the main (western) and southern facades of Building No. 3, constructed ca. 1928, facing southeast. Building No. 2 is visible in the background.

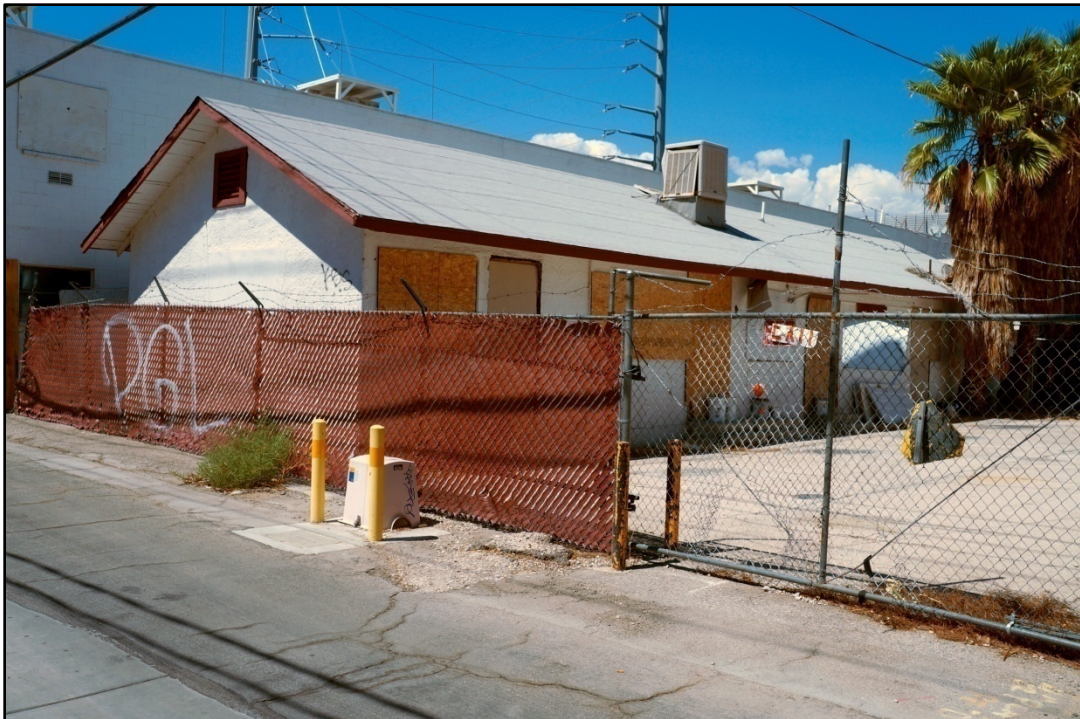
Photograph 5. Photograph showing the main (northern) and eastern facades of Building No. 4, constructed ca. 1928, facing southwest.

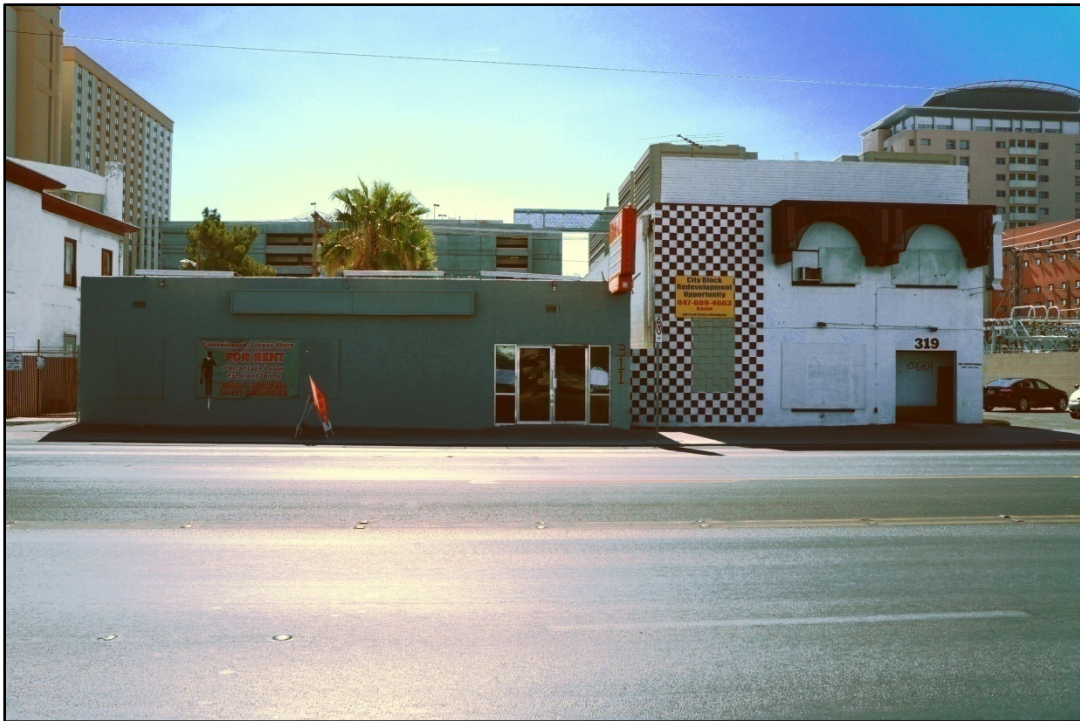
Photograph 6. Photograph showing the main (western) façade of Building No. 5 (at left), constructed ca. 1930, facing southeast. 319 S. Main Street, a two-story masonry building formally housing the Little Hotel rooming house is visible to the right of Building No. 5.

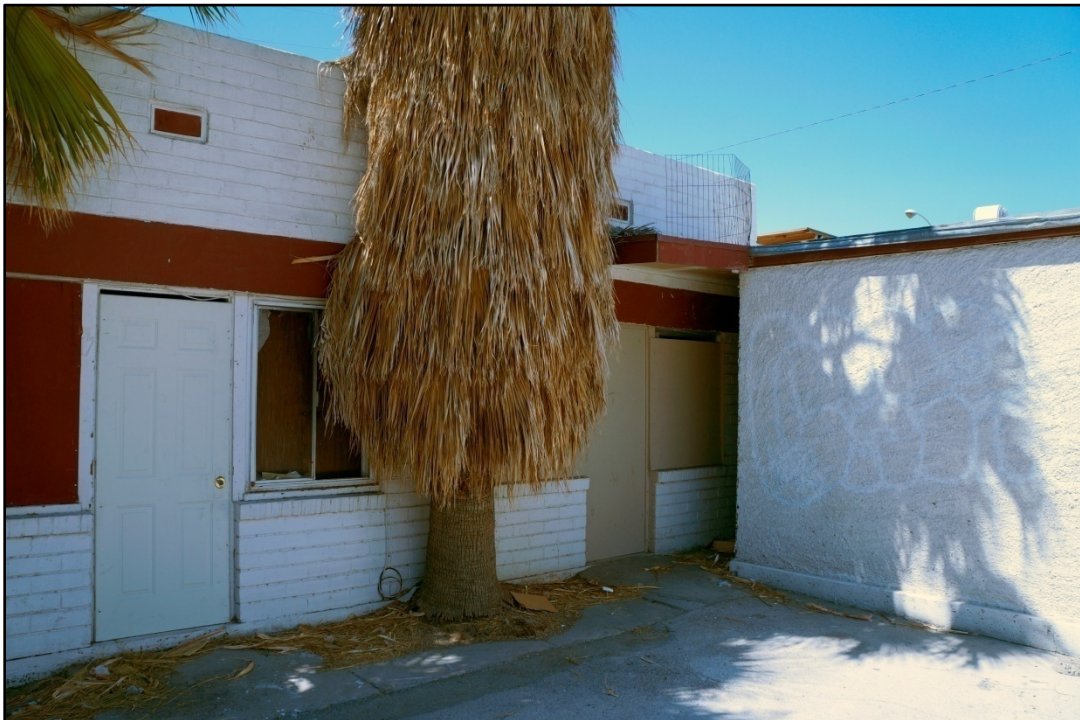
Photograph 7. Photograph showing the main (western) and southern facades of Building No. 6, constructed ca. 1930, facing southwest. An addition (possibly wood frame) to the rear of Building No. 5 is visible at right.

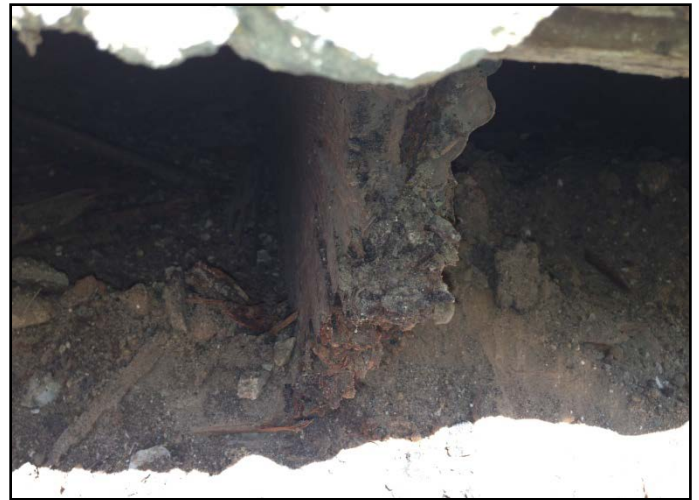
**Ground Floor Framing:** This floor framing is sitting directly on dirt which invites termite damage, water damage, and dry rot, especially at the perimeter.

**Ground Floor Framing:** The entire perimeter should be excavated to reveal the extent of damage to the double rim joists and to confirm whether any unexpected or unobserved pier foundations may exist. If none exist, the entire perimeter and key locations on the interior at intermediate bearing walls, such as the posts supporting the stair opening and adjacent to wall offsets in the hallway, should be excavated deep enough to jack up the vertical wall framing while the rotted rim joists are removed and the lower wall studs inspected. The new double 2 X 4 rim joists or 4 X 6 floor beams should be pre-treated termite resistant lumber.

Once the perimeter bearing walls are stabilized, the floor joists should be inspected in several areas to determine the extent of damage. This may require gently removing portions of the original wood flooring to inspect a representative sampling of condition of the floor joists. Where severely compromised, they should be replaced in kind or “sistered” with new pre-treated lumber.

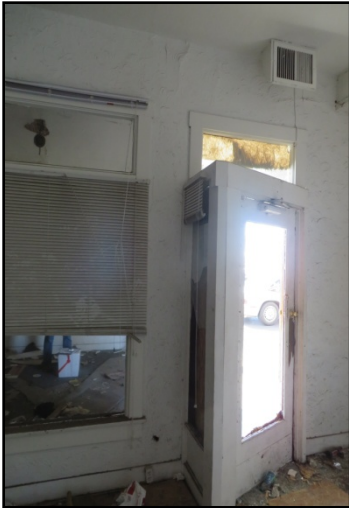
Judging from the oddly angled and recessed configuration, the resultant narrow sidelight and the location of the original transom, the main front door (00) appears to have been relocated ca. 1959 and replaced by a single lite door. None of the hardware appears original except perhaps the door closer at the top.

Missing original hardware and multiple layers of paint.

The front door (00) should be moved back to its original location with the new door matching the original balcony door above.

Multiple layers of paint should be stripped from all original doors and/or door frames and transoms. The wood should be patched and re-finished as required. Re-paint with original color.

Locate original or find period appropriate restoration hardware and install where missing.

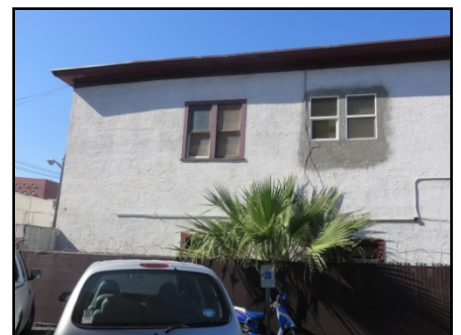
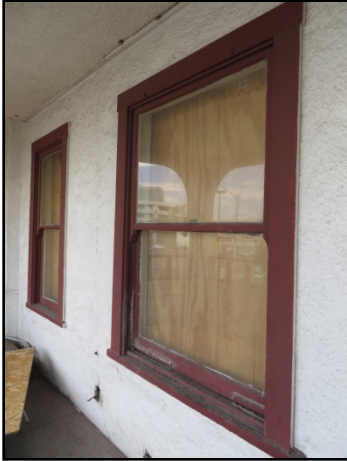
The majority of the exterior windows are original double hung counter-weighted operable windows with single pane glass. All but two exterior windows (M1 & M2) appear to be original. Many have been protected by being boarded up, others vandalized severely. Window (B) at Proprietor's Suite appears from earlier photos to have iron bars covering it and the transom window is either missing or covered.

**Double hung windows:** Several missing and broken window sashes, missing trims, and broken glass. Operation of the counterweights is unknown. Multiple layers of paint on window frames, sash and trims, with some windows are painted and/or caulked shut.

**Double hung windows:** Replace missing and restore broken window sash, add missing trims in kind, replace broken glass, restore operation of counterweight.

Multiple layers of paint should be stripped from all original windows and transoms. The wood should be patched and re-finished as required. Re-paint with original color. All windows trims should be restored.

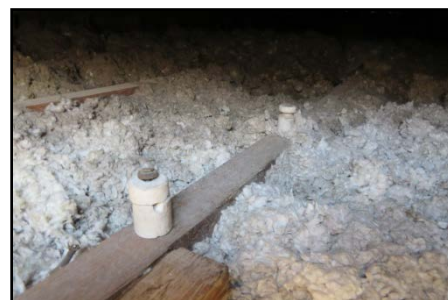
Building Insulation is minimal and weather-stripping is non-existent. The only building insulation found was 4 inches of blown-in attic insulation.

Building Insulation and weather-stripping.

**Wall Insulation:** Add fiberglass blowing wool (i.e., Johns-Manville Spider for Drill & Fill or equal) equaling R-15 in the exterior walls prior to repairing plaster.

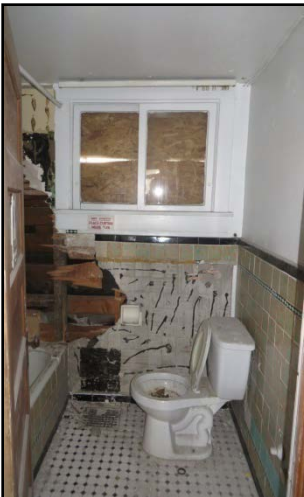
**Lobby & Guest Rooms** The interior walls in the Lobby and each of the Guest Rooms show various states of repair and disrepair. Every guest room has a varying degree of water damage caused by roof and/or plumbing leakage. Plaster is falling off some of the walls (mostly along the inside faces of exterior perimeter walls) exposing the wood lath. Other plaster walls are poorly patched and spalling from re-introduction of moisture. Mold may be present in some of the plaster. Some of the walls reveal multiple layers of peeling paint along with occasional wall paper showing through. In most areas, later roof and ceiling penetrations involving pipes and conduit appear to be the primary avenues for water infiltration.

Water damage to plaster and paint finishes.

Investigate the full extent and sources of water damage. Repair those conditions first to arrest all avenues for water infiltration. Examine water damage to wood latch, patch and repair as required. Patch and repair walls to match original plaster finish. Paint the room its original color if that can be determined.

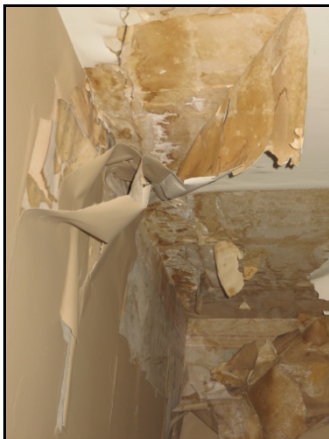
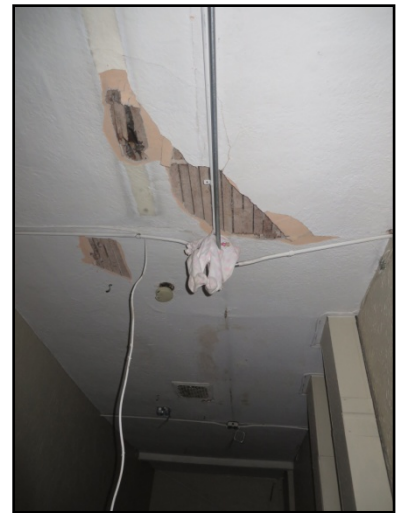
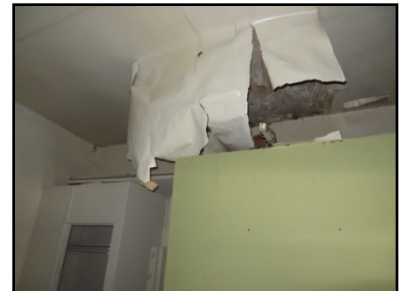
**Lobby & Guest Rooms:** Plaster is falling off portions of most of the ceilings, especially adjacent to exterior perimeter walls, exposing the wood lath. Several plaster ceilings have been poorly patched or covered with acoustic tiles or drywall. Many are spalling from re-introduction of moisture following poor attempts at patching. Mold may be present in some of the plaster. Some of the ceilings reveal multiple layers of peeling and sagging paint. In most areas, later roof and ceiling penetrations involving pipes and conduit appear to be the primary avenues for water infiltration.

Water damage to plaster and paint finishes.

Investigate the full extent and sources of water damage. Repair those conditions to arrest all avenues for water infiltration. Remove all damaged plaster, later non-original patch materials such as gypsum board or ceiling tiles.

Examine water damage to wood lath, patch and repair as required. Re-plaster and/or repair ceilings to match original plaster finish. Paint the ceilings white.

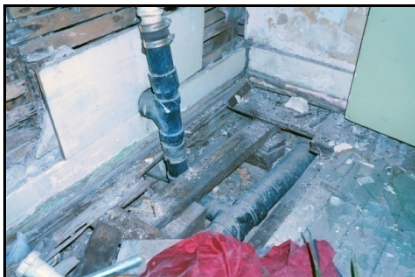
The original hardwood floors are approximately 95% intact and appear to be in good condition. The 3.5 inch wide boards are tongue and groove, with 3.25 inches exposure. They are 1 inch thick and placed on top of a 1 inch thick wood subfloor attached to the floor joists. Wood floors were not viewable in the carpeted Hallways but feel sturdy under foot.

Damaged and missing wood flooring.

Remove or abandon in place the newer waste plumbing and remove later non-full height walls in Rooms 04 and 05, then patch and match hardwood flooring. Patch, match and repair any other missing areas of wood flooring and sub-flooring as required.

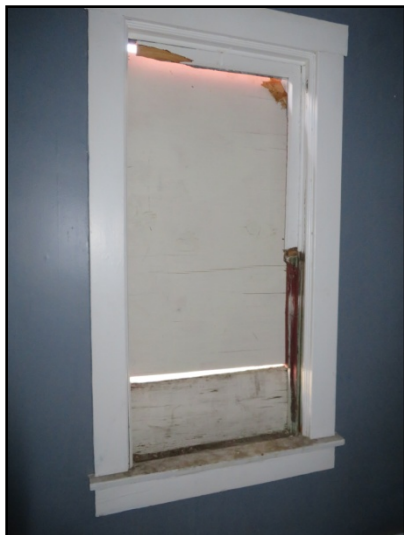
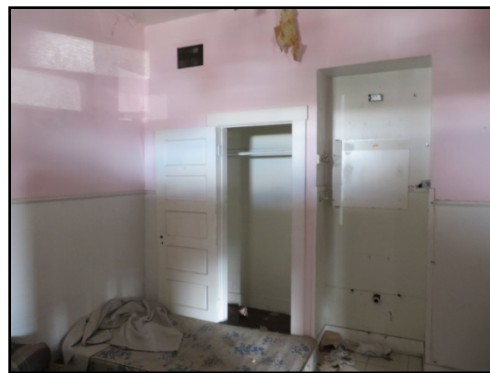
The majority of wood trims and millwork such as door and window moldings and base boards sills are original and in good condition. There are minor exceptions throughout where later alterations or remodeling occurred.

Missing trims and moldings where alterations or remodeling occurred.

Replicate profiles and patch to match all missing or altered trims and moldings where alterations or remodeling occurred.

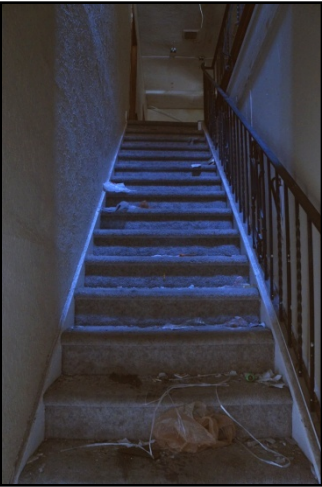
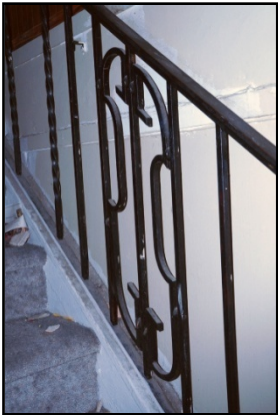
Interior stairs are intact and unaltered with the exception of the circa 1975 stairway enclosure. The original wrought iron balcony and stair railings are generally intact, missing only a few segments of wrought iron balustrades with decorative filigree. Carpet added to stair treads does not allow visual condition assessment, but the treads all felt firm and quite sturdy. The view of originally open stairway and a degree of openness from the Lobby has been lost due to its enclosure.

Stair enclosure is non-original and does not meet Code with door located at the bottom of the stairs disallowing proper access to the floor/landing.

Two segments of wrought iron balustrades with decorative filigree features at upper Hallway balcony are missing.

Open the stairway on the ground floor to fully expose the original chamfered wood columns and the decorative wood siding enclosing the lower portion of the stairs. Rehabilitate minor modifications and patch nail holes, etc. as required.

Restore all missing segments of wrought iron balustrades with decorative filigree on the upper balcony railing.

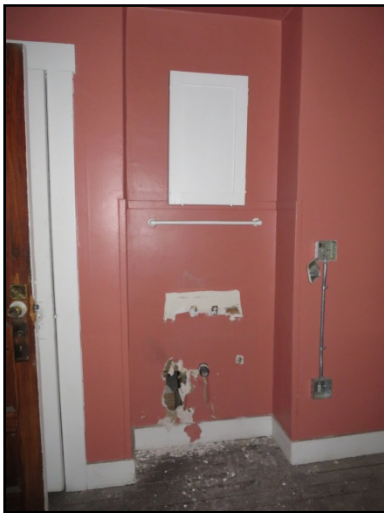
The plumbing systems could not be tested but are suspected to be marginally effective. There are only 2 bathrooms, one on each floor. There are sinks plumbed to each Guest Room but many are missing, with copper piping likely stolen for salvage value. In Guest Room 04, a poor attempt to add a toilet and sink was unsuccessful and has severely damaged the floor. It appears there are no original plumbing fixtures remaining with perhaps the exception of the upstairs tub which has been enclosed.

The entire plumbing system is likely compromised from extended non-use and decaying plumbing.

All new sewer waste and vent plumbing, domestic water copper piping and period appropriate plumbing fixtures are recommended. Sewer line cleanouts and wall cleanouts should be added to new sewer waste piping.

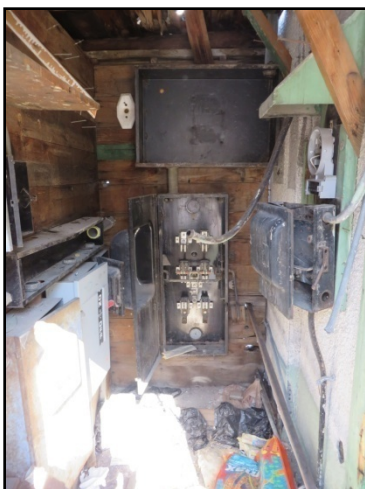
The majority of electrical systems and copper wiring were missing, likely stolen for salvage value. The outdated electrical distribution boxes were still in place in the Electrical shed located below the overhead electrical service. Evidence of later exposed conduit on the interior indicated an upgrade to the original fabric wrapped wiring with ceramic insulators found in the attic attached to ceiling joists.

None of the original lighting fixtures were found, and many of the later lighting fixtures are missing.

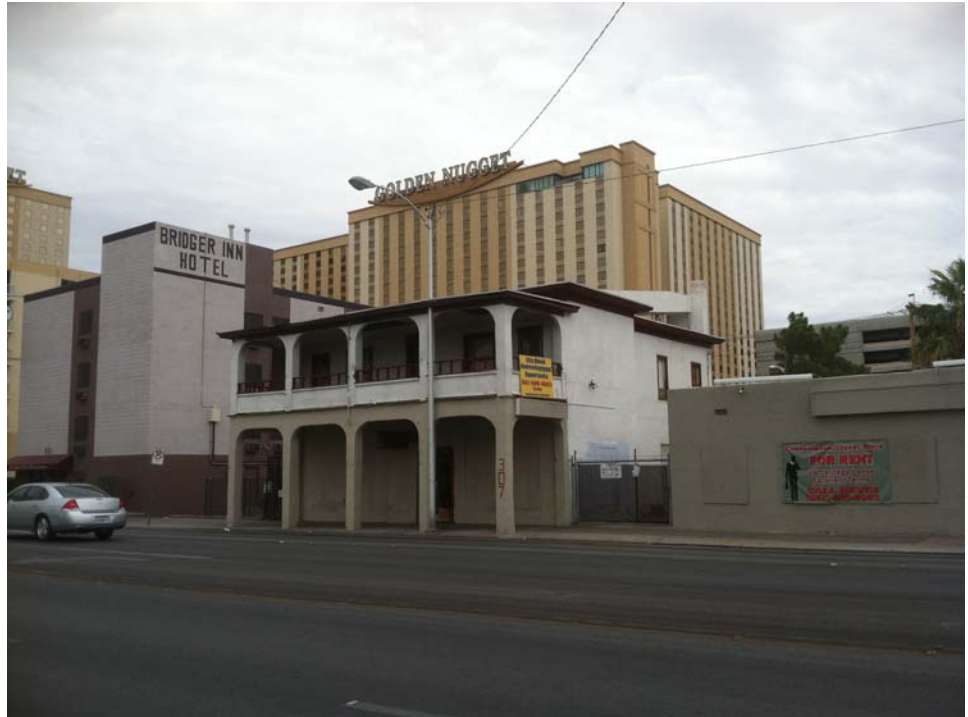
**Photograph 1:** View of the subject site facing northeast.

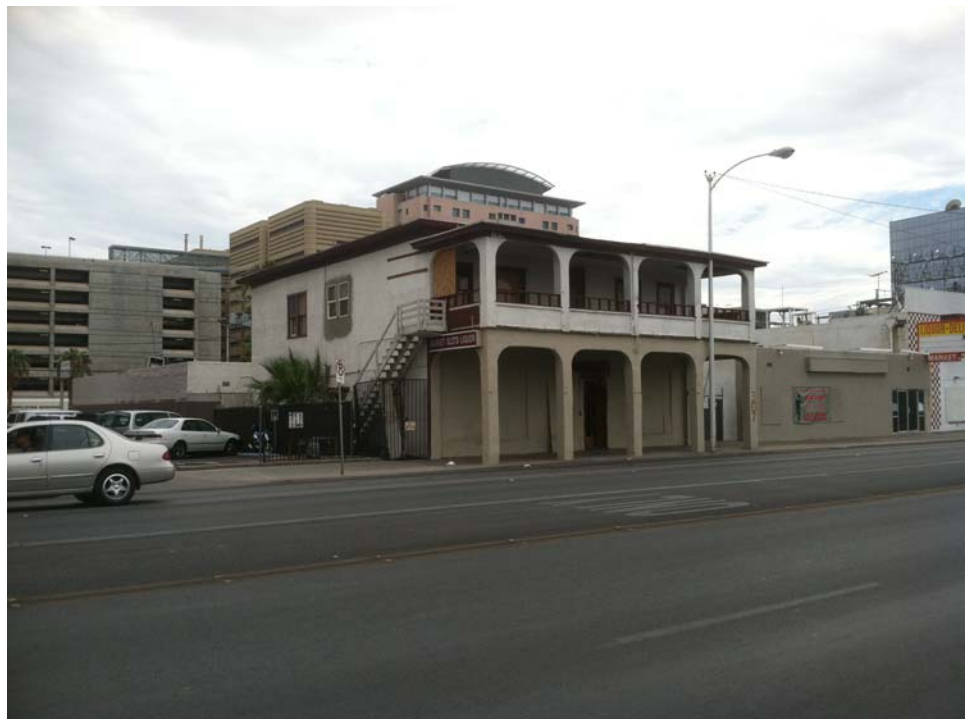
**Photograph 2:** View of the subject site facing southeast.

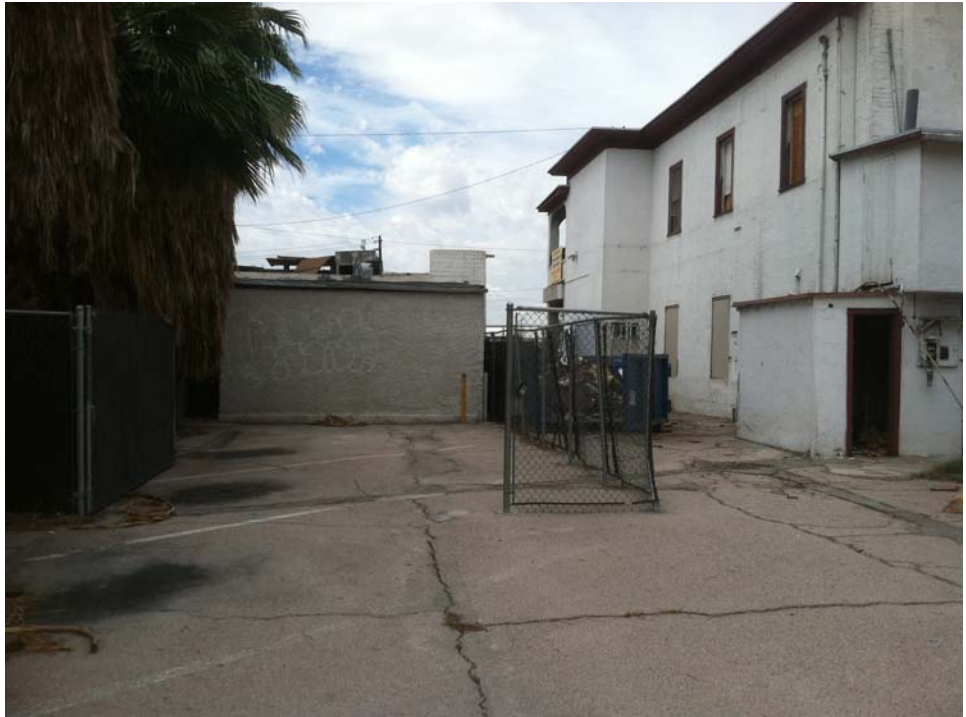
**Photograph 3:** View of south margin of main building, facing west.

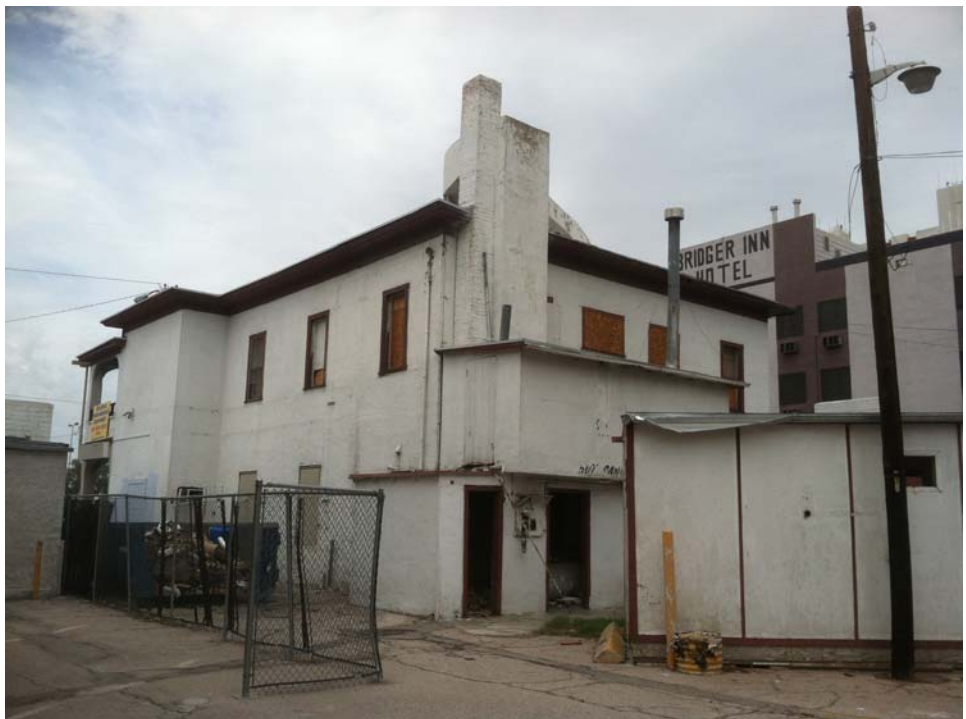
**Photograph 4:** View of south and west side of subject structure, facing northeast.

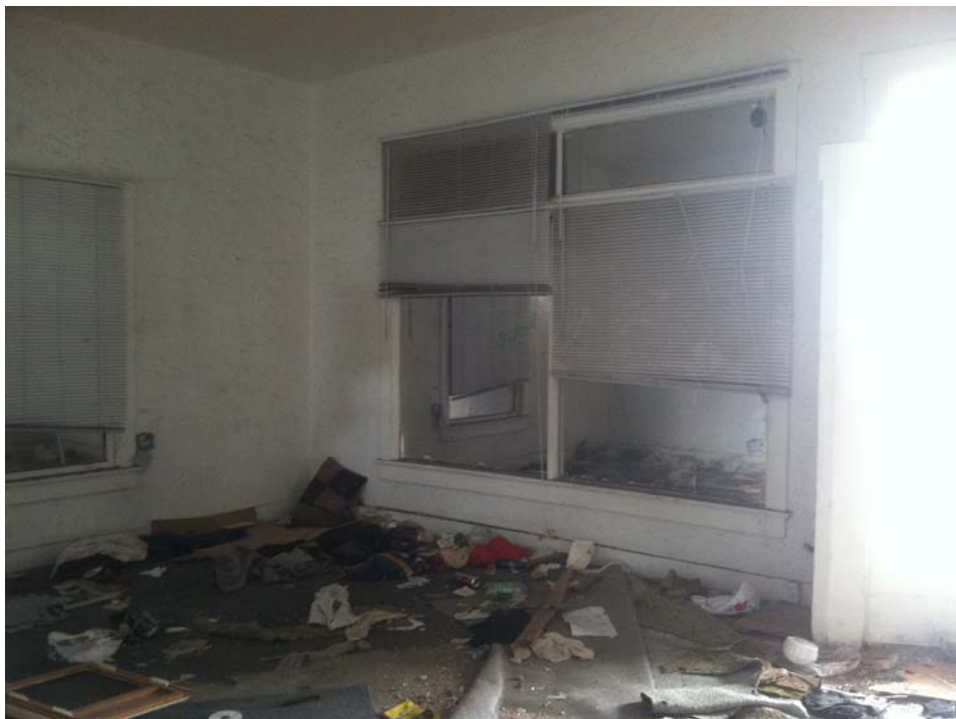
**Photograph 5:** View of lobby area of main structure.

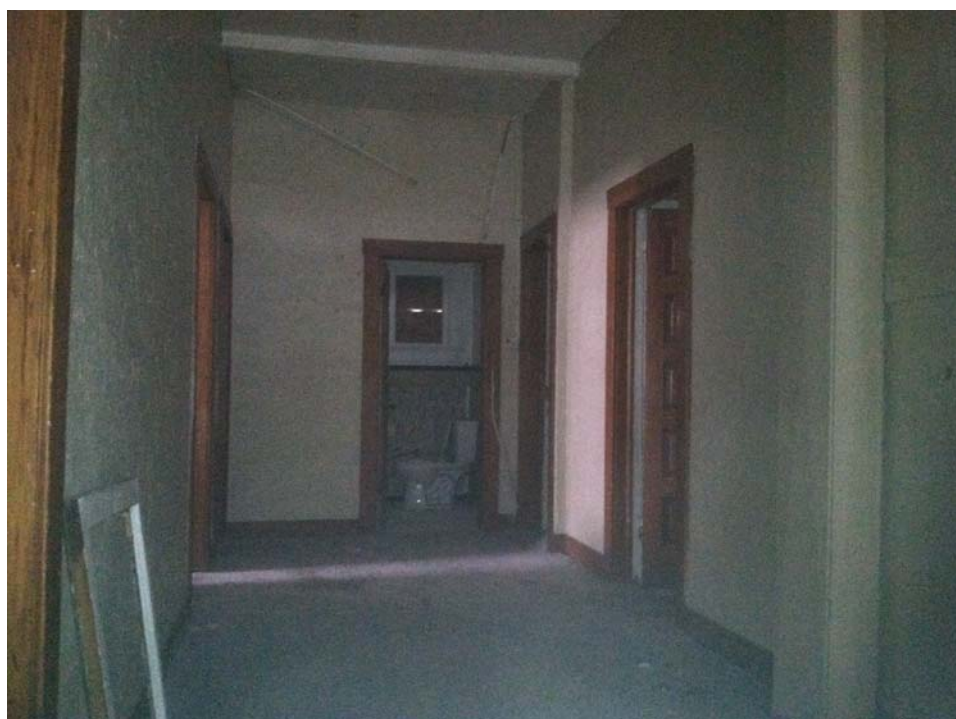
**Photograph 6:** View of second floor hallway, facing east.

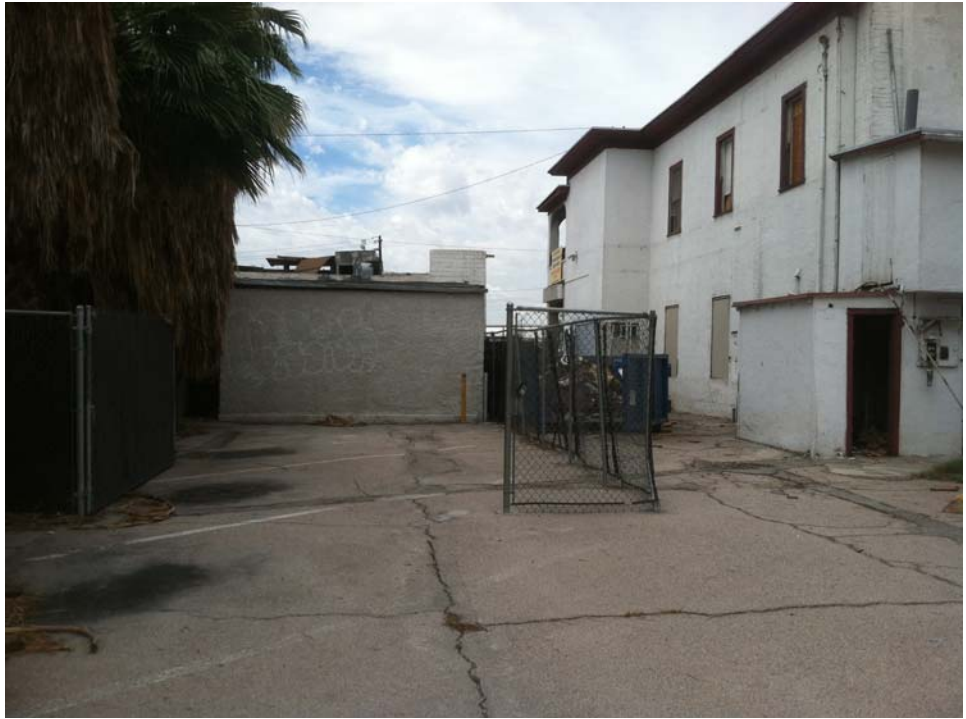
**Photograph 3:** View of south margin of main building, facing west.

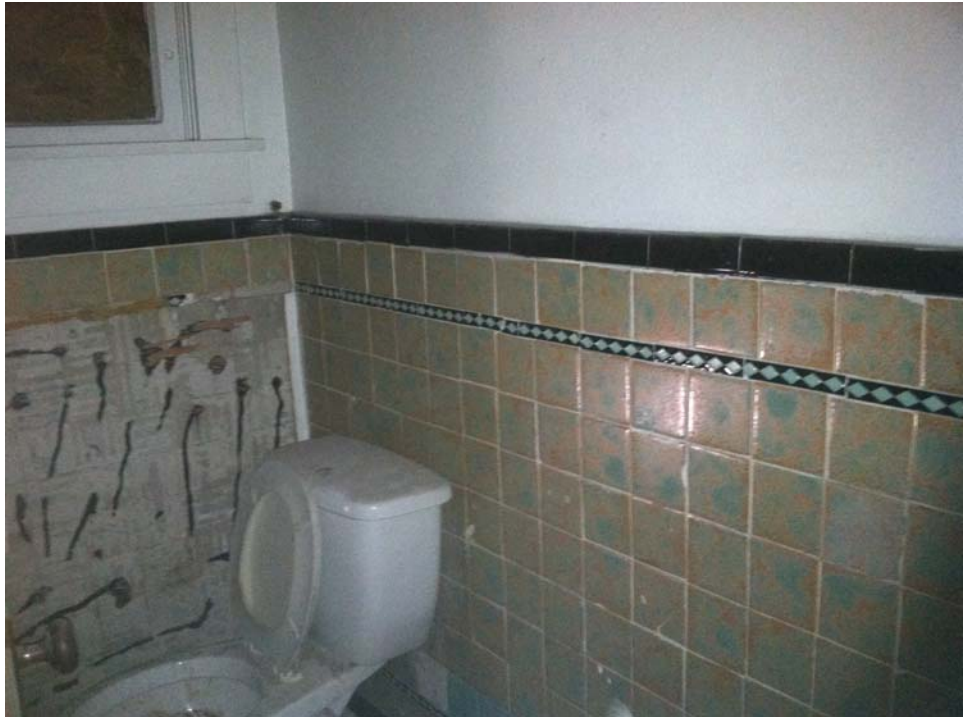
**Photograph 7:** View of the second floor common restroom wall with wall and bull nose tile.

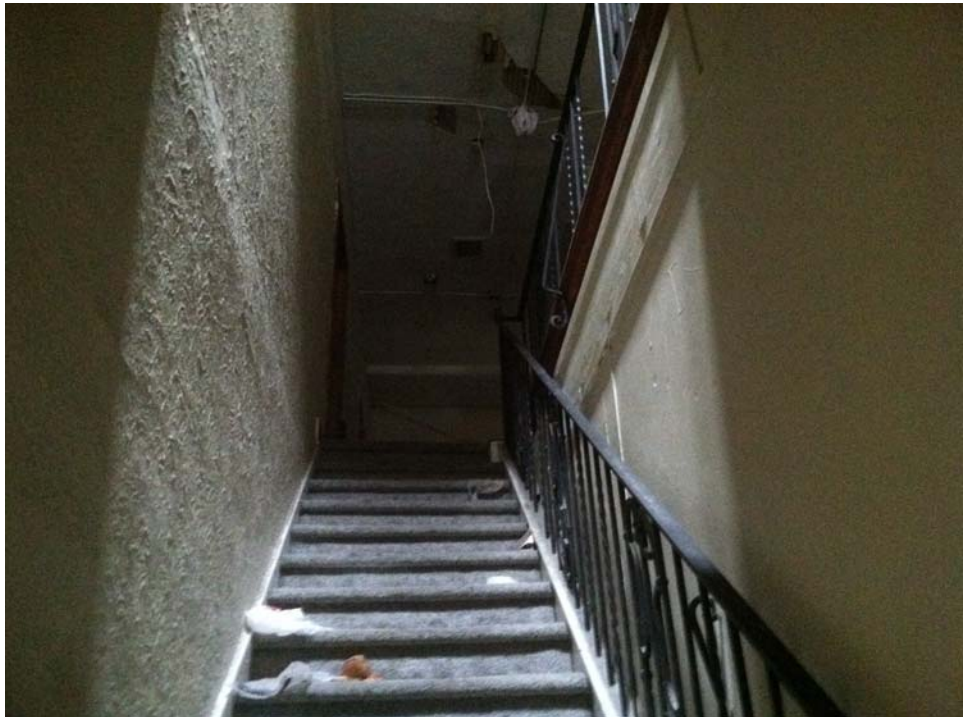
**Photograph 8:** View of the stairwell with heavy texture.

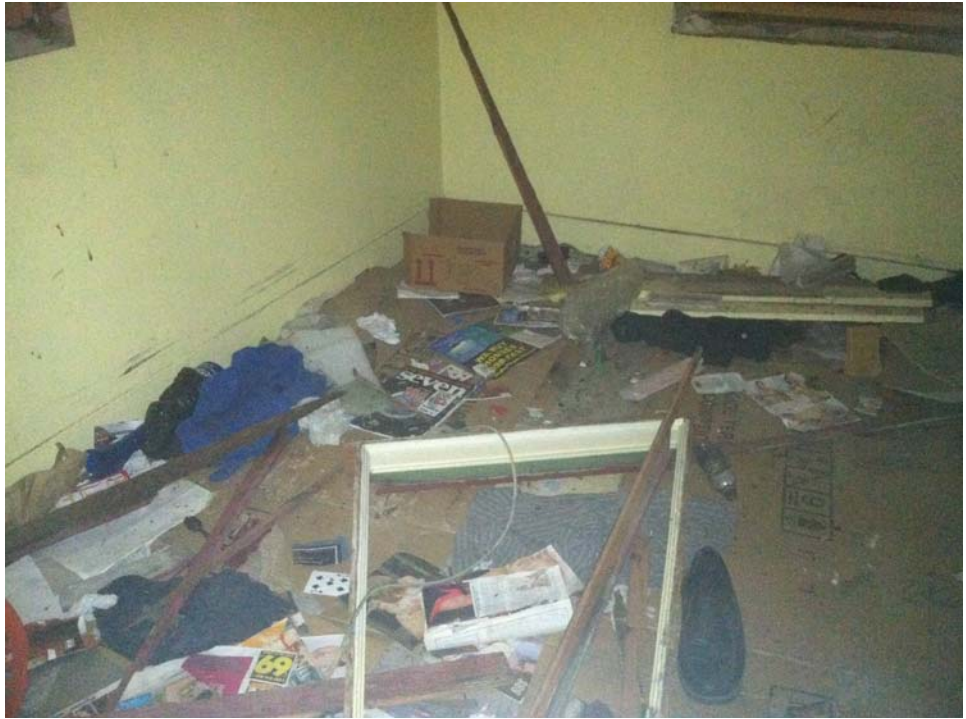
**Photograph 9:** View of window frame debris in Room 4.

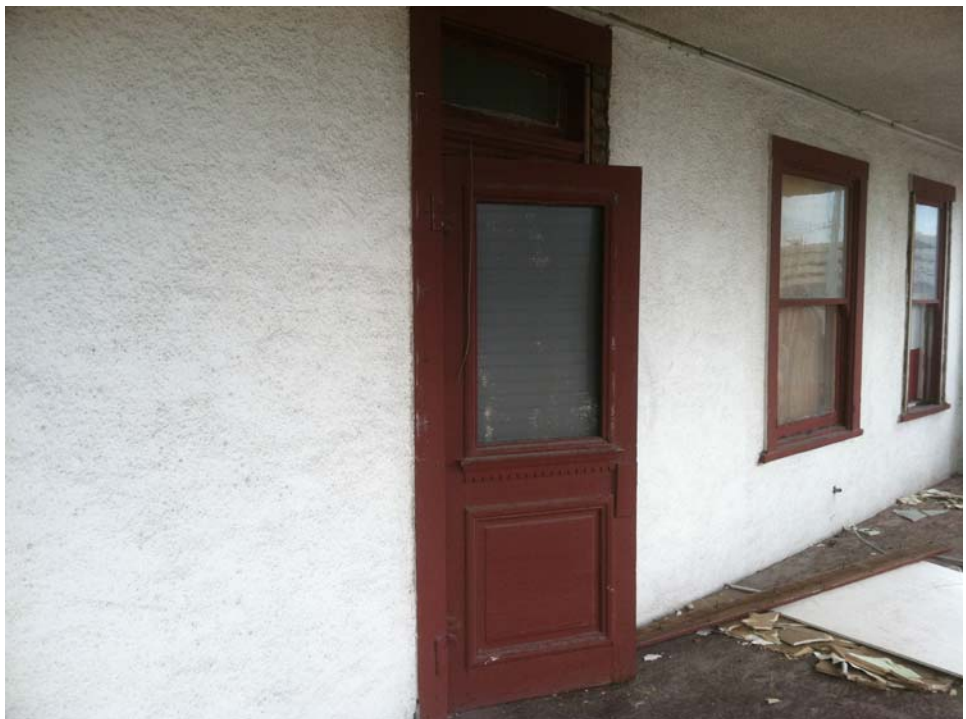
**Photograph 10:** View of exterior balcony door and south window.
