HSA Architects, Inc.
ARCHITECTURE PLANNING INTERIORS
1531 West Oakey Boulevard, Las Vegas, Nevada 89102
(702) 383-0077

Sheet Title: **ROOF PLANS**
Job Title: **FLOYD LAMB STATE PARK**
Job No: **910902.0**
Date: **7/1/94**
Drawn By: **GMH**
Check: **TS**
Sheet: **A5.1**
Of: **24**

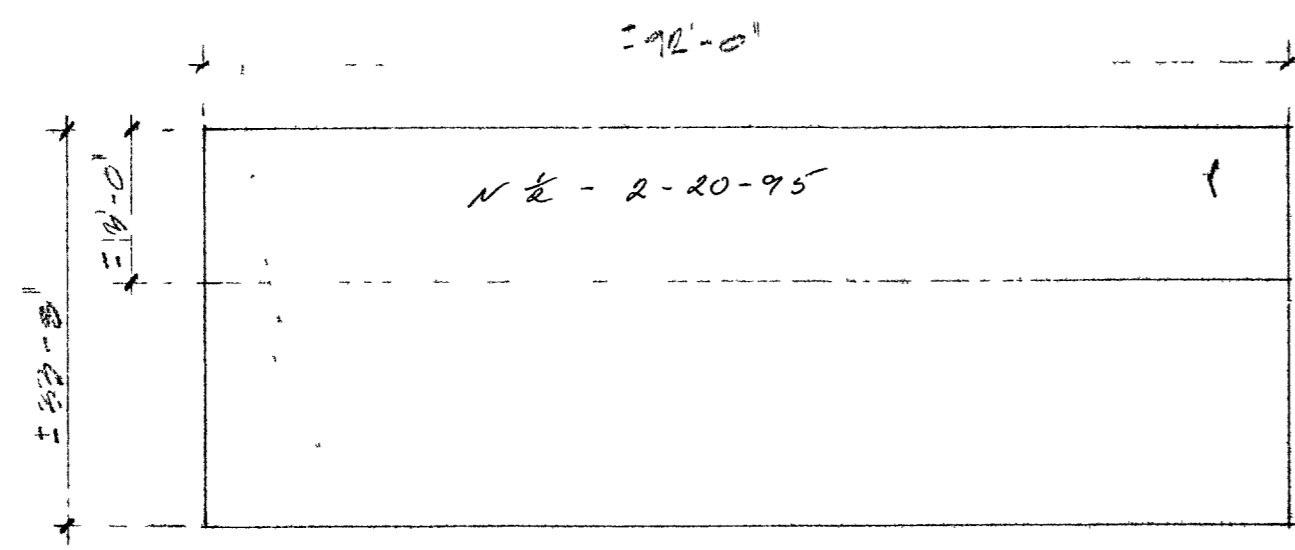
BUILDING #17
EVENT HOUSE
118'-0" V.B.I.
96'-0" H.B.I.

REMOVE ALL EXISTING EAVES - IS. REMOVE EXISTING 1x SHEATHING & GABLES. REPAIR ROOF (FIELD VERIFY) WITH METAL SHEATHING. REPAIR TO CORRESPONDING TO EXISTING. 1x SHEATHING & GABLES. REFER TO 1/ASB.

EXISTING STRUCTURE: 2x6 RAFTERS @ 24" O.C. 1x 2x6 OUTSHEATHING & RAKE PAGES.

NOTE: ROOF SQUARE FOOTAGE: 8826 SF

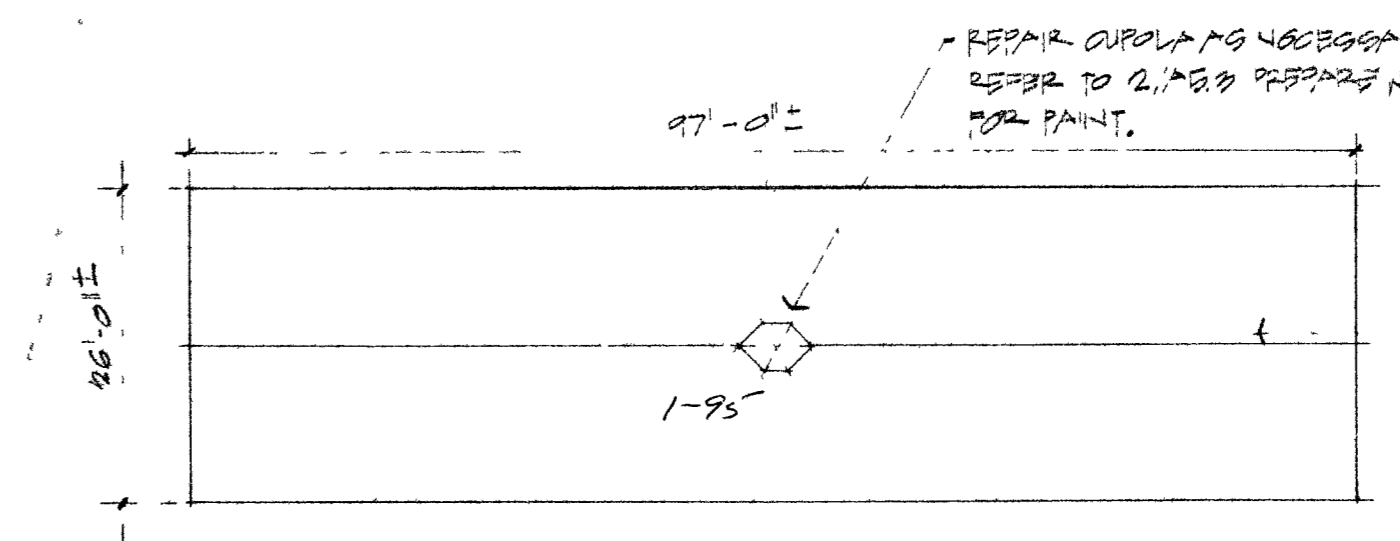
BUILDING #18
DAIRY BUILDING
26'-0" V.B.I.
97'-0" H.B.I.

EXISTING STRUCTURE: 2x6 RAFTERS @ 24" O.C. 1x 2x6 OUTSHEATHING, RAKE PAGES, 1x SHEATHING.

NOTE: ROOF SQUARE FOOTAGE: 2732 SF

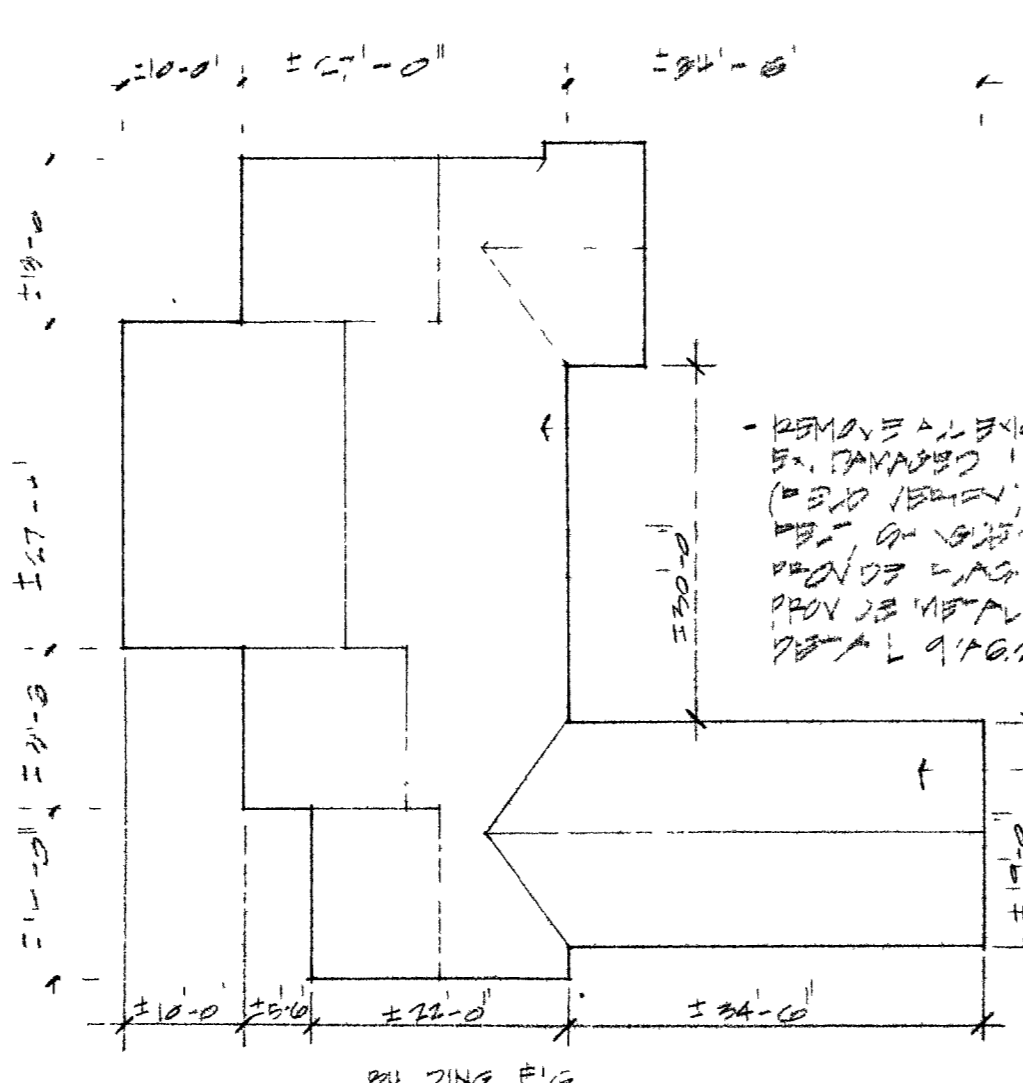
BUILDING #16
VETOPS CENTER
BASE BLDG
116'-0" V.B.I.
118'-0" H.B.I.

REMOVE ALL EXISTING ROOF SHEATHING & EAVES. REMOVE EXISTING 1x SHEATHING & GABLES. REPAIR ROOF (FIELD VERIFY) WITH METAL SHEATHING. REPAIR TO CORRESPONDING TO EXISTING. 1x SHEATHING & GABLES. REFER TO 1/ASB.

NOTE: ROOF SQUARE FOOTAGE: 4400 SF

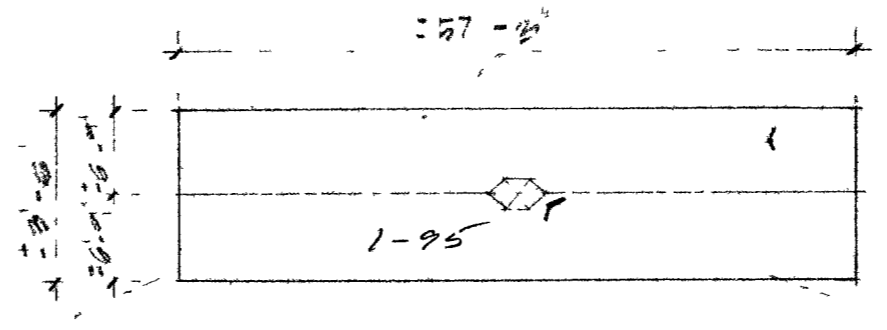
BUILDING #19
CHICKEN COOP
16'-0" V.B.I.
97'-0" H.B.I.

REMOVE EXISTING STRUCTURE. 2x6 RAFTERS @ 24" O.C. 1x 2x6 OUTSHEATHING & RAKE PAGES. 1x SHEATHING. REFER TO 1/ASB.

NOTE: ROOF SQUARE FOOTAGE: 881 SF

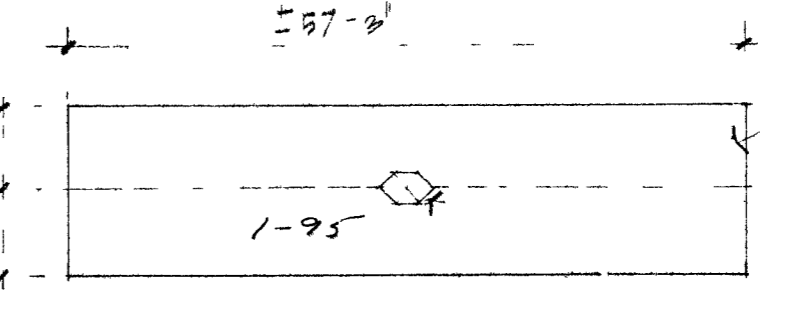
BUILDING #20
CHICKEN COOP
16'-0" V.B.I.
97'-0" H.B.I.

EXISTING STRUCTURE: 2x6 RAFTERS @ 24" O.C. 1x 2x6 OUTSHEATHING & RAKE PAGES. 1x SHEATHING.

REPAIR CUPOLAS AS NECESSARY. FIELD VERIFY. REFER TO 1/ASB FOR REPAIRS & METAL SHEATHING.

NOTE: ROOF SQUARE FOOTAGE: 881 SF

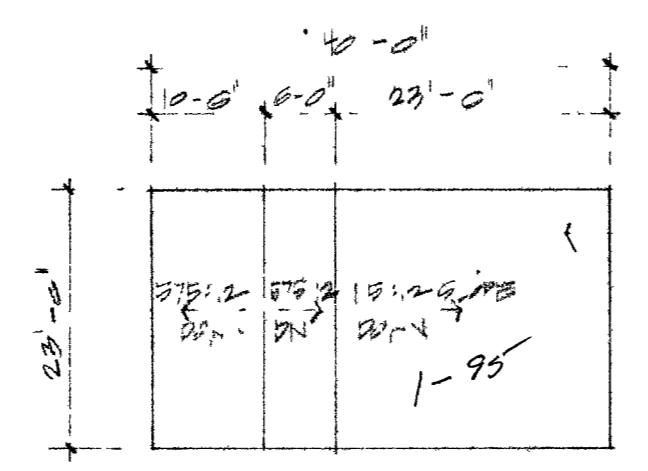
BUILDING #22
DOVE HUT
23'-0" V.B.I.
23'-0" H.B.I.

REMOVE ROOF SHEATHING. 2x6 RAFTERS @ 24" O.C. 1x 2x6 OUTSHEATHING & RAKE PAGES. 1x SHEATHING.

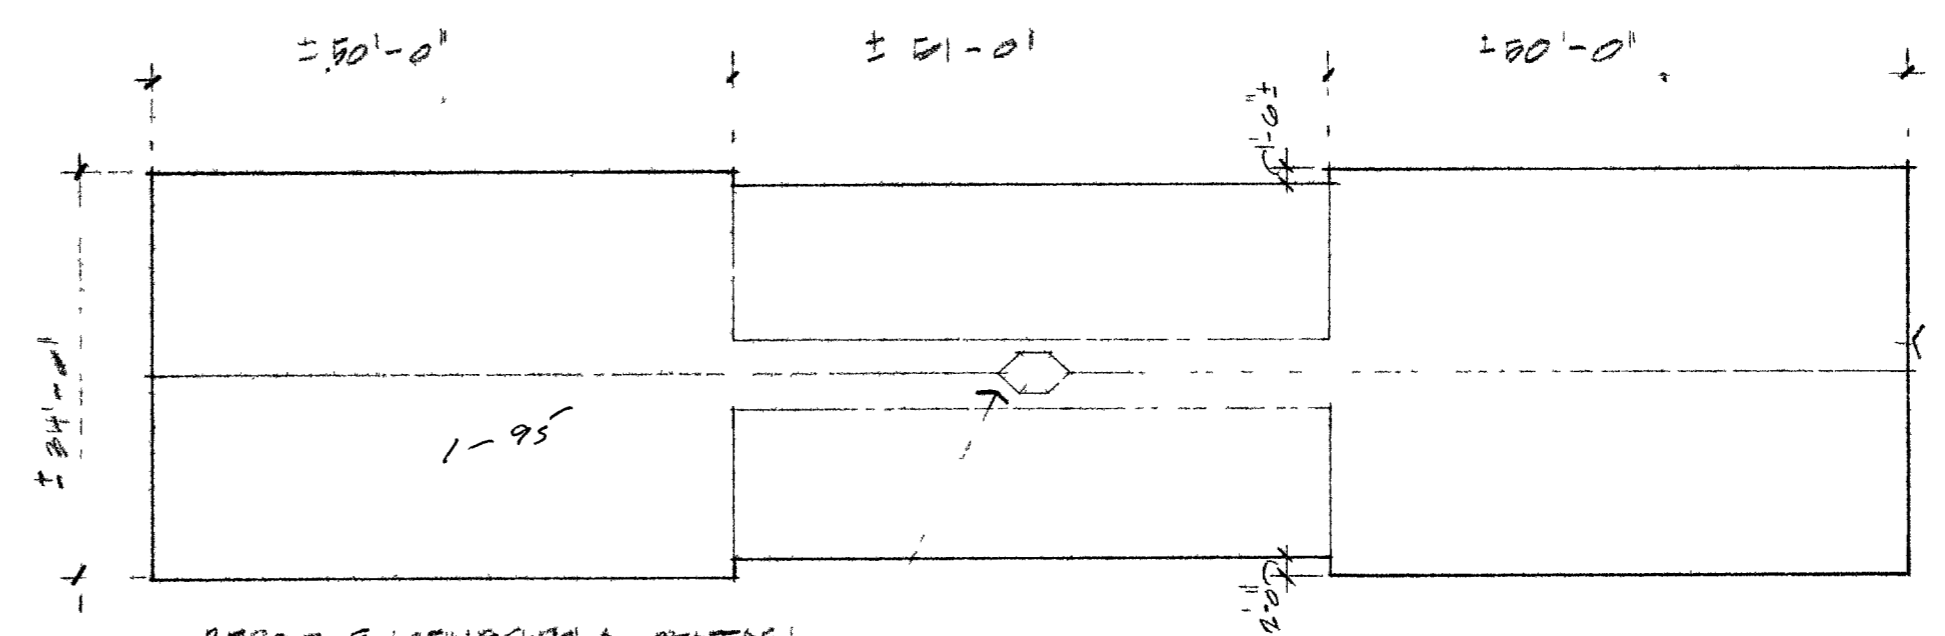
BUILDING #23
MACHINE BUILDING
10'-0" V.B.I.
110'-0" H.B.I.

EXISTING STRUCTURE: 2x6 RAFTERS @ 24" O.C. 1x 2x6 OUTSHEATHING, RAKE PAGES, 1x SHEATHING.

REPAIR EXISTING CUPOLAS, EAVES, & RAFTERS. REFER TO 1/ASB.

NOTE: ROOF SQUARE FOOTAGE: 6340 SF

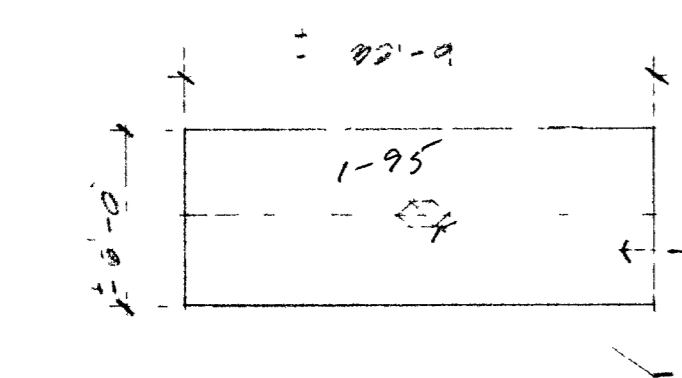
BUILDING #24
PIG PEN
12'-0" V.B.I.
22'-0" H.B.I.

REMOVE EXISTING CUPOLAS. 2x6 RAFTERS @ 24" O.C. 1x 2x6 OUTSHEATHING & RAKE PAGES. 1x SHEATHING.

NOTE: ROOF SQUARE FOOTAGE: 3640 SF

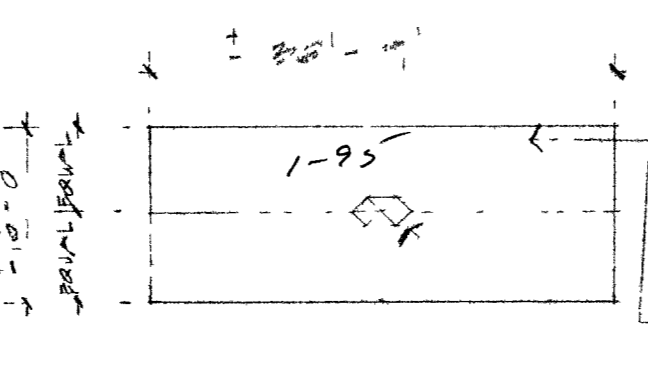
BUILDING #25
ANIMAL HOUSE
23'-0" V.B.I.
23'-0" H.B.I.

EXISTING STRUCTURE: 2x6 RAFTERS @ 24" O.C. 1x 2x6 OUTSHEATHING.

NOTE: ROOF SQUARE FOOTAGE: 640 SF

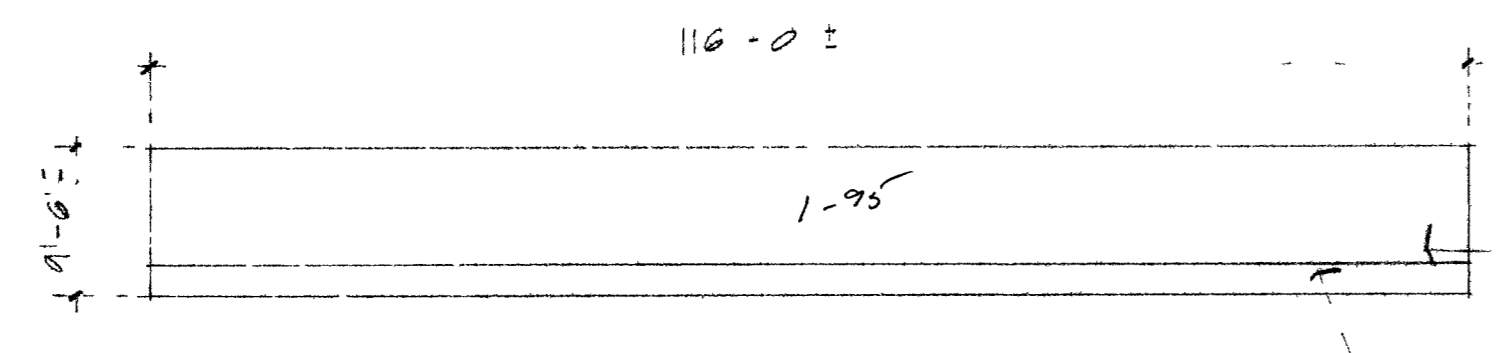
BUILDING #27
PIG PEN
11'-0" V.B.I.
116'-0" H.B.I.

EXISTING STRUCTURE: 2x6 RAFTERS @ 24" O.C. 1x 2x6 OUTSHEATHING.

NOTE: ROOF SQUARE FOOTAGE: 1195 SF

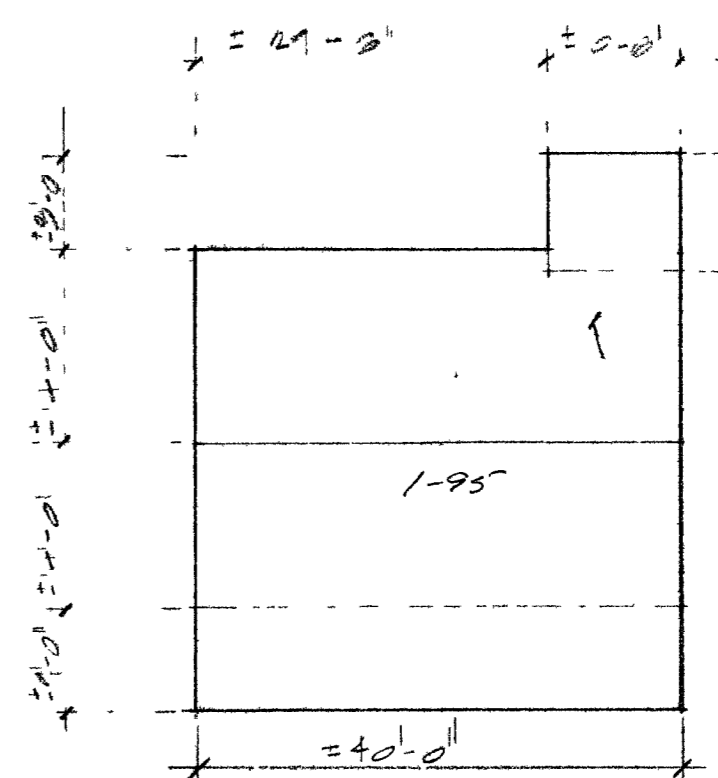
BUILDING #28
BUNKHOUSE
21'-0" V.B.I.
42'-0" H.B.I.

REMOVE ALL EXISTING ROOF SHEATHING. 2x6 RAFTERS @ 24" O.C. 1x 2x6 OUTSHEATHING, RAKE PAGES, 1x SHEATHING.
