**DRAFT REPORT  
CITY OF LAS VEGAS  
DOWNTOWN STORM DRAIN ASSESSMENT**

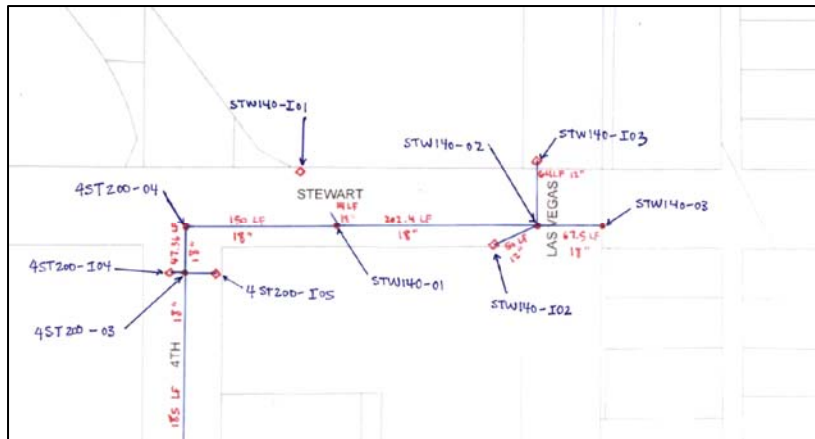
**Figure A Storm Drain Feature Naming**

The adopted convention was to name the manholes starting from the upstream end going to the downstream end using the current “IDMile” of the pipeline. An example of this is shown below.

The City desired to continue to use the “IDMile” convention and has provided existing GIS data labeled in this system. The City elected to permit Brown and Caldwell to name the manholes and drain inlets using the existing “IDMile” system and improvise as necessary. When the City receives the survey and CCTV they will modify the naming to fit their convention.
