# Key Notes

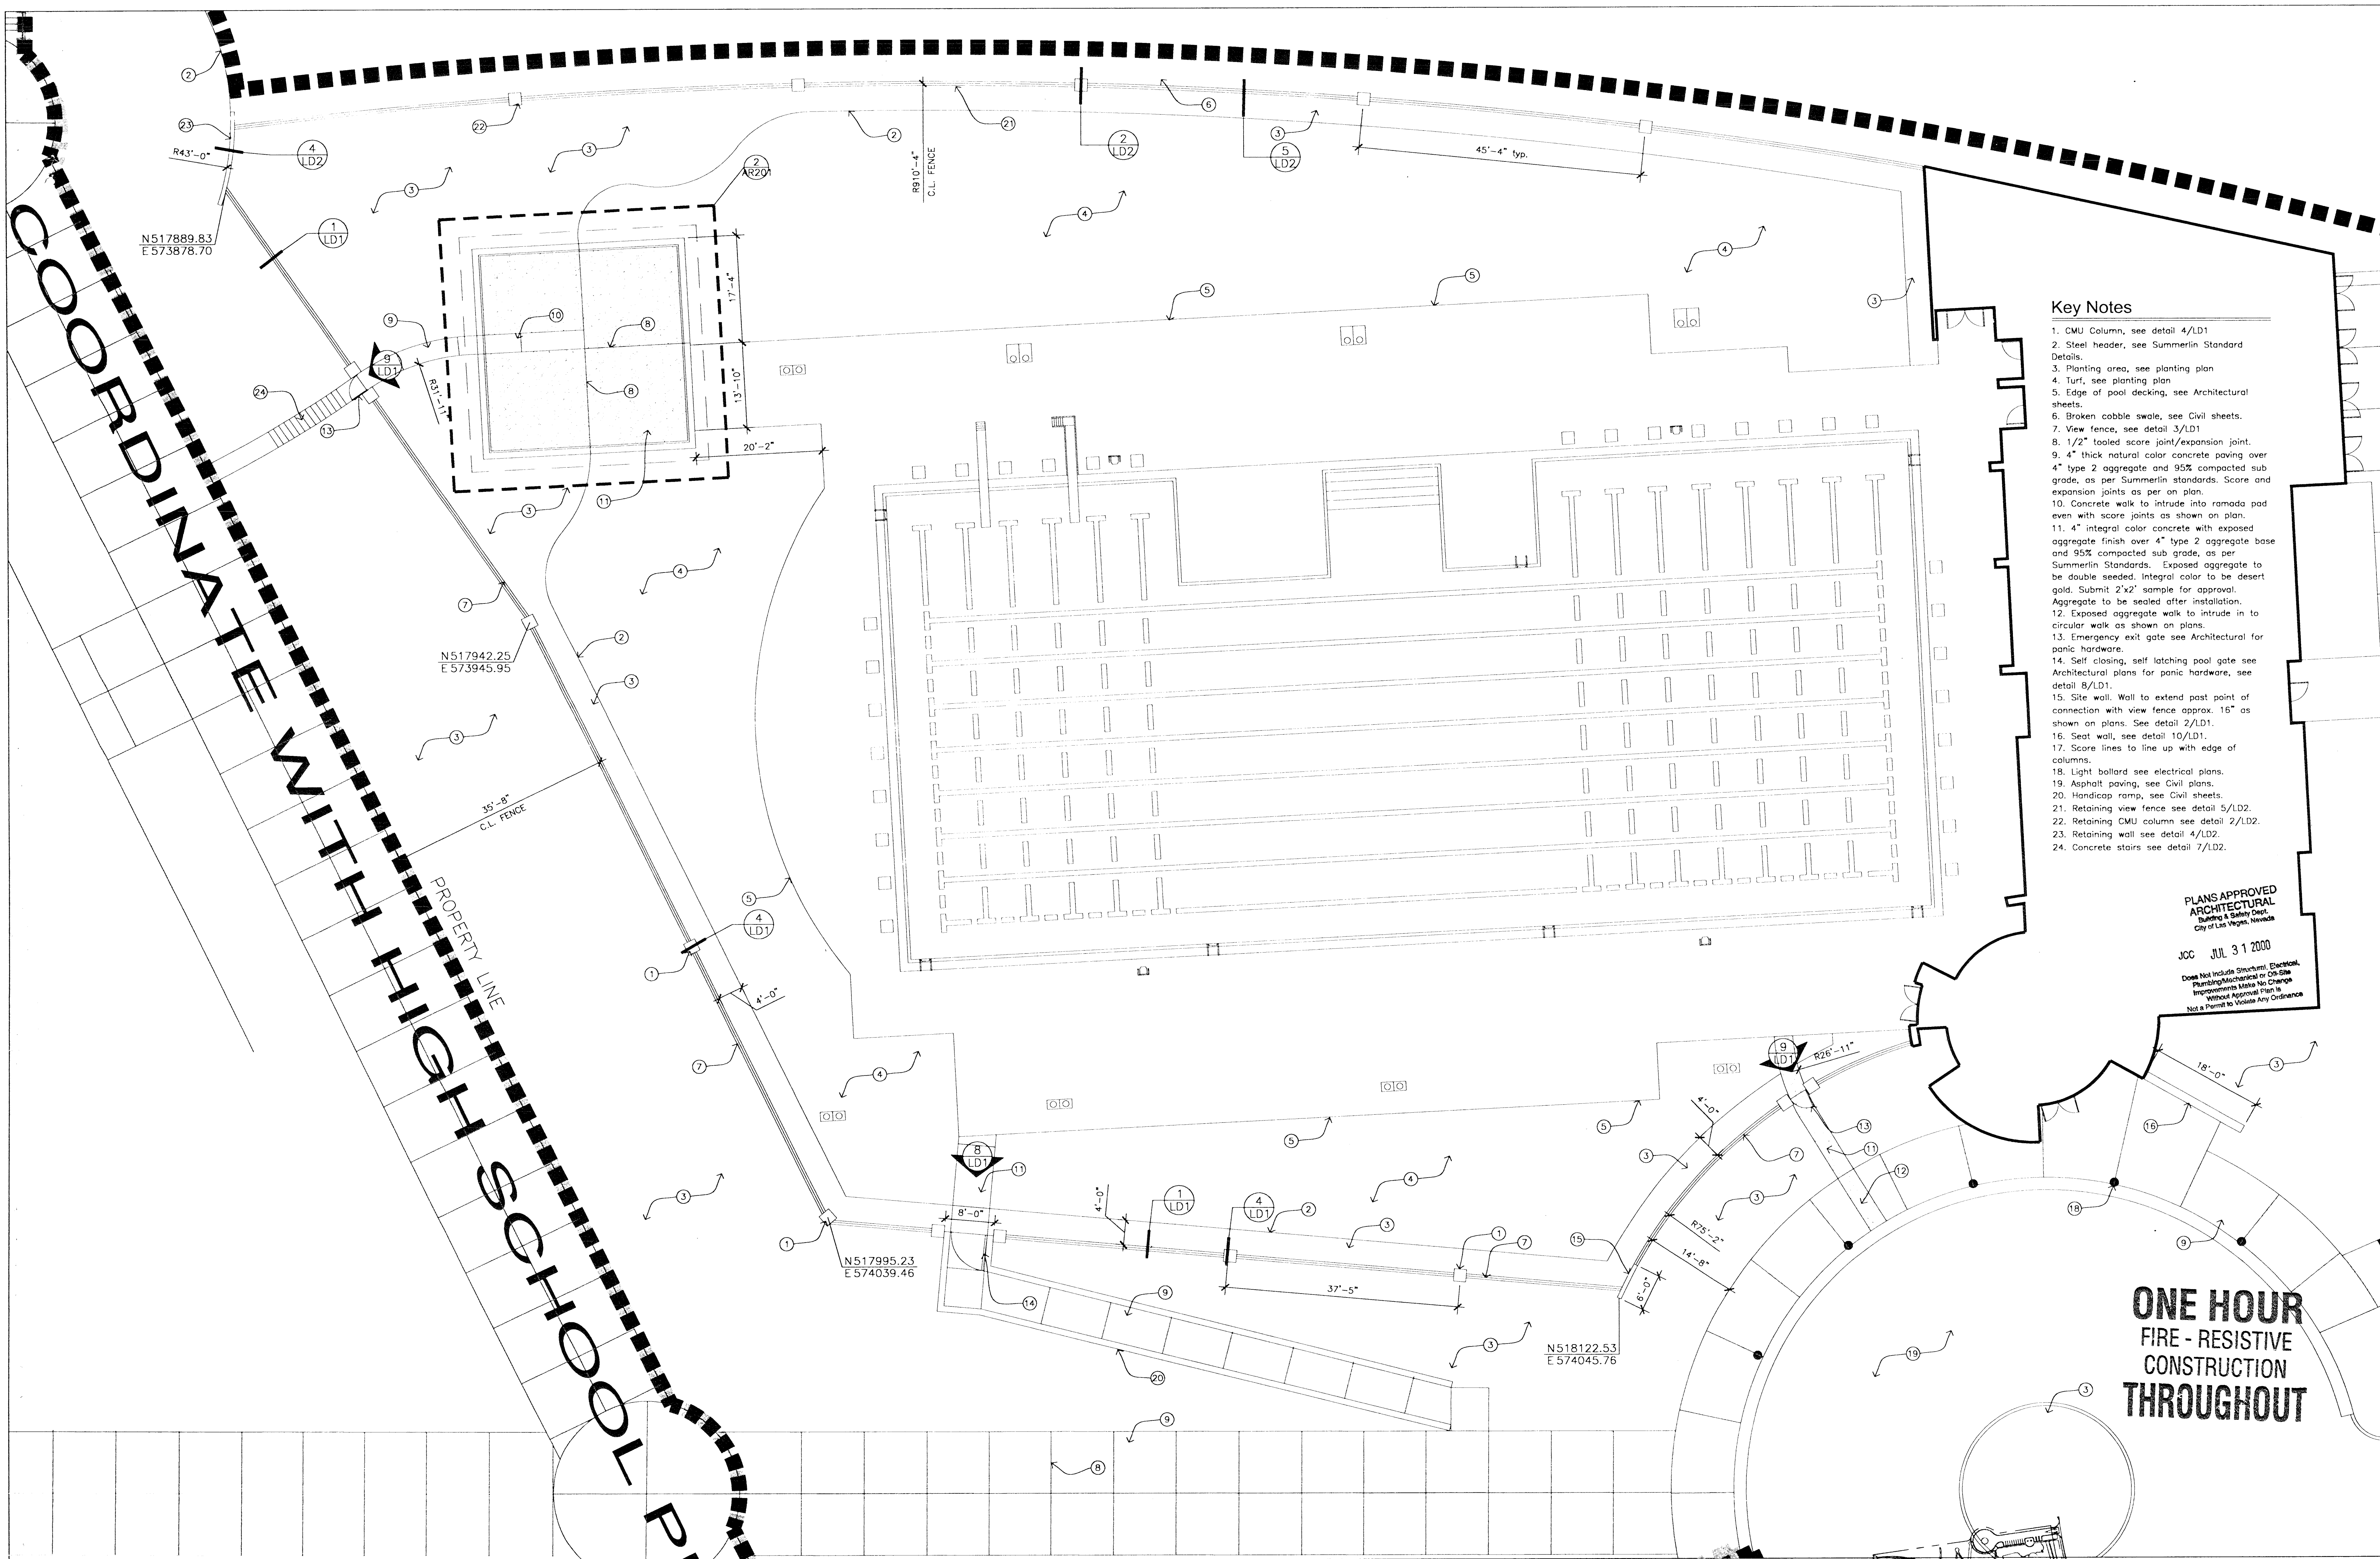
1. CMU Column, see detail 4/LD1
2. Steel header, see Summerlin Standard Details.
3. Planting area, see planting plan
4. Turf, see planting plan
5. Edge of pool decking, see Architectural sheets.

6. Broken cobble swale, see Civil sheets.
7. View fence, see detail 3/LD1
8. 1/2" tooled score joint/expansion joint.
9. 4" thick natural color concrete paving over 4" type 2 aggregate and 95% compacted sub grade, as per Summerlin standards. Score and expansion joints as per on plan.

10. Concrete walk to intrude into ramada pad even with score joints as shown on plan.
11. 4" integral color concrete with exposed aggregate finish over 4" type 2 aggregate base and 95% compacted sub grade, as per Summerlin Standards. Exposed aggregate to be double seeded. Integral color to be desert gold. Submit 2"x2" sample for approval. Aggregate to be sealed after installation.

12. Exposed aggregate walk to intrude into circular walk as shown on plans.
13. Emergency exit gate see Architectural for panic hardware.
14. Self closing, self latching pool gate see Architectural plans for panic hardware, see detail 8/LD1.

15. Site wall. Wall to extend past point of connection with view fence approx. 18" as shown on plans. See detail 2/LD1.
16. Seat wall, see detail 10/LD1.

17. Score lines to line up with edge of columns.
18. Light bollard see electrical plans.
19. Asphalt paving, see Civil plans.
20. Handicap ramp, see Civil sheets.

21. Retaining view fence see detail 5/LD2.
22. Retaining CMU column see detail 2/LD2.
23. Retaining wall see detail 4/LD2.
24. Concrete stairs see detail 7/LD2.
